Preventing Electrocutions During Work with Scaffolds Near Overhead Power Lines

AUGUST 1991

DHHS (NIOSH) PUBLICATION NUMBER 91-110

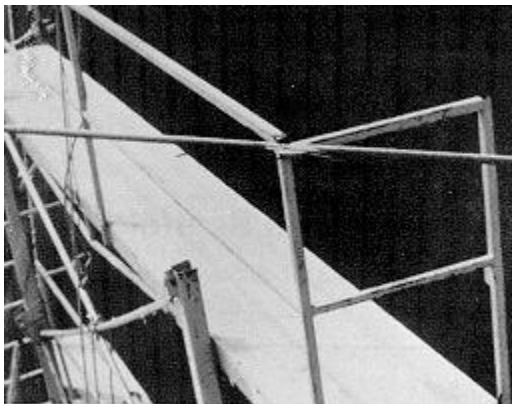
When scaffolds, conductive tools, or other materials contact overhead power lines (see Figure 1), workers receive serious and often fatal injuries. Data from the NIOSH National Traumatic Occupational Fatalities (NTOF) data base indicate that nearly 6,500 traumatic work-related deaths occur each year in the United States; an estimated 7% of these fatalities are electrocutions [NIOSH 1991]. The NTOF data base also shows that from 1980 through 1986, at least 25 deaths resulted when workers contacted overhead power lines while erecting or moving scaffolds or while using conductive tool on scaffolds.

Figure 1. *Metal scaffold contacting an overhead power line.*
