REPORT#: 23CA003

REPORT DATE: July 25, 2024

Ironworker Working in a Trench Dies When He Is Crushed by an Adjacent Retaining Wall That Fell on Him — California

State FACE Program

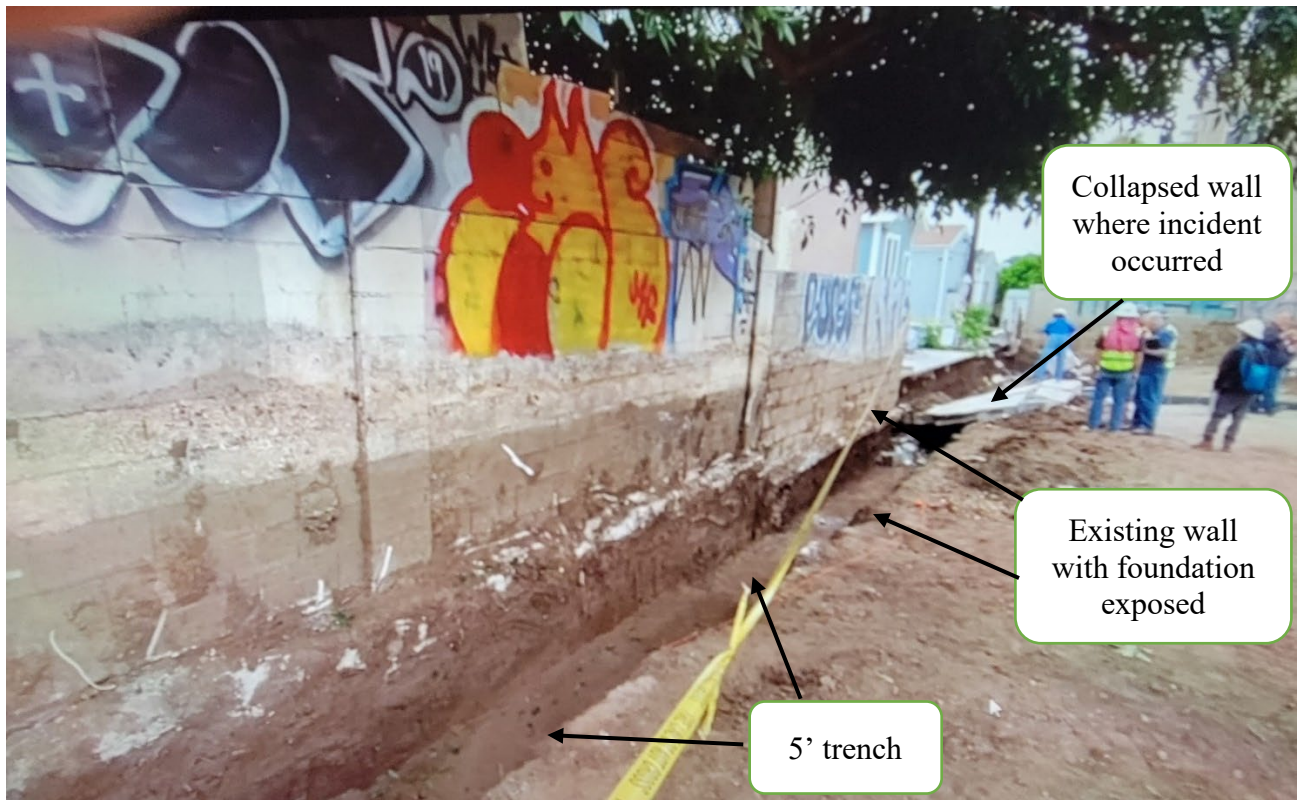
The incident scene was a vacant lot that was being prepared for the construction of a warehouse. A general contractor was building the warehouse, and the employer (subcontractor) was building a perimeter wall on the south side of the lot bordering a mobile home park. The fatality occurred in a five-foot deep, 150-foot-long trench (Exhibit 1) where the foundation for the new perimeter wall would be.

Exhibit 1. The incident scene depicting the trench in relation to the existing retaining wall. Photo courtesy of KTLA 5 News.

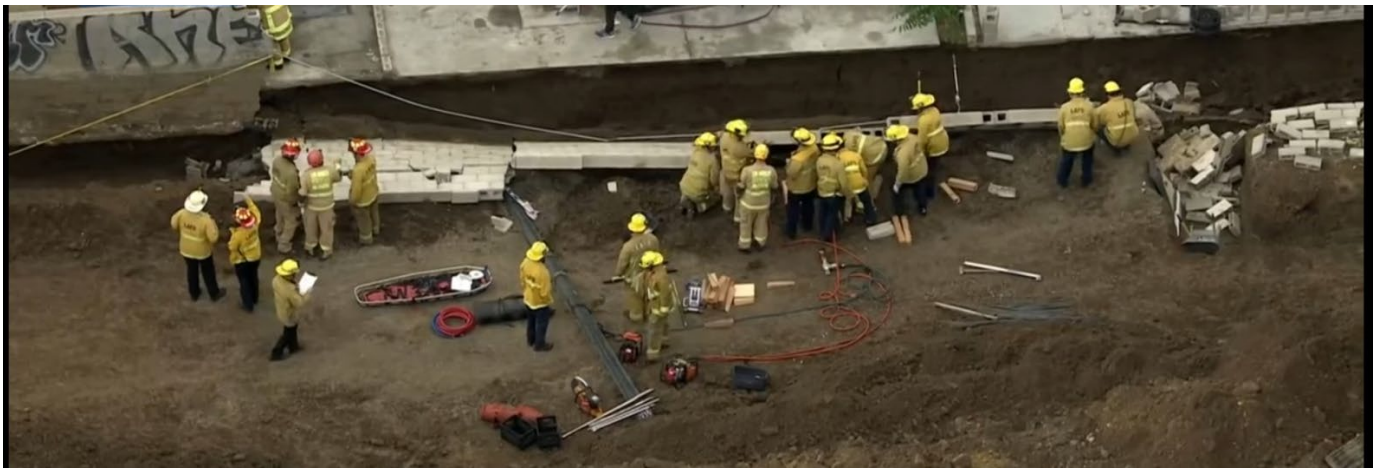
On the morning of the incident, the victim and three co-workers reported to the location to begin work. They entered the trench and began installing rebar for the new retaining wall. The workers dug below the level of the base or footing of the adjacent retaining wall. Shoring was not in place and no bracing or underpinning was used to ensure the stability of the existing wall. While they were working in the trench, the retaining wall suddenly collapsed. Two of the workers were able exit the trench unharmed. 911 was immediately called and the fire department and rescue squads arrived and attempted to rescue the two remaining trapped workers (Exhibit 2). One worker was removed successfully and transported to the hospital for treatment, but the victim was pinned underneath the retaining wall and died at the scene.

Exhibit 2. The incident scene from overhead. Photo courtesy of ABC Air 7 HD News.
