**REPORT#:** 2023OR01

## Lumber mill employee fatally struck by forklift—Oregon

#### Oregon Fatality Assessment and Control Evaluation Program

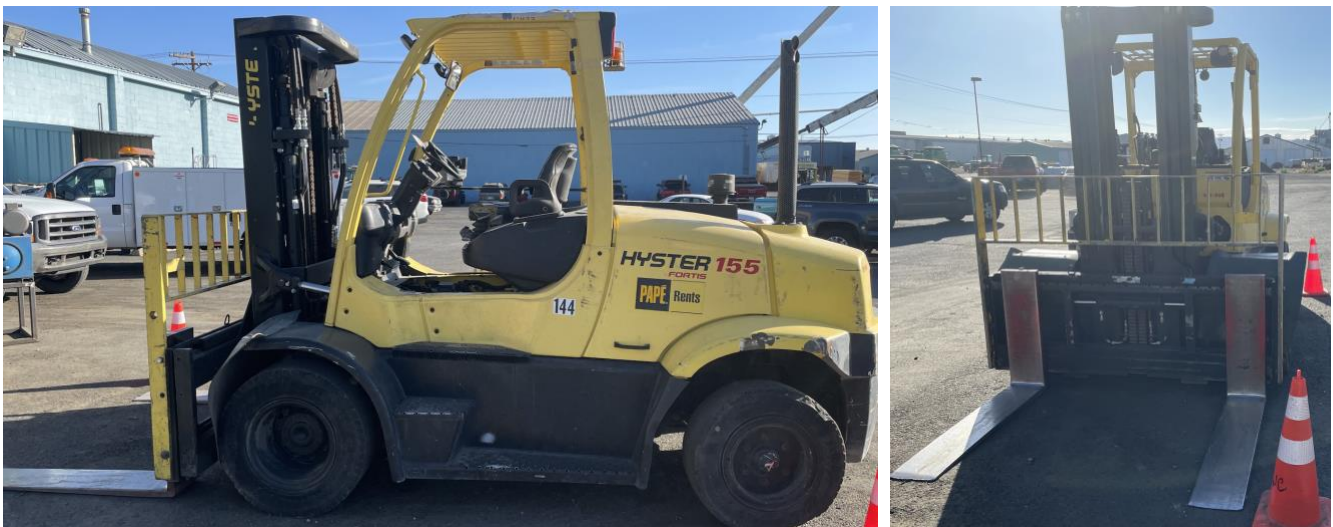
The equipment involved in this incident was a Hyster Forklift Model H155FT. This particular model has a maximum load capacity of 14,350 pounds and without a load, the forklift itself weighs 21,900 pounds. The tread width of this forklift was 72.6 inches. At the time of the collision, the forklift was carrying a load of two 12-foot-long lumber units. The height of the forklift load was 51 inches, 5 inches shorter than the backrest of the forklift.

**Image 1. Side and front view of the forklift involved in incident (courtesy of OR-OSHA).**

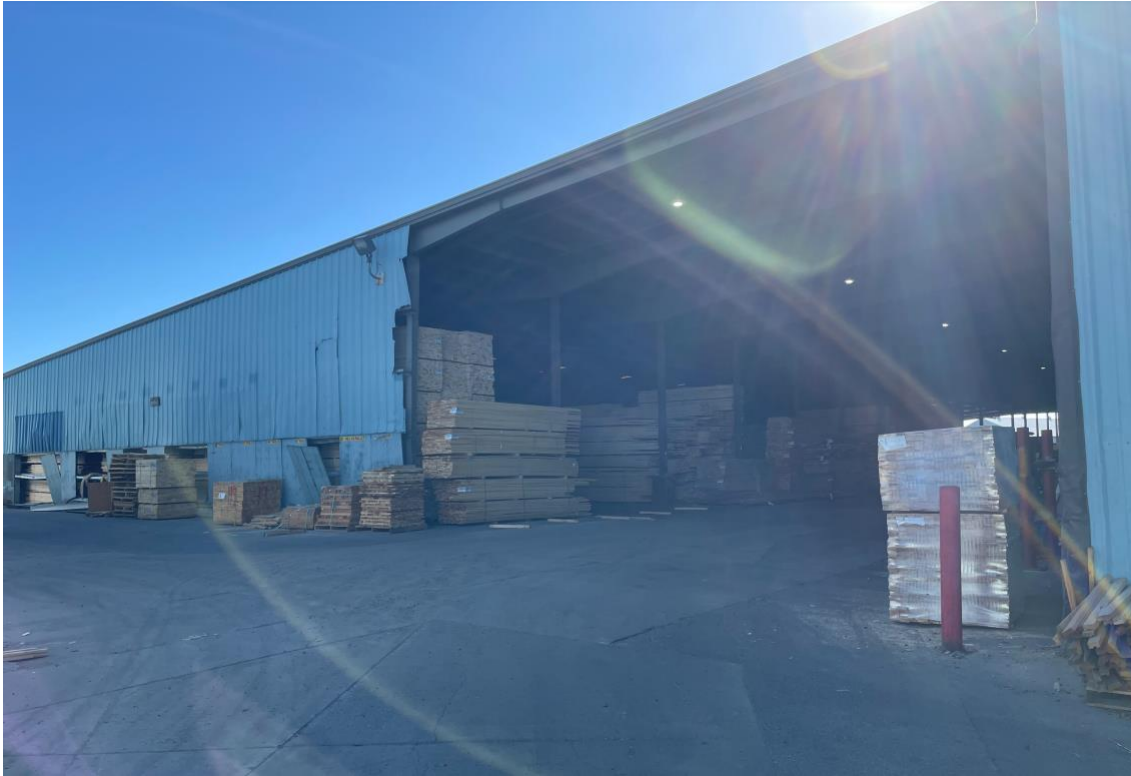
The weather on the day of the incident was approximately 60°F at 9:00am, and reached a high temperature of 83°F that afternoon. It was a clear sunny day with few clouds. The weather was a factor in the incident related to visibility inside the lumber shed for the forklift driver. As the forklift driver drove around the outside corner of the building to enter the lumber shed, the driver was facing southeast with the sun shining directly towards him (as shown by **Image 2**, taken at

the same time of day during the Oregon OSHA investigation). The sun created a glare when facing this direction just prior to entering the shade of the lumber shed.

**Image 2. Glare of sun when entering lumber shed at approximately 9:30am on a sunny day (OR OSHA Investigation Report).**

The forklift driver was headed southeast as he was driving into the lumber shed. The forklift carried two 12-foot loads of lumber, but the loads did not obscure his vision. However, due to the direction he was driving and the weather, he was facing towards the morning sun as he drove into the shed. This limited his vision of the shaded area of the shed. The forklift driver reported that he did not see the employee standing in the forklift travel path. From the video footage, the collision appeared to have occurred at the moment that the driver transitioned from being in direct sunlight to the shade of the lumber shed. The transition from sunlight to low light conditions can further limit visibility, due to dark adaptation of the eyes. According to an article by Dr. Rafael Caruso, during bright light conditions low light photoreceptors (rods) in the eye are saturated and adjust slowly when transitioning from bright light to low light. Full visibility or dark adaptation of the eyes can take up to 20 to 30 minutes to reach the maximum adjustment (Caruso, 2007).

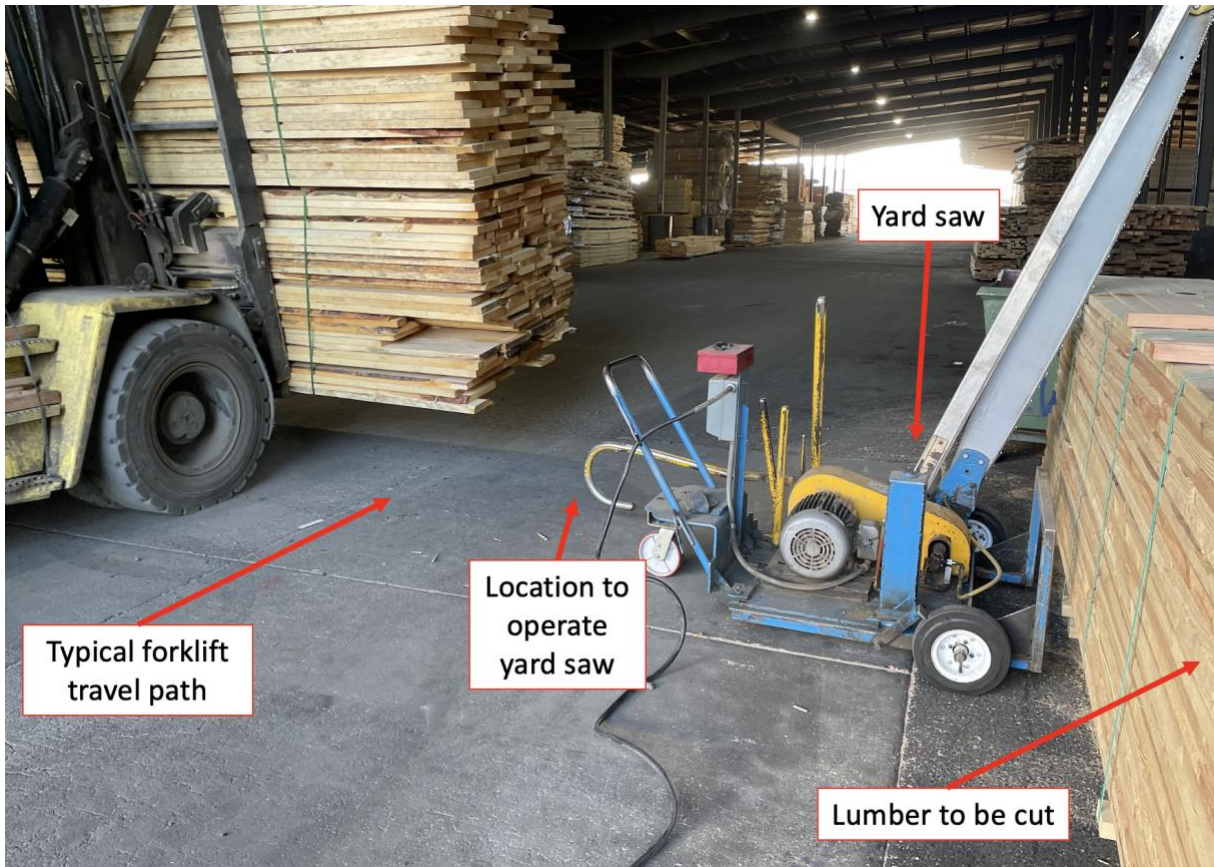
The forklift collision occurred inside the lumber shed near the yard saw workstation. **Image 3** shows the yard saw workstation with lumber and the proximity to the typical forklift travel path. There was no visible outline on the floor of the lumber shed to show the forklift travel path, but multiple tire tracks can be seen. Although the decedent was not operating the yard saw at the time of the incident, he was preparing for this work and was standing close to the workstation in the forklift pathway.

**Image 3. Yard saw workstation for pallet department located inside lumber shed (photo: OR OSHA Investigation Report).**

Discussion: At the time of the incident, the yard saw workstation was in a location very close to forklift traffic, and potentially within forklift traffic depending on the length of the lumber the forklifts carried. During the yard saw workstation design, this location was selected based on the availability of appropriate electrical access. When first designated as a work station, there was little forklift traffic in the area. However, when facility upgrades were installed in 2021 and 2022, the production improvements resulted in an increase in forklift traffic through the lumber shed and an increase in hazard exposure. When updates or improvements are made at a workplace, it is important to evaluate the impact of these changes even to other parts of the facility.

In the hierarchy of controls, elimination is considered the most effective way to protect employees because it removes exposure to a hazard. This is typically the easiest to implement during the design phase of a project. Because the yard saw workstation is portable and included minimal requirements in the form of space and electrical, this station could have been relocated or redesigned to eliminate worker exposure to forklifts while operating the equipment.

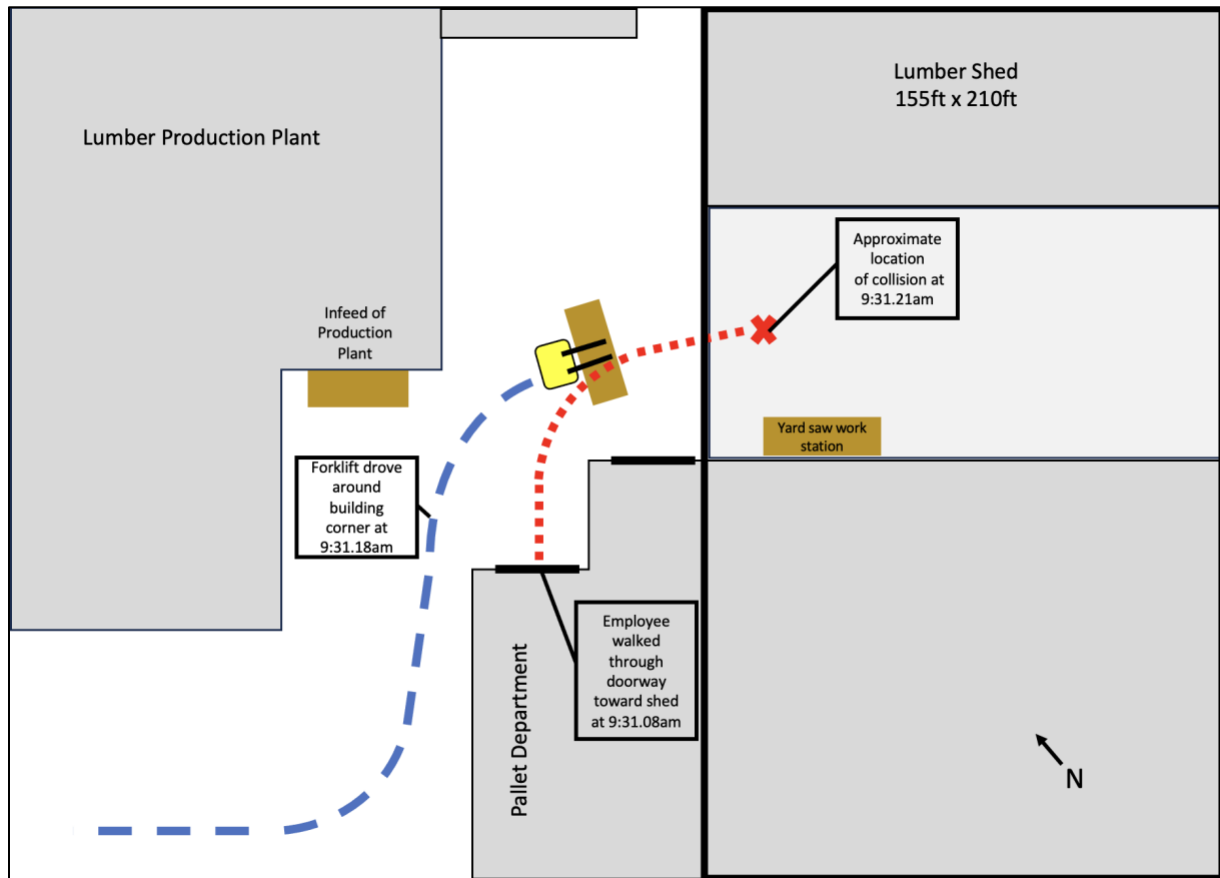
At 9:31.18 a forklift drove around the corner of the building into the view of the camera. Prior to entering the lumber shed the forklift driver honked the forklift horn. The driver was facing the direction of travel. Although no speed was recorded, it appeared from the video footage that the driver was travelling at an appropriate speed. As the forklift driver traveled into the lumber shed, the load that was being transported on the forklift accidentally struck the decedent while he was standing near the entrance. The collision occurred out of view of the camera and took place approximately 11 seconds after the employee exited the pallet department door.

The diagram in **Image 4** shows the layout of the lumber shed, pallet department, lumber production plant, and the pallet department yard saw station. Based on the video footage, the diagram also shows the path of the employee and forklift.

**Image 4. Diagram of incident based on OR-OSHA sketch, Google maps, and video footage (not to scale).**
