REPORT#: 2014-02

REPORT DATE: January 30, 2018
Revised Date: June 19, 2020

Laborer, Pipefitter, and Utility Foreman Crushed by Falling Block Wall—Tennessee

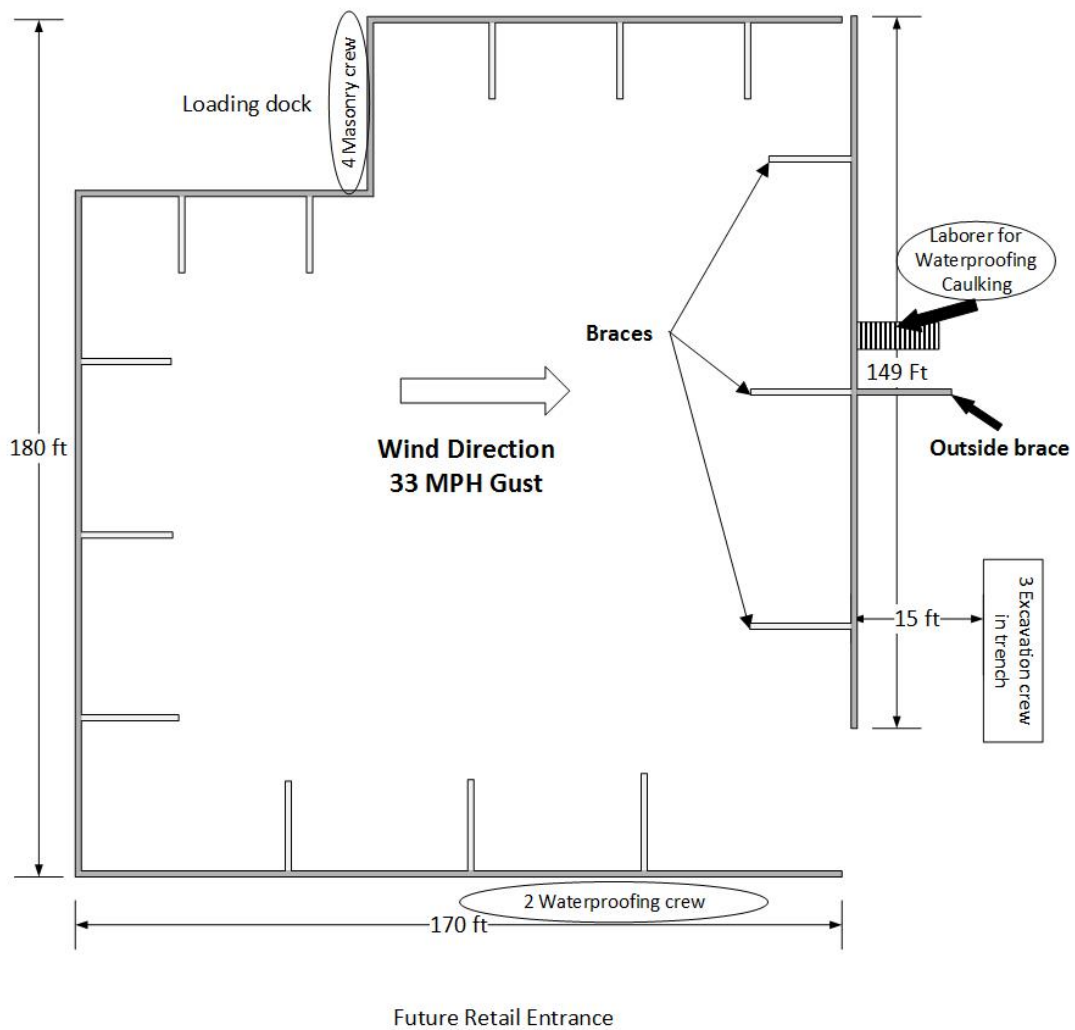
Diagram. Incident scene.

The building being constructed was a 28,000-square-foot retail store in a retail development area. Construction began in March of 2013 with a concrete footer measuring 2 feet wide and 1 foot deep. Rebar was to be placed 40 inches on center in the footer. The walls were constructed of typical concrete masonry unit blocks that were 8 inches tall, 8 inches wide, and 16 inches long. The walls were 36 courses (24 feet) tall and consisted of panels, with masonry control joints between each panel. Masonry control joints prevent the wall from cracking caused by shrinkage, wind, soil pressure, seismic forces, or settlement. The masonry walls were completed at different times so they were all in different stages in their curing process. The west wall was completed on March 26, the east wall was completed on April 3, the north wall was completed on April 5, and the south wall was completed on April 12. On the day of the incident the masonry subcontractor's 5 employees were in the process of constructing the loading dock wall (Diagram).

The excavation crew arrived at work on April 18, 2013, around 6 a.m. The masonry crew arrived around 7:30 a.m. The waterproofing crew arrived at work at 8 a.m. Between 9 and 9:15 a.m., the subcontractor crews took a break and returned to work around 9:30 a.m. The waterproofing laborer (decedent) was caulking the control joints on the east wall from a 16-foot fiberglass extension ladder. Two other waterproofing crew members were spraying waterproofing on the south wall. The three excavation crew members, including the utility foreman (injured) and pipefitter (decedent), were in the trench installing a backflow preventer for the building's sprinkler system. The foreman for the masonry subcontractor was meeting with the prime contractor and a framing subcontractor at the south end of the project. The four other employees for the masonry subcontractor were constructing the loading dock wall on the north side (Diagram).

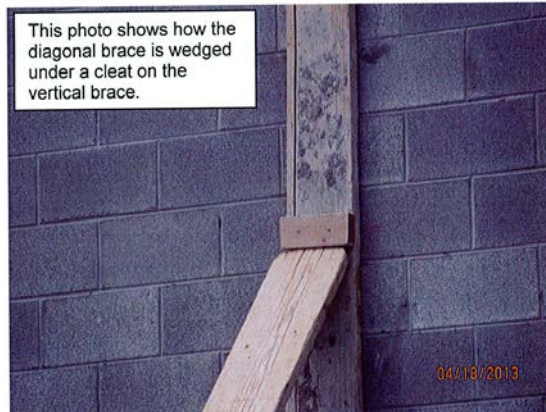
**Photo 1. Top cleat of wall brace.
(Photo courtesy of TOSHA.)**

The wall bracing system used in this incident was a modified triangle system and composed of two scaffold boards. The vertical board was positioned on the wall but not attached to the wall. The vertical board had a 2- by 4-foot cleat across it horizontally (Photo 1 and Photo 3). The inclined brace boards were wedged at an angle that varied between 34 and 41 degrees. A 4-foot length of rebar was driven into the ground; one masonry block was placed over the rebar with the other placed on top of the inclined board (Photo 2 and Photo 3). There was no permanent tie from the ground to the wall brace. The wall extended between 13½ and 15 feet above the brace.

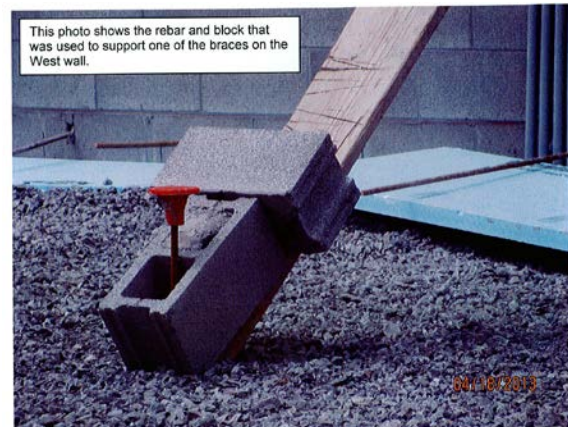
Photo 2. Blocks and rebar used to secure wall brace. (Photo courtesy of TOSHA.)

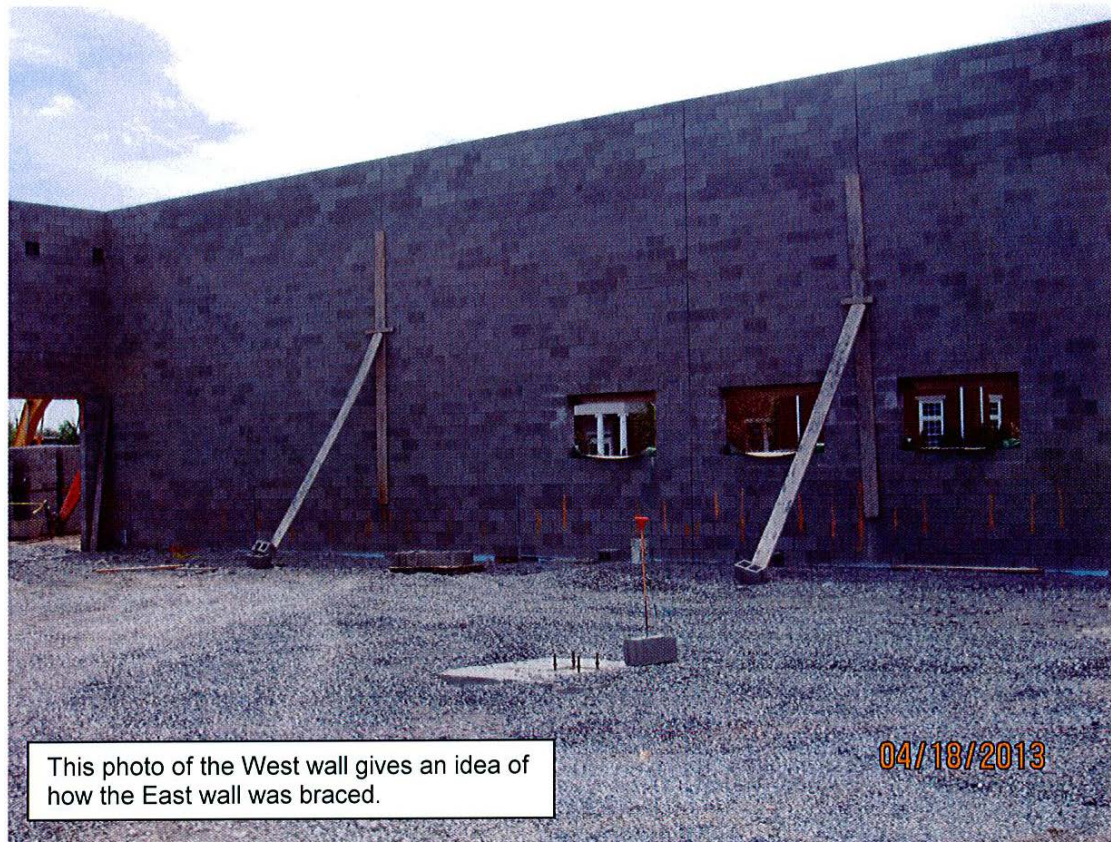
Photo 3. Interior wall bracing. (Photo courtesy of TOSHA.)

In this incident, the wall extended more than 8 feet 8 inches above the braces in some instances, and several of the recommended brace system components were missing. If a masonry wall bracing plan had been in place and one of the employers had a trained competent person at the time of the incident, the competent person could have recognized the hazard posed by the unbraced wall and made the appropriate changes to provide a safe bracing system. Since this incident, the masonry subcontractor has trained their employees on proper concrete and masonry wall bracing.

Recommendation #2: Employers should develop and follow a masonry wall bracing plan, train employees on proper masonry wall bracing, and ensure masonry walls are properly braced throughout the project.

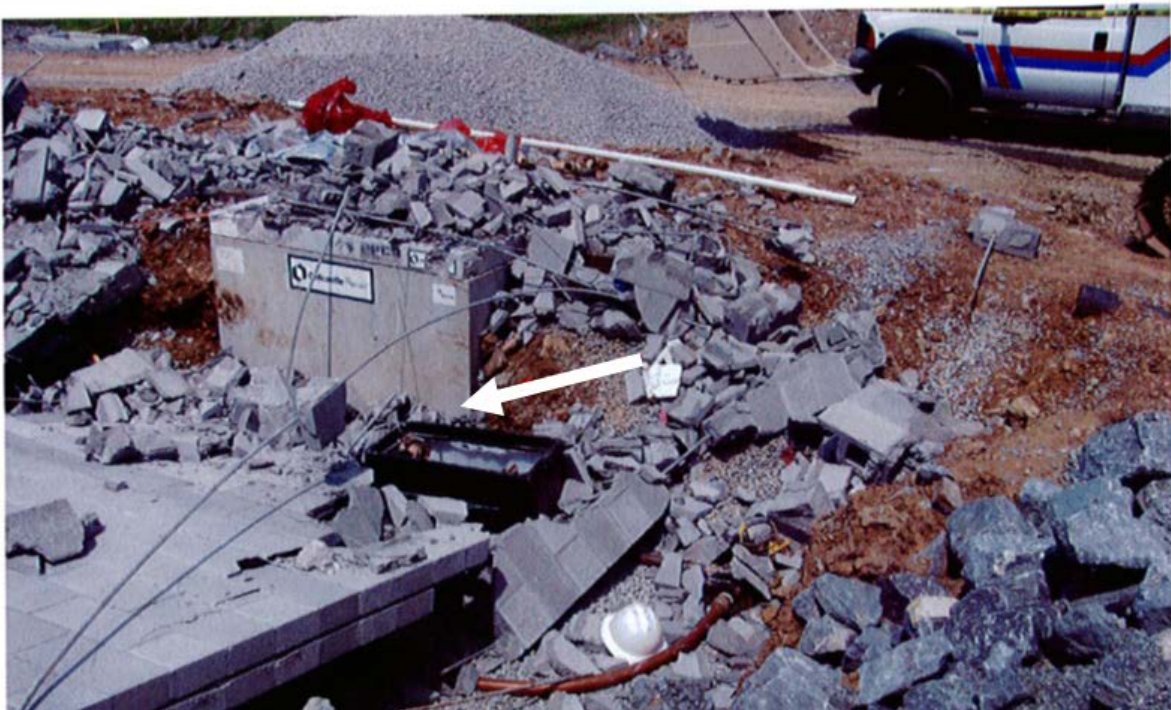
The east wall, the incident wall, was 149 feet long and was not structurally tied to the other three walls at the time of the incident. The east wall had seven panels, with a control joint between each panel. The east wall was originally braced with three wooden braces on the inside and three wooden braces on the outside, with the braces opposing each other. The braces consisted of three pieces: one vertical scaffold board, positioned on the wall but not attached to the wall; a cleat board measuring 2-inch by 4-inch placed horizontally across the vertical scaffold board approximately 9 to 10½ feet up the scaffold board (Photo 1); and another scaffold board was wedged at an angle between the cleat and a 4-foot long piece of rebar driven into the ground. Two masonry blocks were placed on top of the rebar and board as extra weight for the scaffold board and as protection around the rebar (Photo 2). The spacing between braces varied, as did the angle of the braces (Photo 3). Two of the three outside braces were removed, leaving one brace in the center of the outside wall the day before the incident to allow the waterproofing subcontractor to caulk the control joints. No permanent supporting elements of the structure were in place. A 3 foot deep, 5½ foot wide, and 8 foot long trench ran parallel to the east wall. The trench was positioned 15 feet from the wall and was dug to allow installation of the building's sprinklers back-flow system. There was a 3½-foot tall concrete meter box toward the south end of the trench that was being used as a table (Photo 4).

Photo 4. Concrete meter box. Arrow indicates where three excavation employees were working.
(Photo courtesy of TOSHA.)

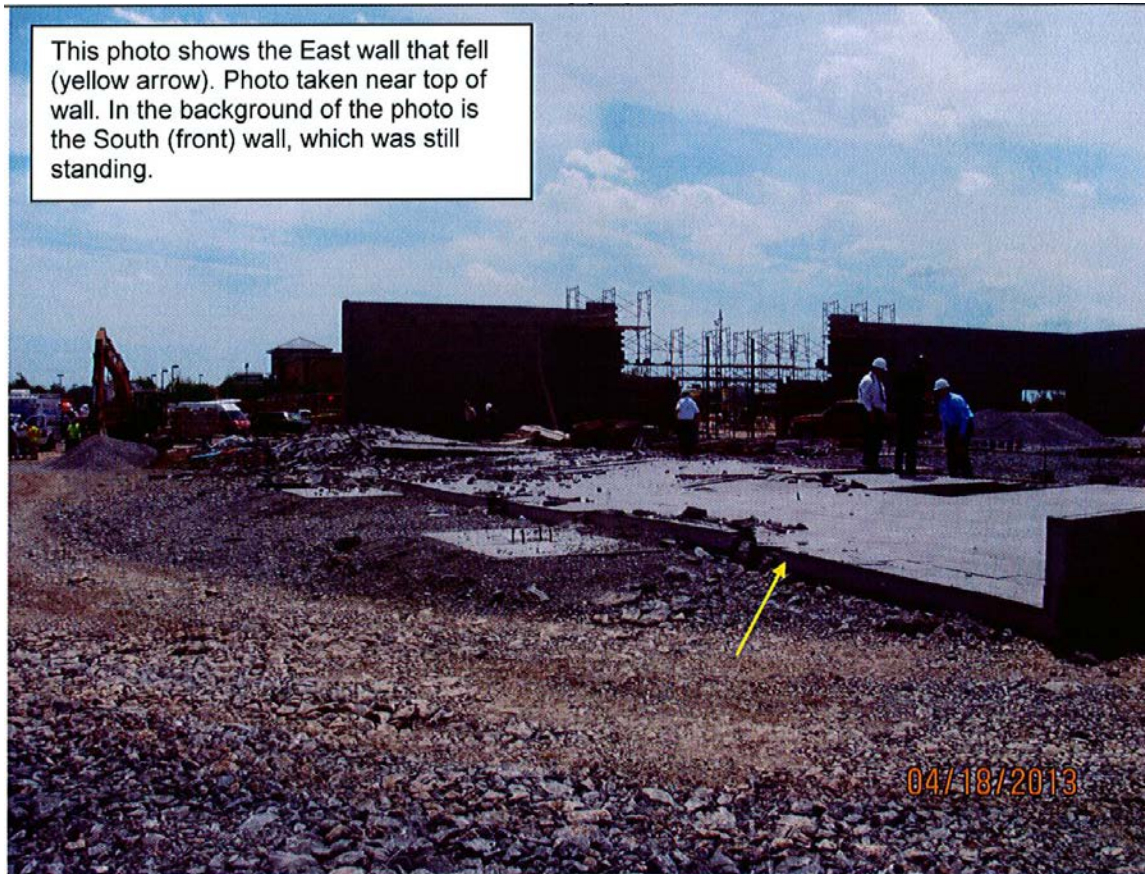
Photo 5. Collapsed wall.
(Photo courtesy of TOSHA.)

At 9:45 a.m., the east wall fell during a 33-mph wind gust, on top of the waterproofing laborer, the pipefitter, and the utility foreman (Photo 5). The excavation foreman was able to run to safety. Once the wall fell, the project superintendent called 911 and emergency medical services (EMS) were dispatched and arrived within four minutes. Several crew members ran to remove the block wall from the utility foreman before EMS arrived. The laborer and pipefitter were pronounced dead at the scene. The utility foreman was airlifted to a local hospital.

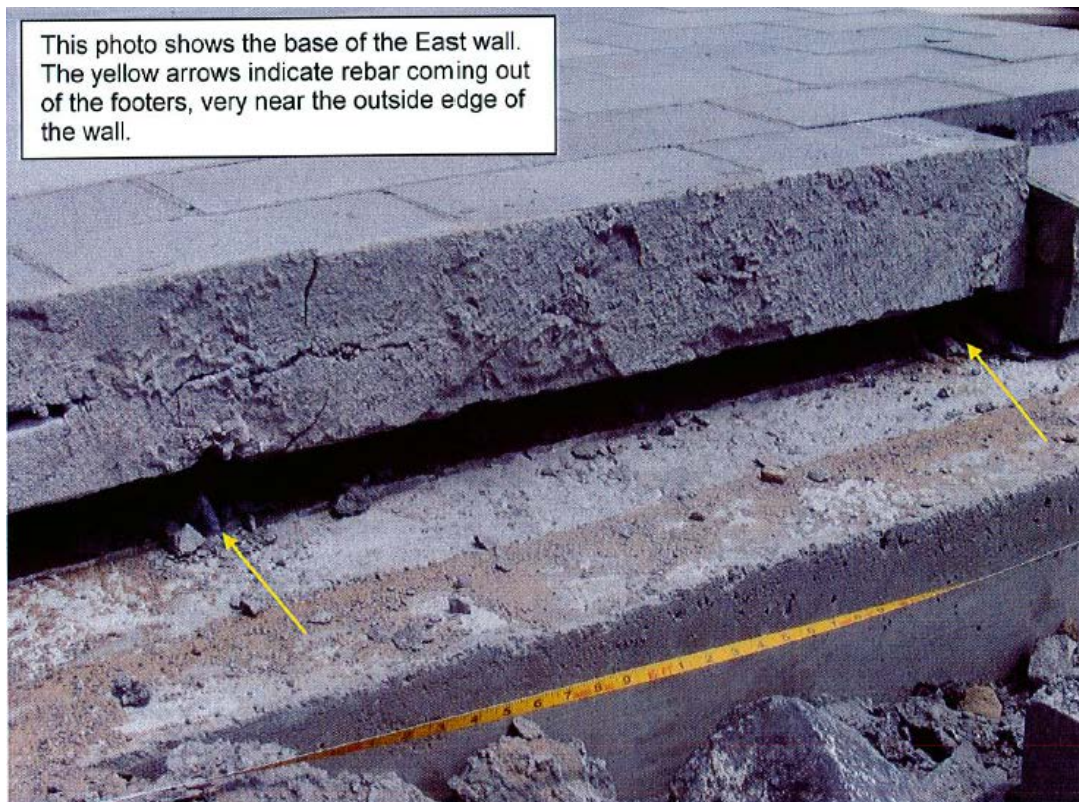
Prior to building the east wall, the masonry subcontractor noticed the rebar in the east wall footer was not positioned in the center of the footer according to the engineering drawings, but was 2 to 4 inches off center, positioning them near the exterior of the wall. The masonry subcontractor notified the prime contractor of the error, and the prime contractor instructed the masonry contractor to fix it by bending the rebar toward the center of the footer so it would fit inside the center of the blocks. The out-of-place rebar went unnoticed by the engineer during inspection and the engineer was not notified of the change in the rebar.

Discussion: Based on the original engineering drawing, with rebar placed in the center of each block and secured with grout, the unsupported block wall in the intermediate period should have been able to sustain wind speeds up to 35 mph [[MIOSHA 2010](#); [MCCA 2012](#); [NMCA 2005](#); [NCMA 2014](#)]. Additionally, masonry control joints were designed to prevent wall damage due to cracking caused by shrinkage, wind, soil pressure, seismic forces, or settlement. The wall panels were designed to fail independently in the event of a wind gust. The rebar dowel coming out of the footer for the east wall was not placed in the center of the footer as specified in the engineering drawings, but was off-center by 2 to 4 inches toward to exterior edge [Photo 6]. The engineer did not notice the misplacement of the rebar during inspections. The masonry subcontractor brought the rebar placement issue to the attention of the general contractor. The masonry subcontractor was instructed to fix the problem by bending the rebar toward the center of the footer to fit within the centers of the concrete masonry blocks. The resultant rebar/grout combination was no longer strong enough to resist the lateral loads of the wind coming from the west, based on an analysis conducted by the OSHA Directorate of Construction, Engineering Services section, at the request of TOSHA, and the wall presented properties similar to an unreinforced wall design. This rebar misalignment was consistent across all seven wall panels that failed. Procedures to address this issue include placing the rebar dowels in the center of the blocks according to the engineering drawing or correcting the misalignment by drilling correctly positioned holes in the grout and epoxying rebar in place.

Photo 6. Rebar coming out of footer.
(Photo courtesy of TOSHA.)

Recommendation #1: Employers should ensure that employees follow the engineering/architectural drawings during building construction and obtain engineering approval before plan changes are made.
