**LINE OF DUTY  
DEATH REPORT  
REPORT SLIDES**

## **F2019-02**

Captain Died After Crew was Trapped During a Search for a Civilian in a 3rd Floor Apartment Fire – Maine

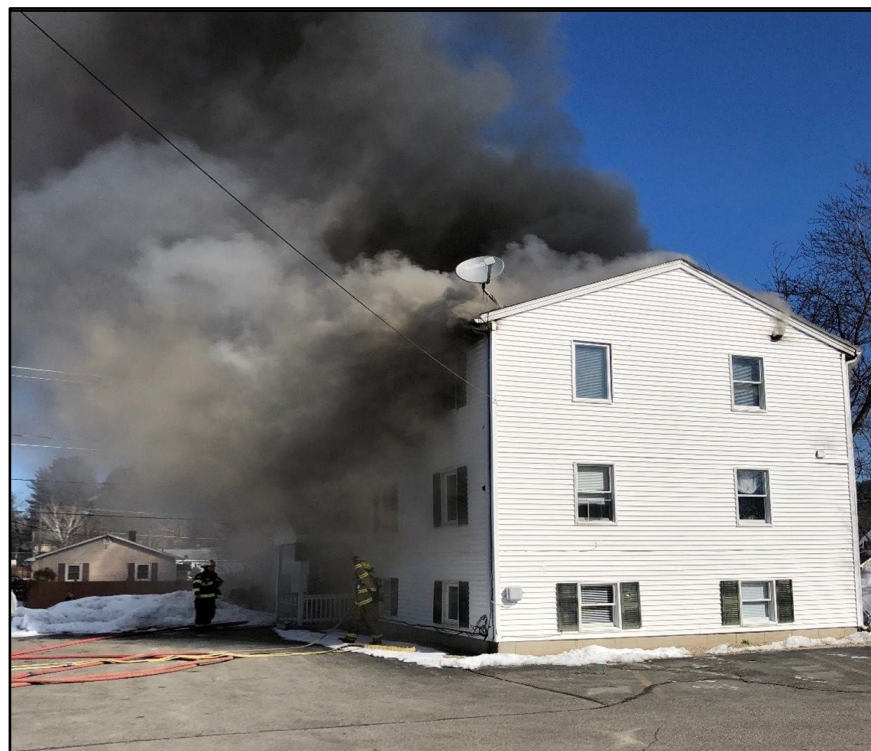
Initial arrival conditions. Showing Side Alpha and Side Delta. The victim was at window on 3rd floor on Side Bravo. The time was approximately 1108 hours.

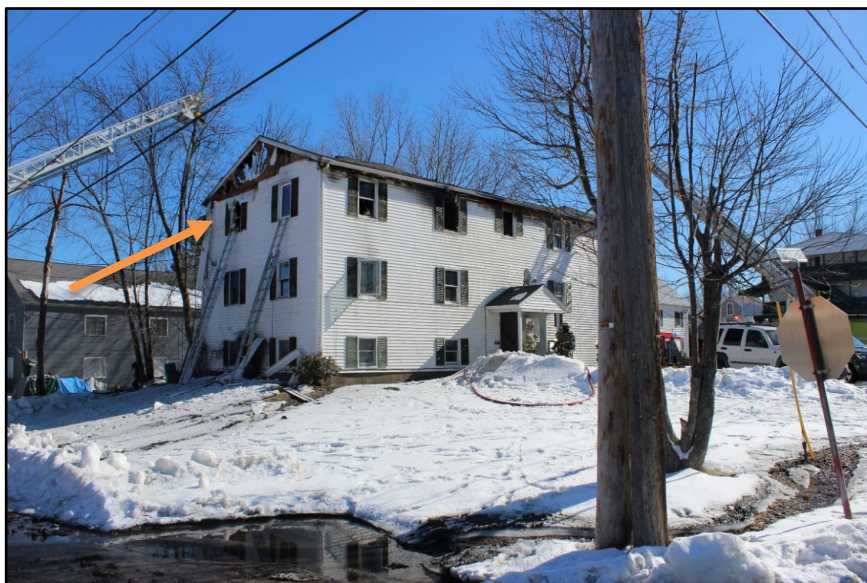
The orange arrow identifies the window where the civilian was located upon arrival of the fire department. The civilian was removed from the 3<sup>rd</sup> floor window via the ground ladder. (Photo provided by the Maine Office of the State Fire Marshal)

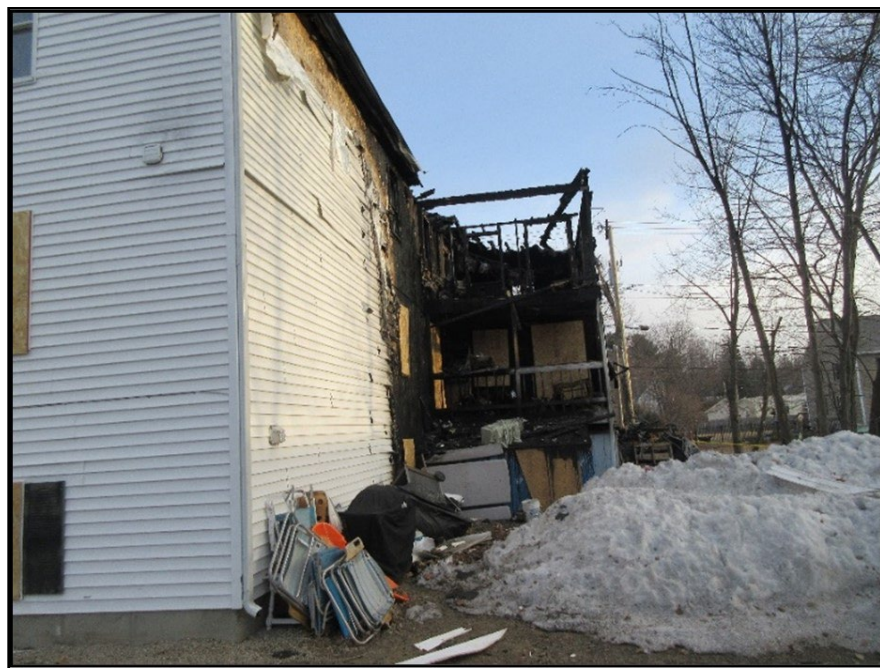
The Side Charlie 3<sup>rd</sup> floor porch where the captain and firefighter 1 were removed. (NIOSH Photo)

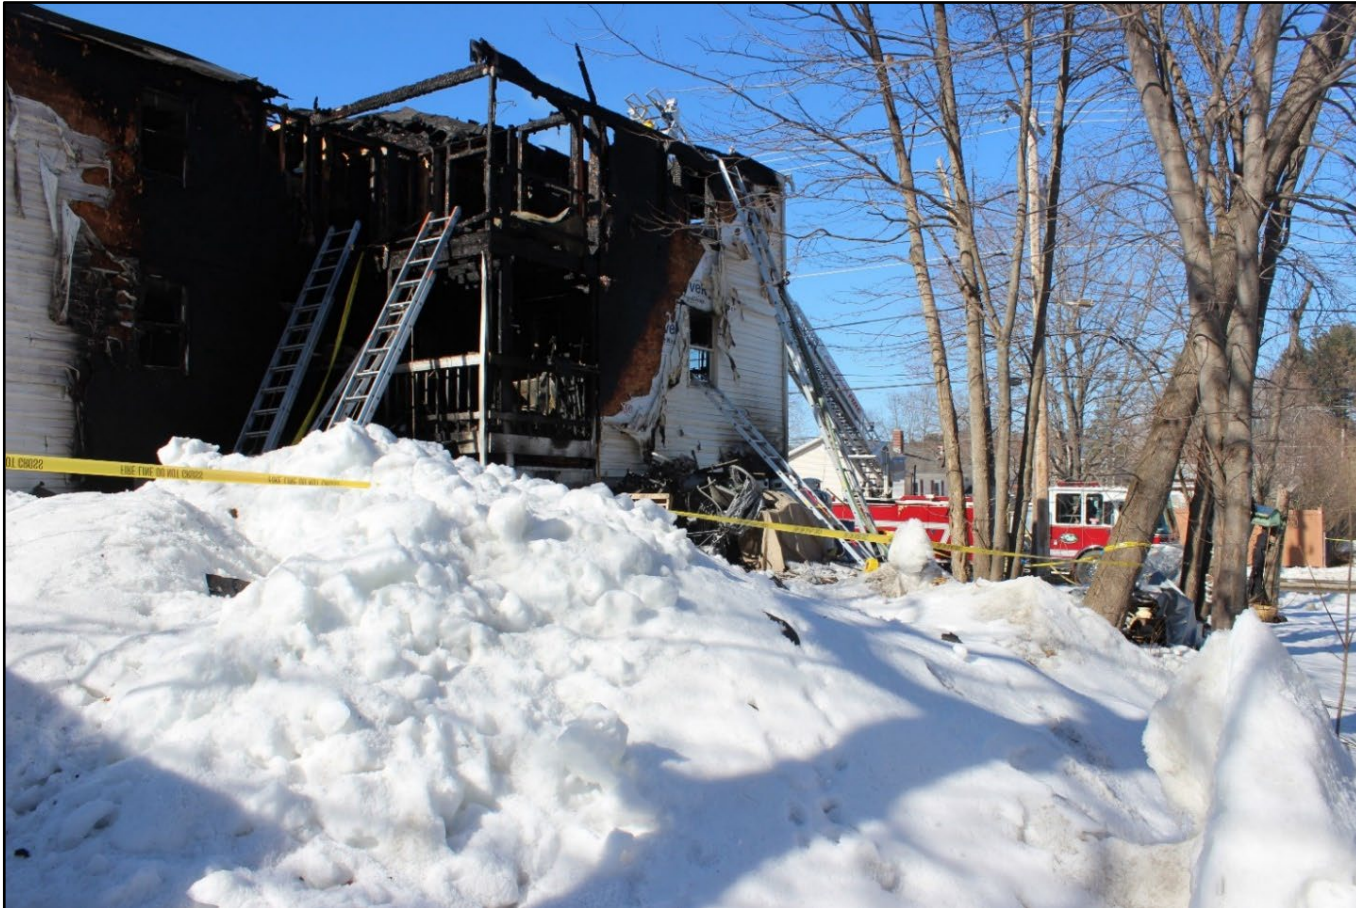
Ground ladders extended to a 3rd floor porch where the captain and firefighter 1 were removed from the structure. (Photo provided by the Maine Office of the State Fire Marshal)
