**LINE OF DUTY  
DEATH REPORT  
REPORT SLIDES**

## **F2019-18 MA**

# **Career Lieutenant Dies and Four Firefighters Injured at a 3-Story Multi-Family Residential Occupancy—Massachusetts**

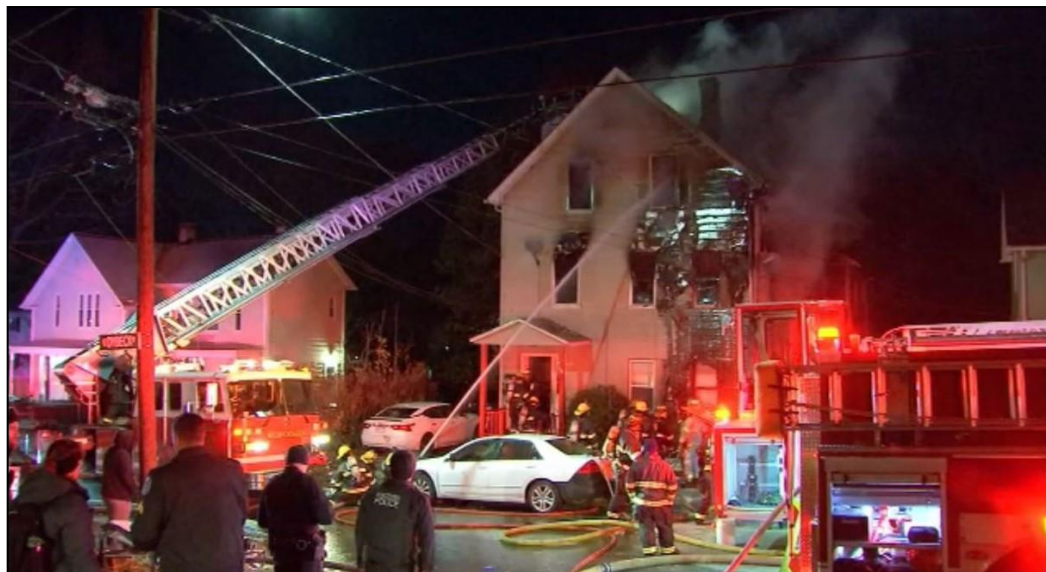
- A 39-year-old career lieutenant died, and four other firefighters were injured while fighting a multi-family residential structure fire.
- At 01:00:06, Fire Alarm dispatched Car 4, Engine 15, Engine 2, Engine 13, Engine 12, Ladder 5 Ladder 3, Rescue 1, and Ladder 4 (rapid intervention team (RIT)) for a fire with occupants on the 2nd floor and a baby on the 3rd floor.
- At 01:02:27, Engine 15 arrived on scene and reported a Type V structure with heavy fire showing on the 2<sup>nd</sup> floor of Side Bravo.

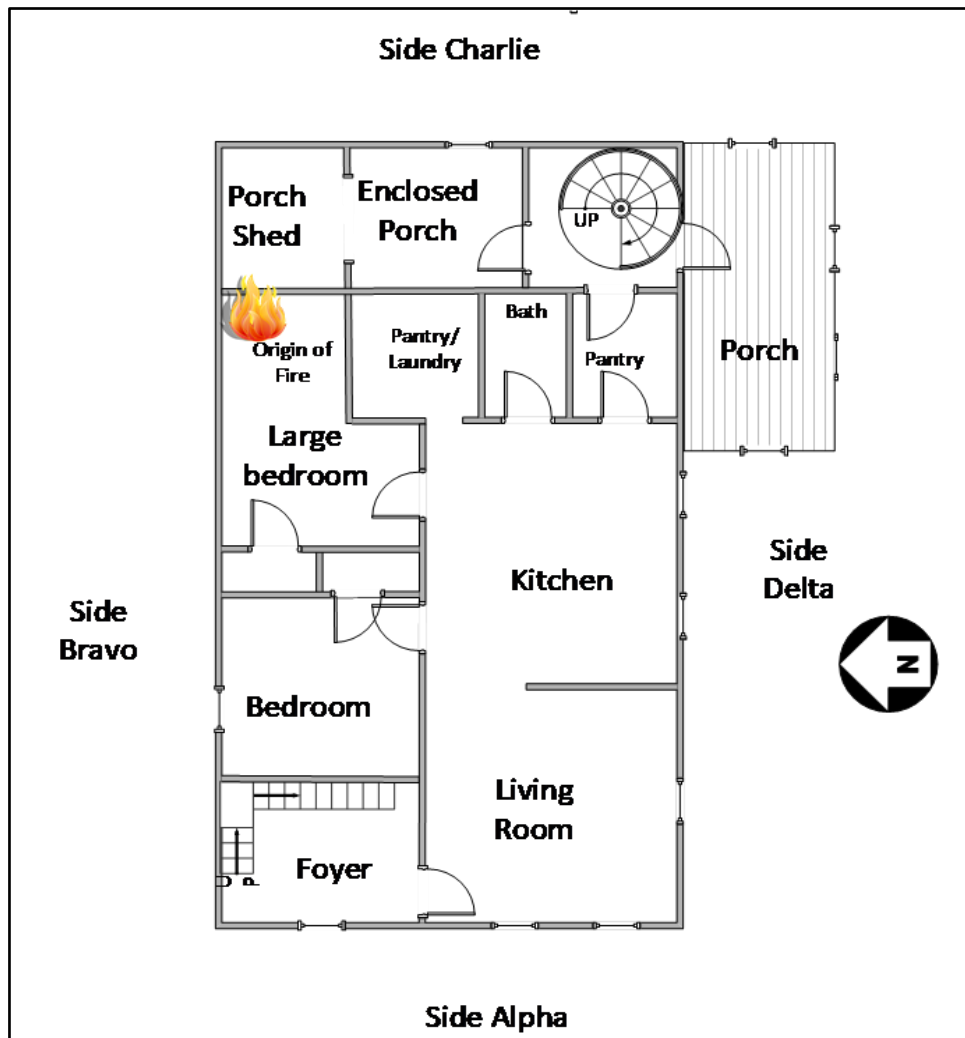
2nd Floor Plan. Note: The origin of the fire started in the large bedroom.

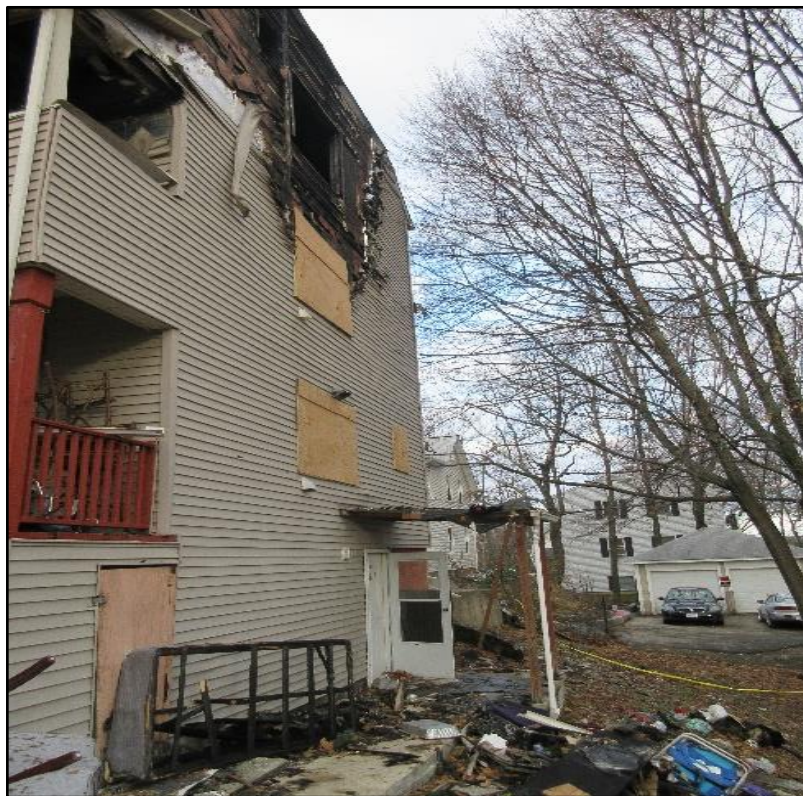
3<sup>rd</sup> floor porch window Ladder 5 firefighter went out of and initially landed on awning over basement door.  
(NIOSH Photo)

- At approximately 01:32, the lieutenant of Ladder 5 grabbed the chauffeur of Ladder 5 and pushed him out of a window on the 3<sup>rd</sup> floor of Side Charlie.
- He fell approximately 15 feet, hitting an awning over the basement man-door, then rolled off and fell about another 10 feet to the ground.
- At 01:34:03, Car 400 notified Command that a civilian stated a firefighter was lying in the backyard (Side Charlie).
- At 01:34:21, Engine 5 located the Ladder 5 chauffeur on the ground and requested EMS.
- Over next 23 minutes, Ladder 4 (RIT), Ladder 1, Rescue 1-Team 2, Engine 12, Engine 4 and Car 2 encountered heavy fire while trying to get to the 3<sup>rd</sup> floor and locate the lieutenant.

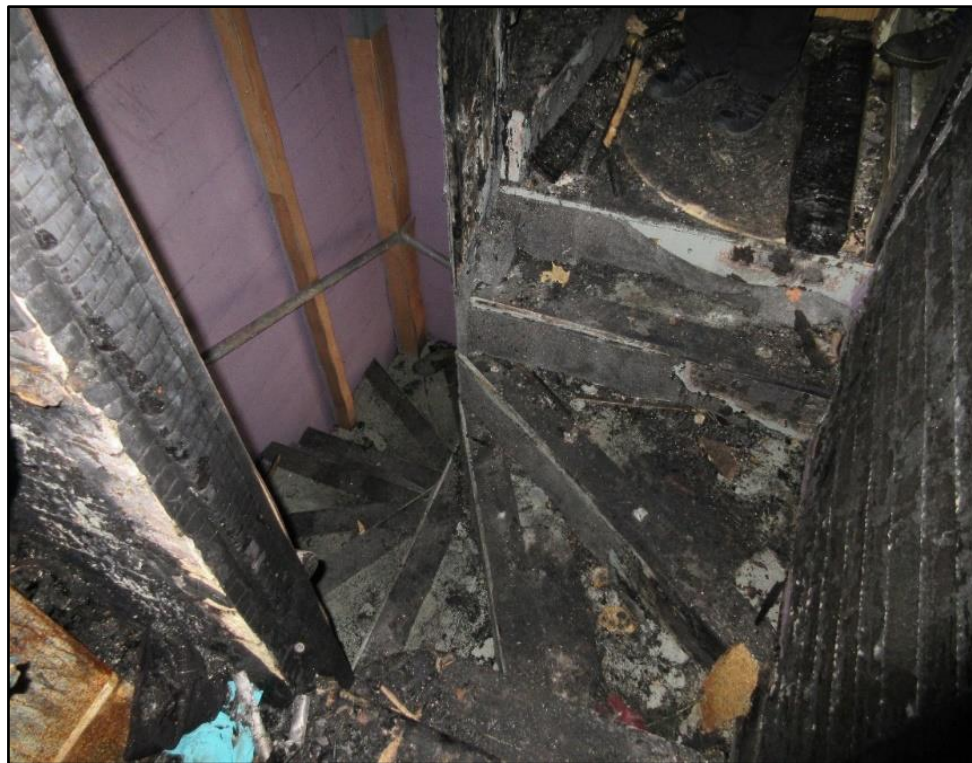
- Crews struggled to access the 3<sup>rd</sup> floor due to limited space in the enclosed stairwell that had high heat, zero visibility due to smoke, and the added obstruction of a hose line that had burned through and was gushing water.
- At 02:07:20, Rescue 2 (Rescue 1-Team 2 and Ladder 4) reached the 3<sup>rd</sup> floor of the Side Delta/Charlie stairs, but debris blocked the entrance to the porch.
- A member of Rescue 2 breached the wall to the porch.
- Several minutes later, after crawling across the porch, Rescue 2 made it to the porch shed door where the lieutenant had returned to take shelter.

Side Delta stairwell second floor where first entry hose line burst.  
(NIOSH photo)

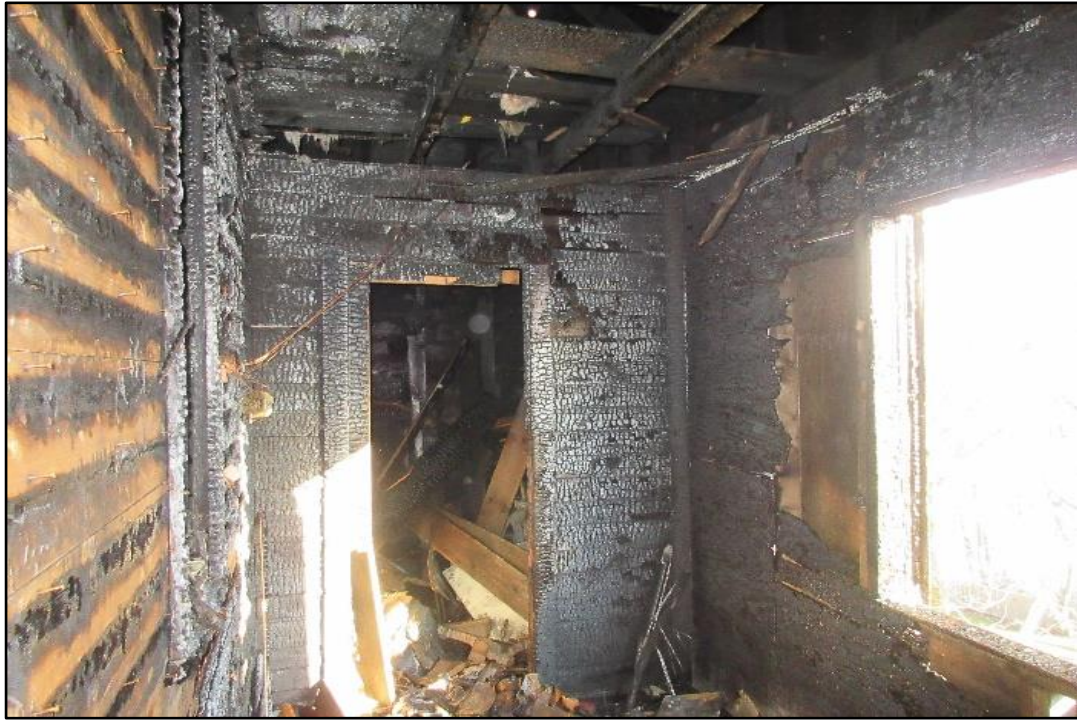
Third floor porch shed breached by Rescue 2 where Ladder 5 Lieutenant took shelter. (NIOSH Photo)

- Rescue 2 could hear the lieutenant's personal alert safety system sounding.
- Rescue 2 breached the shed door and found the lieutenant.
- Rescue 2 accompanied by Ladder 1 located and grabbed the lieutenant.
- Crews from Ladder 4, Ladder 1, and Engine 4 moved the lieutenant down the Side Delta/Charlie stairs.
- The lieutenant was brought out the Side Delta/Charlie rear door where an EMS crew was waiting at approximately 02:13.

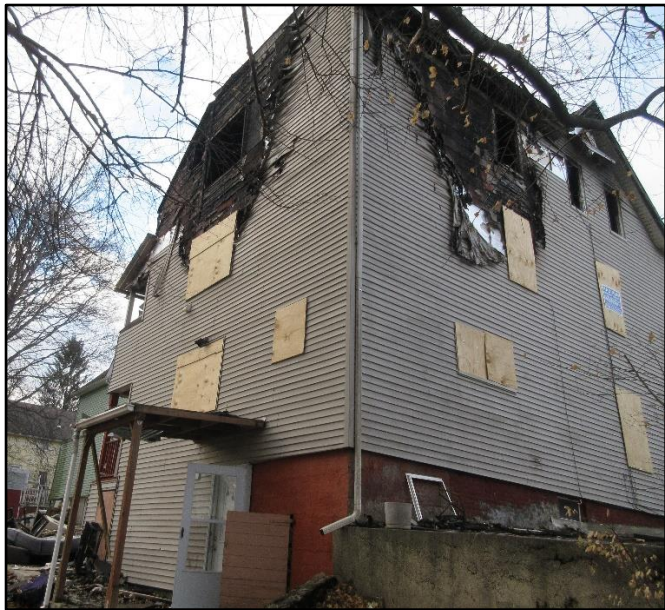
Side Bravo and Side Charlie of the structure.  
(NIOSH Photo)

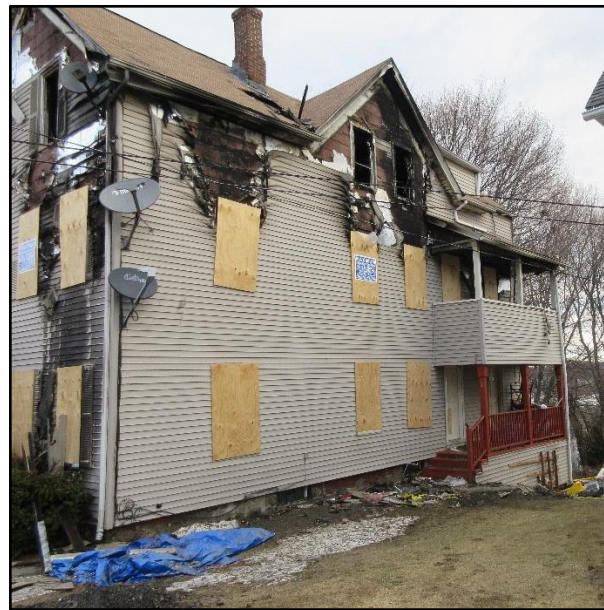
Side Delta of the structure.  
(NIOSH Photo)
