**LINE OF DUTY
DEATH REPORT
REPORT SLIDES**

F2020-02

Firefighter Dies After Falling into the Basement due to Floor Collapse at a Modular Home Structure Fire – Missouri

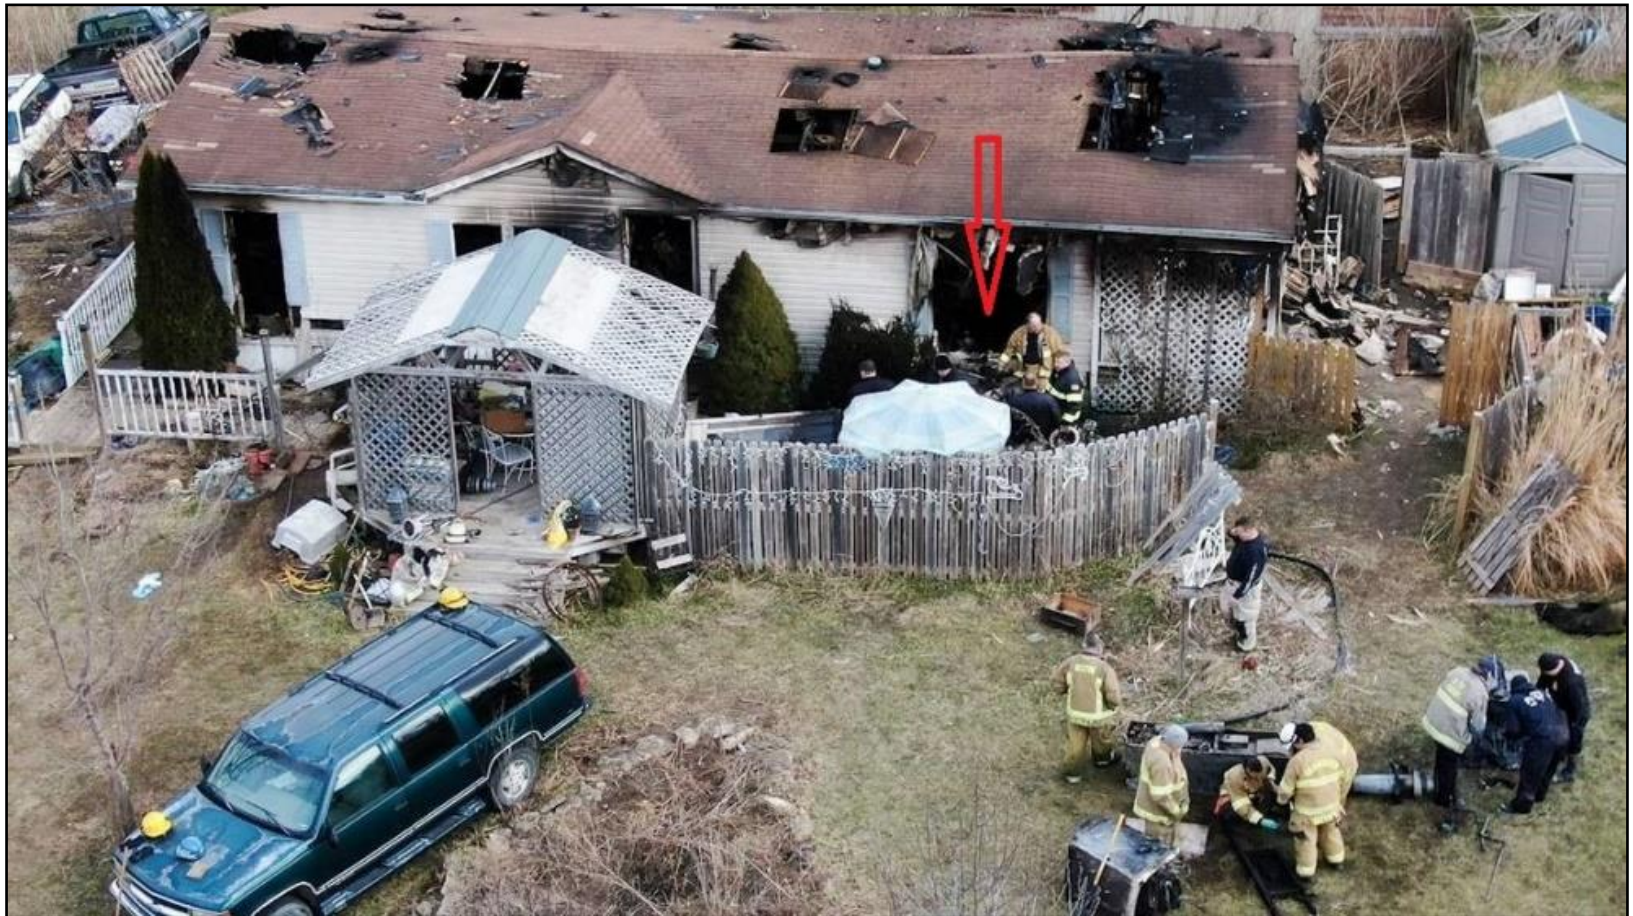
The deceased firefighter was operating a hoseline in the kitchen when the floor collapsed into the basement. The red arrow indicates the kitchen area. Photo courtesy of the fire department.

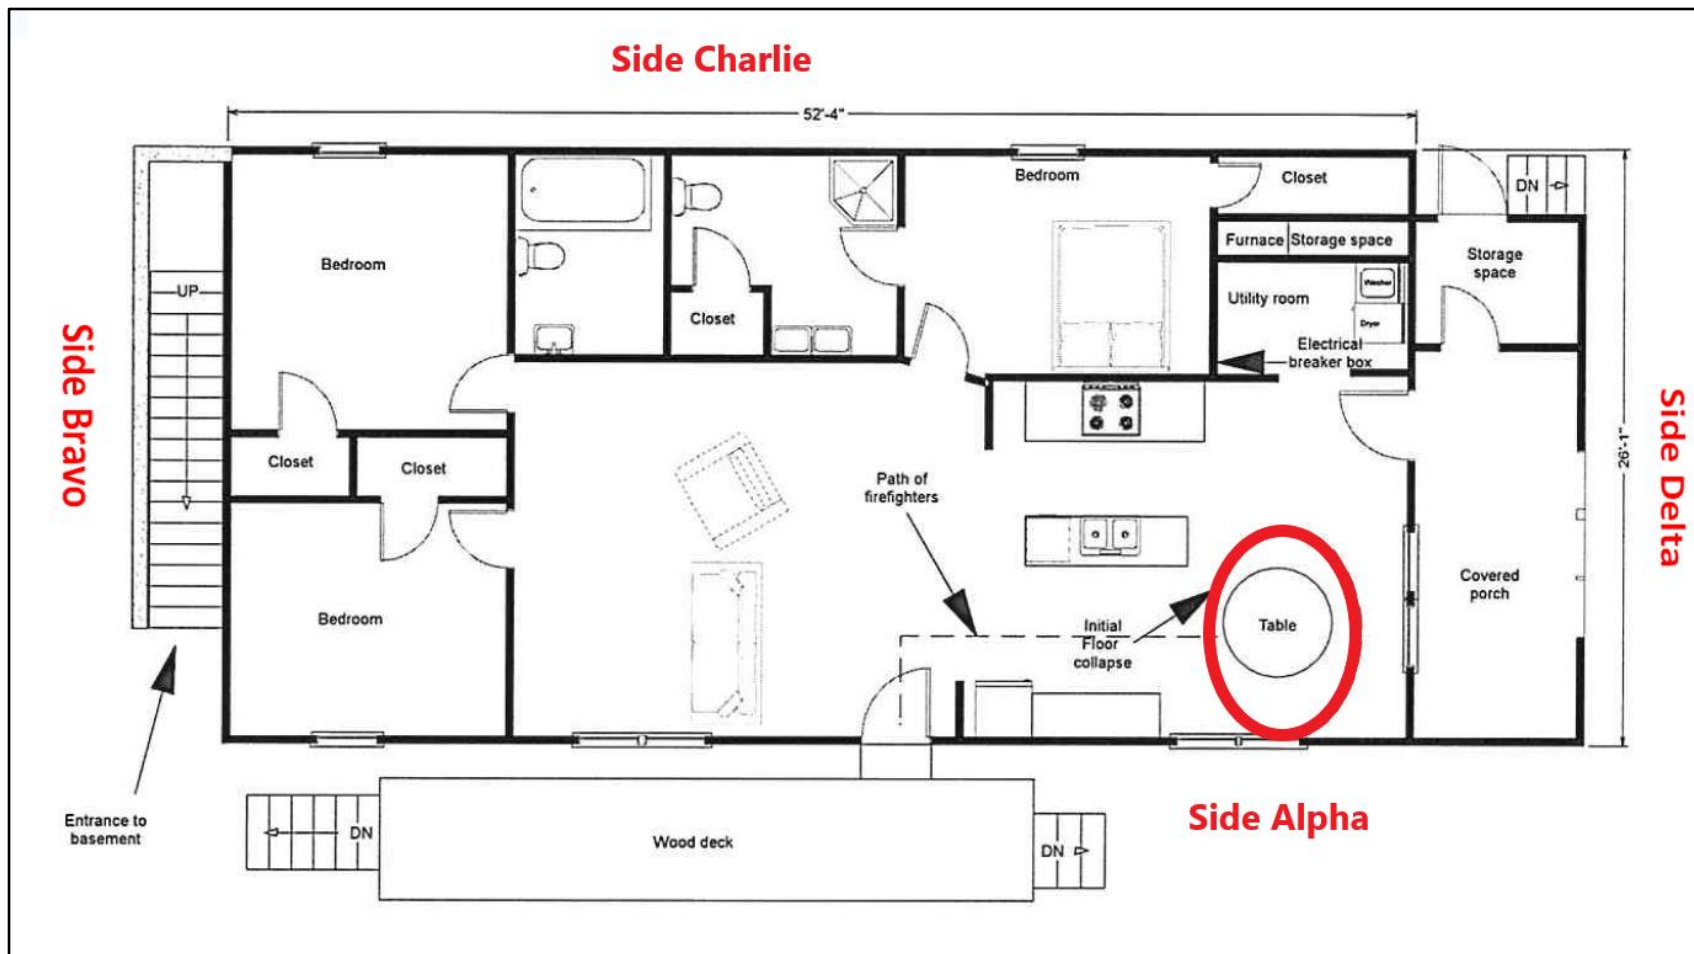
The floor plan of the 1st floor. The area where the floor collapsed is denoted by the red circle in the kitchen. Diagram courtesy of the Missouri Office of the State Fire Marshal.

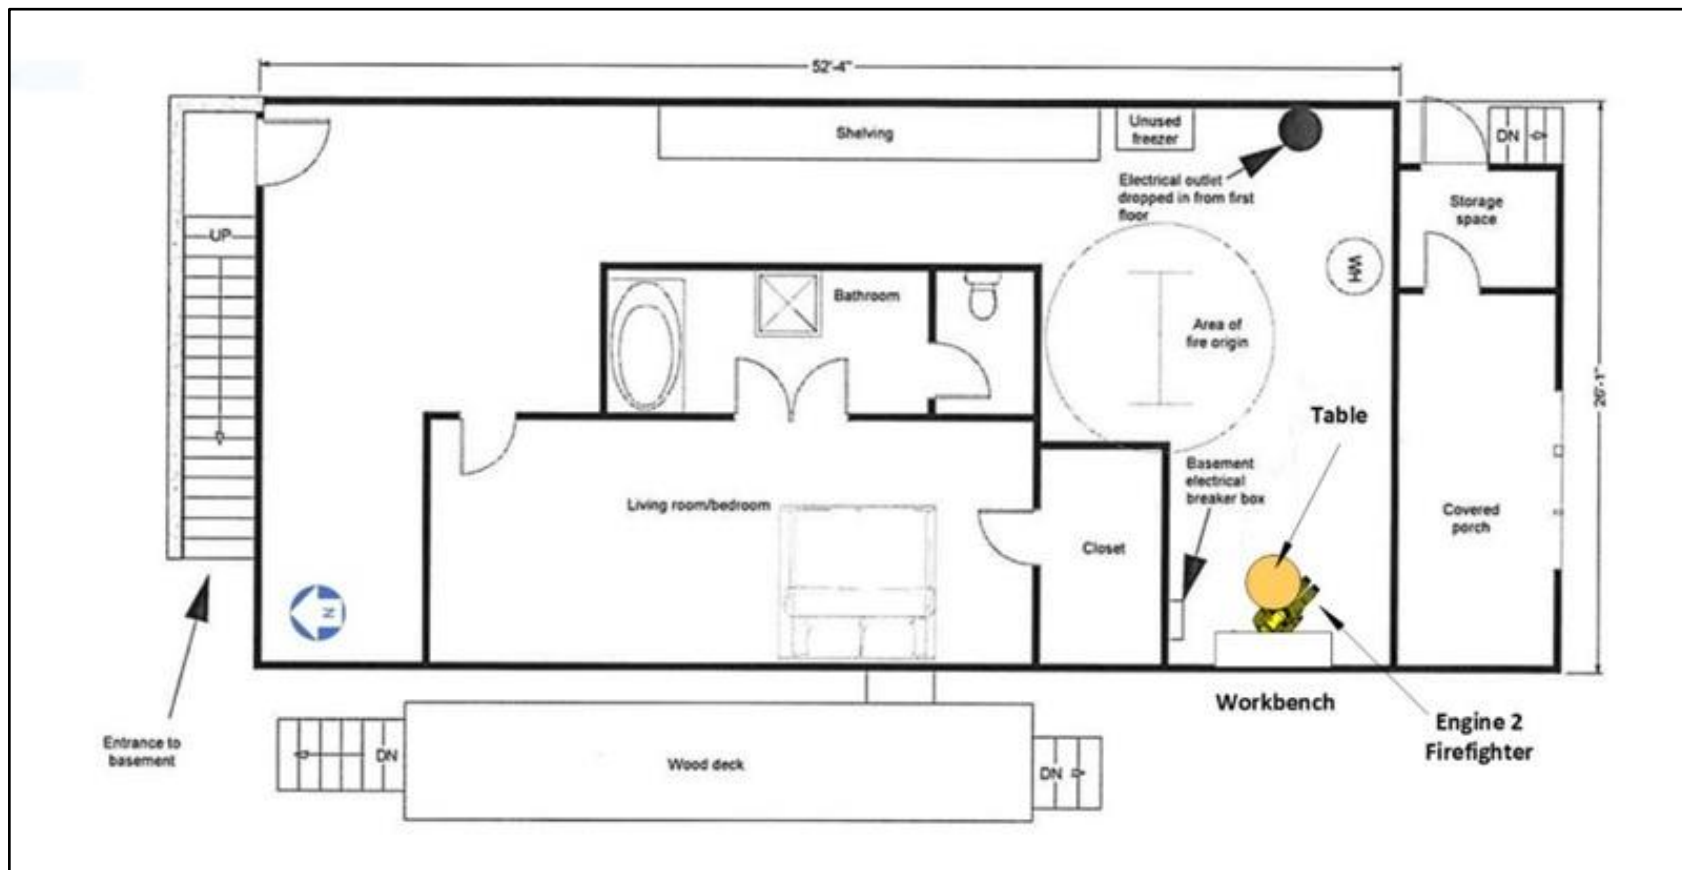
Pumper 45 and Truck 15 found the missing firefighter from Engine 562 under a wall-mounted workbench in the basement. The firefighter was covered with debris, a table and submerged under water. The time was 12:34:13 hours.
