LINE OF DUTY DEATH REPORT

REPORT F2023-09 • September 2024

Career Acting Fire Officer Dies from Floor Collapse during Interior Fire Attack – Maryland

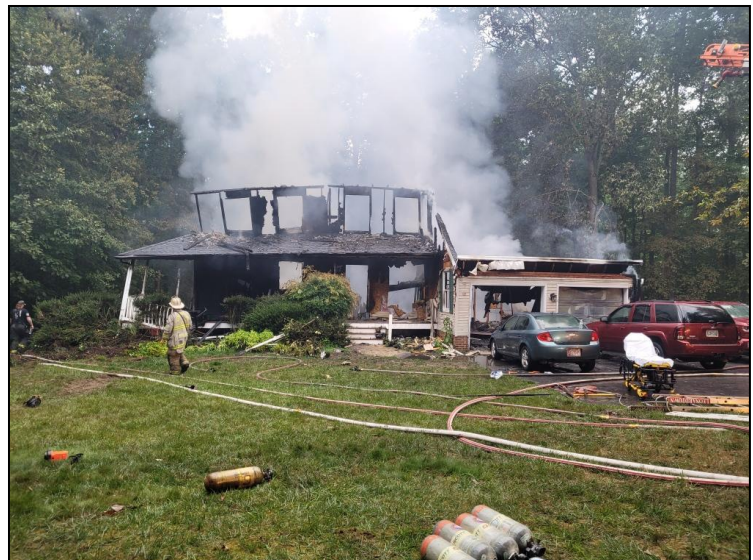
A view of the structure from side Alpha after the fire was knocked down.

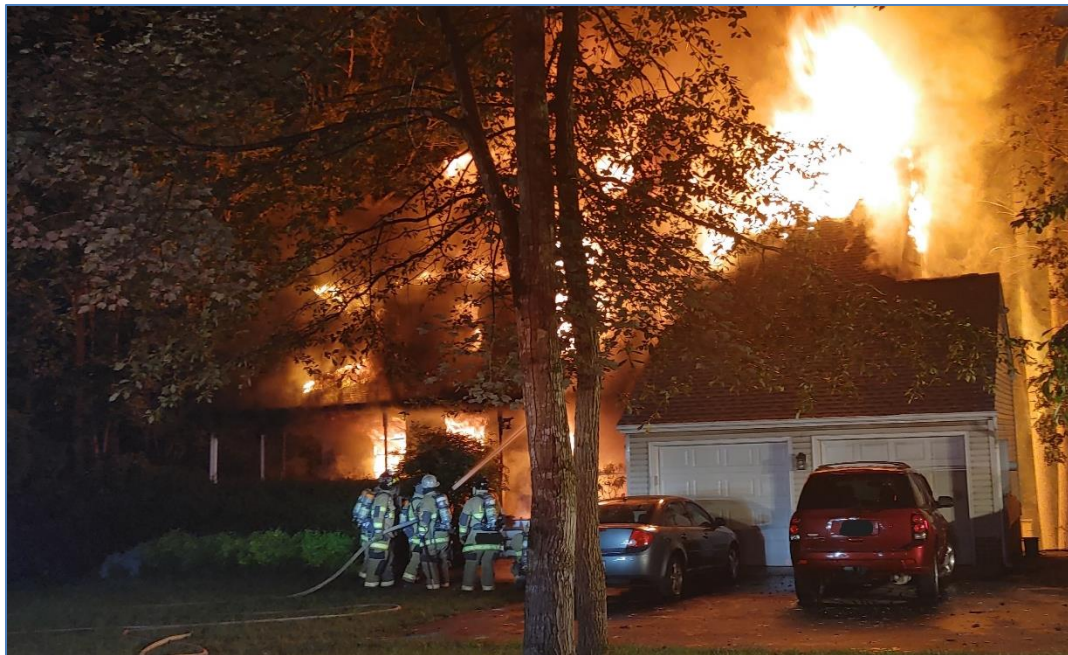
Photo 2. Conditions upon arrival of E1
(Courtesy of Southern Maryland News Network)

The company officer from E132 requested a change in the running assignment order due to E132’s proximity to the scene. E132 requested to be assigned as the second due engine company instead of being assigned to the water supply point. IC approved this request and reassigned E9 from second due engine assignment to the water supply point. IC advised E1 to lay a four-inch supply line from the end of the driveway, to be positioned in the driveway but out of the way for the first arriving truck company. E1 arrived on the scene at 0418 hours, laid a four-inch supply line with a connected humat valve down the driveway. E1 stretched a 200-foot 1 ¾-inch preconnected attack line to side Alpha and began a transitional fire attack of the porch, first, and second floors where heavy fire conditions were observed. (see Photo 2)

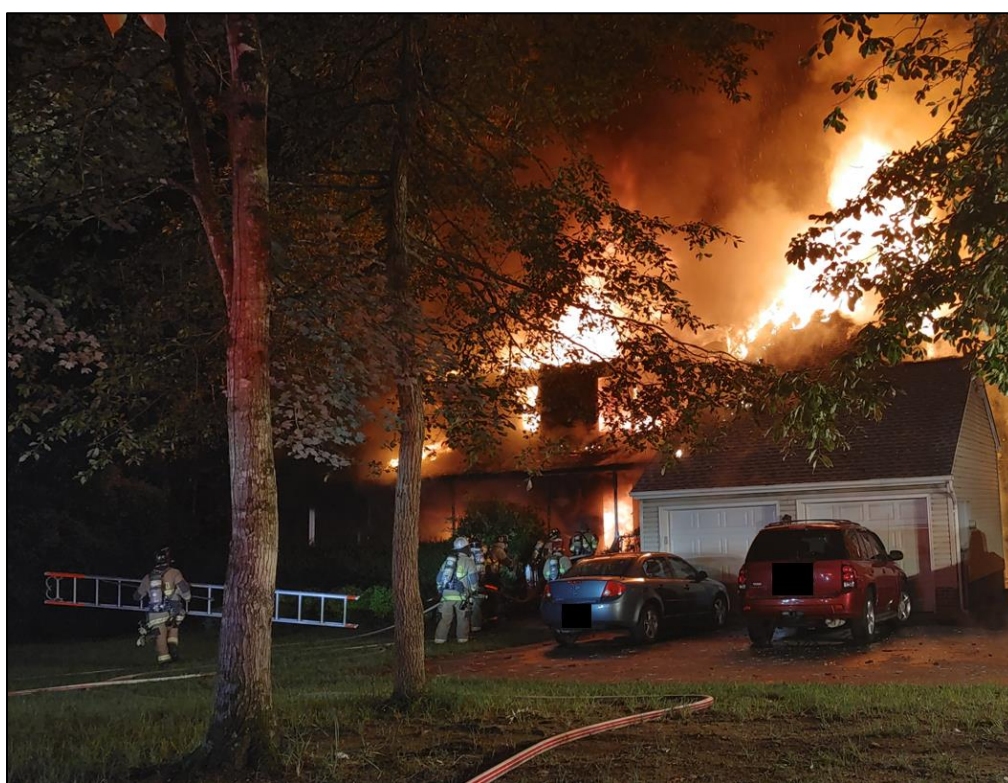
Photo 3. E1, E132 and T1 Transitional Fire Attack
(Courtesy of Southern Maryland News Network)

The nozzle firefighter from E1 advanced approximately three to five feet into an open foyer on his knees while flowing water from a 1¾-inch adjustable fog nozzle. Heavy fire conditions were present throughout the structure with compromised drywall along the framed walls and ceiling. The nozzle firefighter from E1 became thermally saturated and withdrew from the structure, passing the nozzle to a second firefighter from E1 who was in the threshold. The second firefighter from E1 resumed working the fog nozzle with little impact on the fire. The second firefighter continued attempting to extinguish fire on the first floor, den, stairwell, and second floors from a kneeling position before becoming thermally saturated and withdrawing to the exterior. The second firefighter passed the nozzle to the company officer of E132 upon withdrawal. E132’s company officer advanced approximately

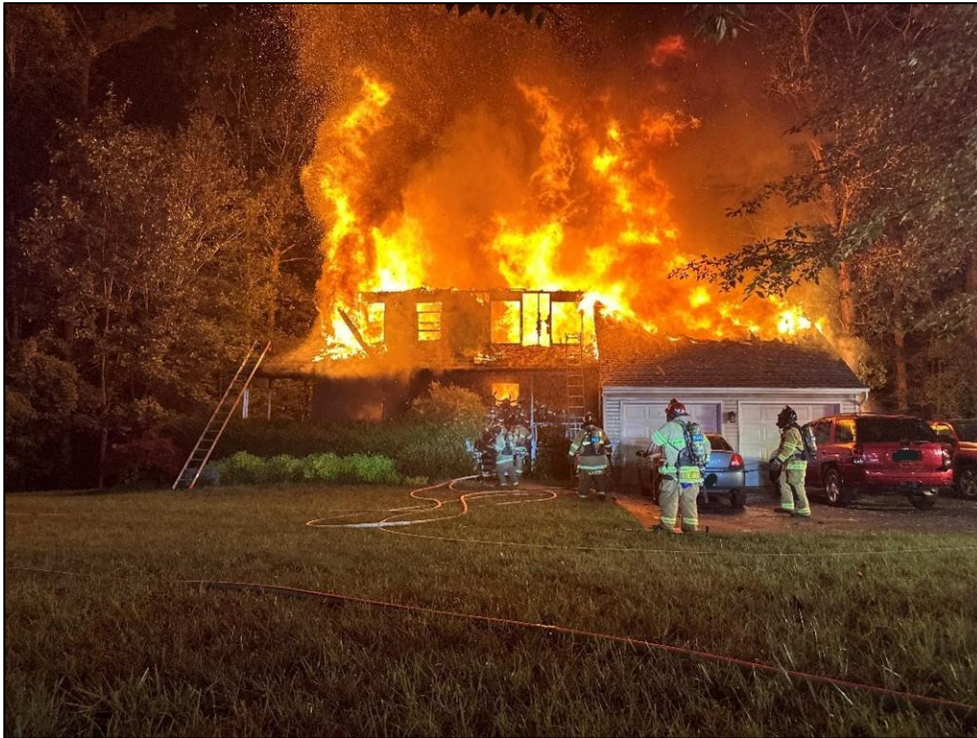
Photo 4. Fire conditions after second floor collapse
(Courtesy of Southern ScanMD.org)

E6 arrived on-scene and was assigned as the RIT with the company officer from E6 assigned as the RIT group leader. At 0426 hours C9B, who had arrived on-scene and been assigned as the Safety Officer by the IC in a face-to-face meeting, was obtaining a 360-degree walkaround when the Safety Officer transmitted a priority message to IC indicating “we just lost the second floor on side Charlie.” A firefighter from E132 who entered through the window on side Alpha into a den observed a line working from E1 and a “fireball” over his head to the right towards the E132 officer. The E132 firefighter felt the first floor “settle” as he retreated to the window and exited headfirst. At 04:26:56 and 04:27:00 hours there were inaudible radio transmissions of yelling in the background on-scene. IC requested that all companies evacuate the structure and the local PSAP initiated the evacuation tone at 04:27:10 hours.

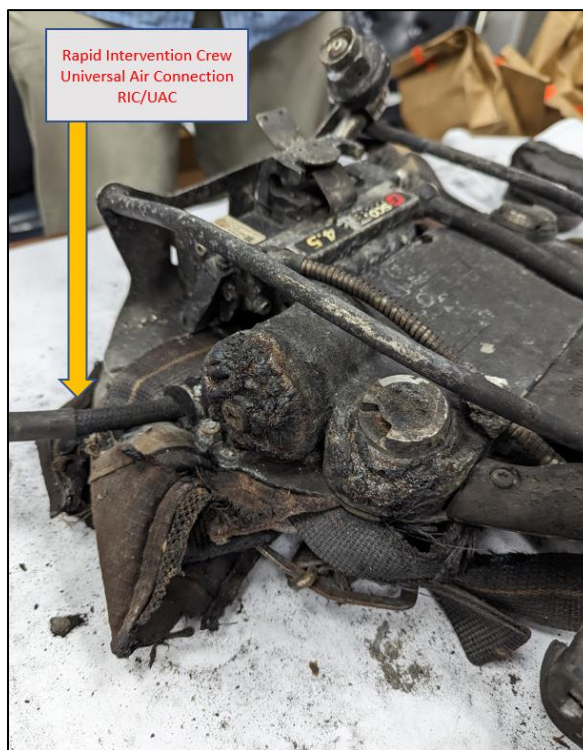
Photo 5. E132's Company Officer SCBA
(Courtesy of NIOSH)

After cutting, digging, and removing debris, a rescue group firefighter crawled as close as possible to the SCBA bottle being worn by the company officer from E132 trying to determine the position of E132's company officer, check the air supply on the neck of the SCBA bottle, and establish contact. After several attempts to establish communication, it became apparent that the company officer from E132 was unconscious. The rescue group firefighter was unable to get any closer to assess the company officer from E132 but observed that his helmet was off while his SCBA facepiece was on and intact. The rescue group firefighter attempted to shut the PASS device off but was unsuccessful. The rescue group firefighter noted that E132's company officer had suffered thermal degradation to his PPE, primarily on the right shoulder, arm, and SCBA.
