LINE OF DUTY DEATH REPORT REPORT SLIDES

F2023-09

Career Acting Fire Officer Dies from Floor Collapse during Interior Fire Attack – Maryland

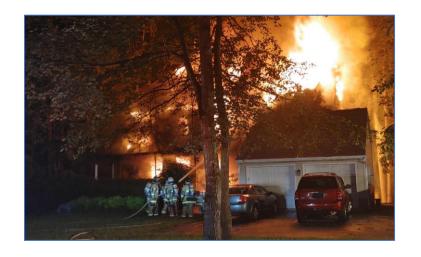
Conditions upon arrival of El (Courtesy of Southern Maryland News Network)

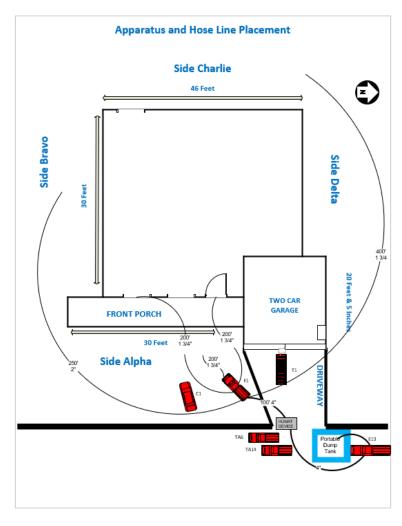
Scene Diagram (Courtesy of: NIOSH)

- The acting officer (deceased firefighter) of Engine 132 reported to the command post in the yard on side Alpha.
- Engine 132 was assigned to Chief 3B, the Division 1 supervisor.
- Engine 132 was assigned to stretch a second 200' 1<sup>3</sup>/<sub>4</sub>-inch attack line to the front porch.
- Both 1¾-inch attack lines were operated in a transitional mode from the front porch prior to making an offensive interior attack.
- At approximately 0425 hours, two firefighters from Engine 132 advanced their 13/4-inch attack line through a first-floor window to the left of the front door.

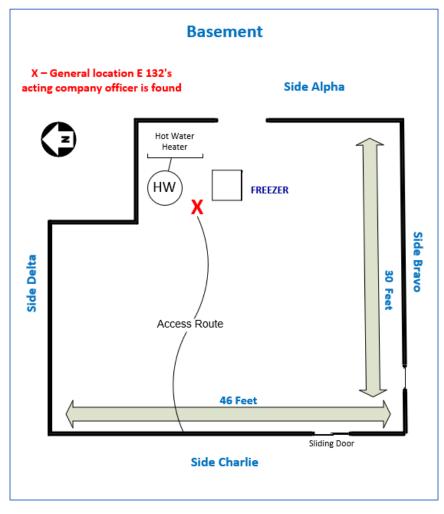
Diagram of the Basement (Courtesy of: NIOSH)

- At 0426 hours, emergency traffic was transmitted from the safety officer
   Chief 9B on the tactical channel that the second floor collapsed on side
   Charlie.
- IC requested the county fire dispatcher to transmit the evacuation tone.
- A Mayday was declared at 0427 hours by Chief 7A reporting a missing firefighter on the first floor who had possibly fallen into the basement.
- The IC moved the fireground operations communications to ALPHA 4 and assigned Chief 6 to oversee the fireground operations while the IC maintained the Mayday on ALPHA 3.

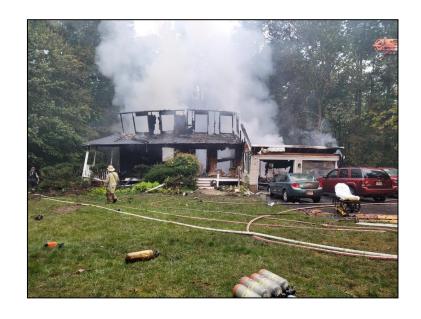
A view of the structure from side Alpha after the fire was knocked down. (Photo courtesy of Fire Marshals Office)
