PILLAR STABILITY ISSUES BASED ON A SURVEY OF PILLAR PERFORMANCE IN UNDERGROUND LIMESTONE MINES

Gabriel S. Esterhuizen, Sr. Research Fellow
Anthony T. Iannacchione, Acting Geotechnical Engineering Section Chief
John L. Ellenberger, Research Geophysicist
Dennis R. Dolinar, Mining Engineer
NIOSH-Pittsburgh Research Laboratory
Pittsburgh, PA, USA

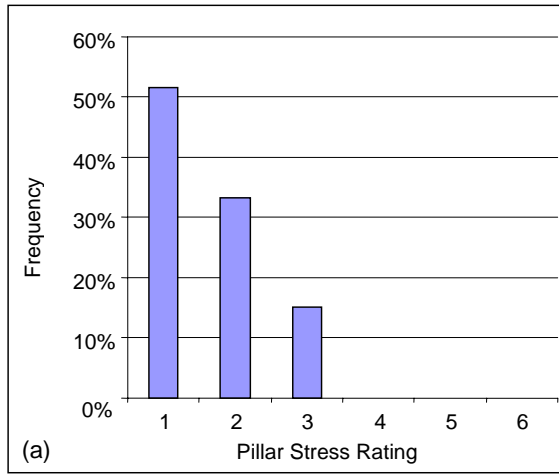
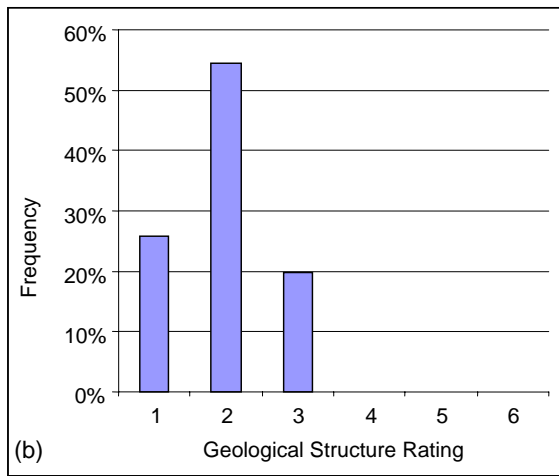
Figure 1a shows that 85% of all layouts visited had PSR values of 1 or 2, implying “None” to “Minor” stress related damage. Only 15% of cases were rated as “Moderate”. The relationship between the average pillar load in a layout and the PSR is shown in figure 2. The pillar stress was determined by the tributary area method, based on measurements of pillar dimensions and the depth of cover. The results show that stress related fracturing can become “moderate” as the average pillar stress approaches and exceeds 20 MPa. It was observed that mine operators installed rib support in some of the pillars rated as “moderate” to maintain safe working conditions.

Regarding geological structure effects, figure 1b shows that 20% of pillar layouts visited had GSR rating of 3, implying “Moderate” pillar damage caused by geological structures. These were caused by a variety of structures, including weak bedding

Figure 1. Distribution of the Pillar Stress Rating and the Geological Structure Rating for pillar layouts (refer to tables 1 and 2).

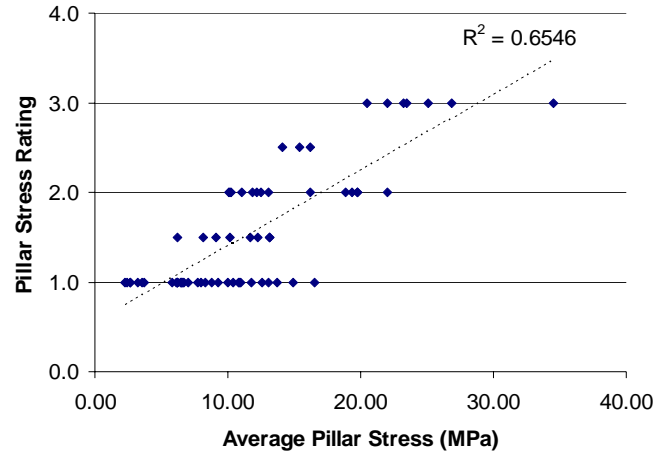
Figure 2. Relationship between average pillar stress, calculated by the tributary area method, and the Pillar Stress Rating

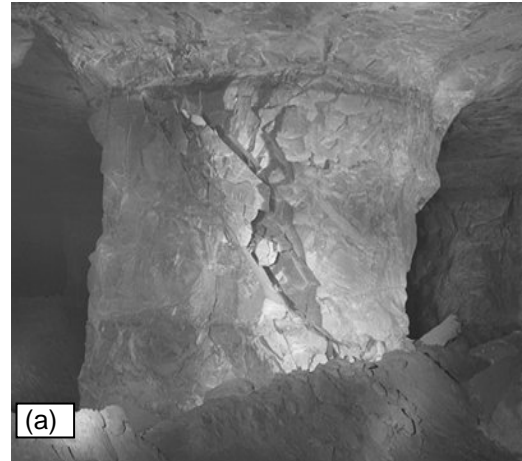
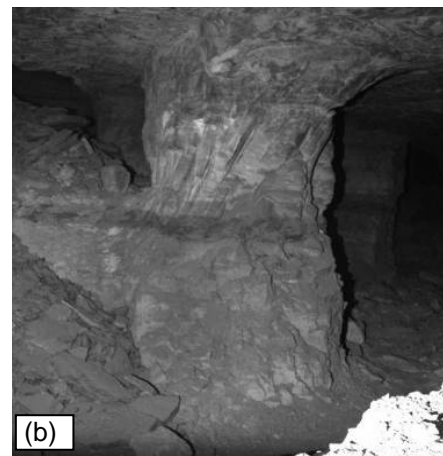
Figure 3 shows two pillars that became unstable during benching. The large angular discontinuities prominent in the photographs did not open or extend until benching occurred. The structures are often very difficult to see on development, when the pillar width-to-height ratios are typically greater than 1.0. They are most likely to be recognized when benching occurs and greater pillar heights expose more structures and additional bench blasting loosens the rock associated with these discontinuities. In both cases, benching could not be completed around the pillars for fear of total pillar collapse.

Figure 3. Partially benched pillars that became unstable during benching at Mine A (Cases 1 and 2 in table 5). Figure 3a shows failure along two discontinuities while figure 3b shows evidence of multiple discontinuities.
