# Reinforced Concrete Design

## Instructor's Manual

DHHS (NIOSH) Publication No. 2013-135

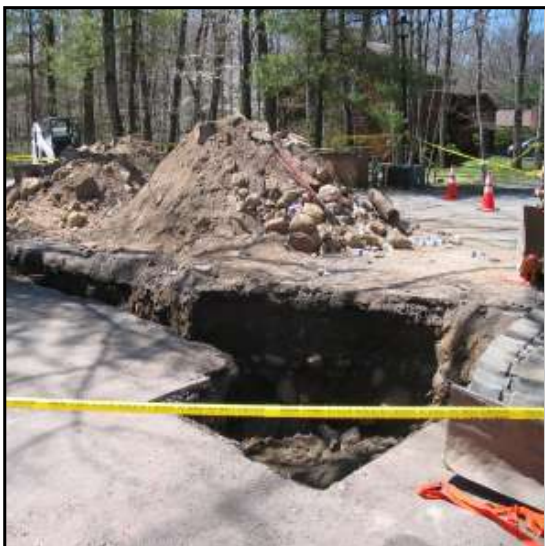
*Figure 3: Location of collapse.  
Note spoils piles and equipment located less than 2 feet from the edge of the trench (courtesy of OSHA)*

The OSHA investigation resulted in findings that the trench section that collapsed was a triangular shaped area at the northwest corner of the excavation, approximately 5 feet 1 inch (5' 1") in length, 4 feet (4') wide, and 6-7 feet (6-7') deep. Multiple hazards were present, but had not been identified and remediated. The W side of the excavation collapsed and pieces of asphalt paving and rock fatally crushed the victim while he was making the sewer tap (Figures 3 and 4).

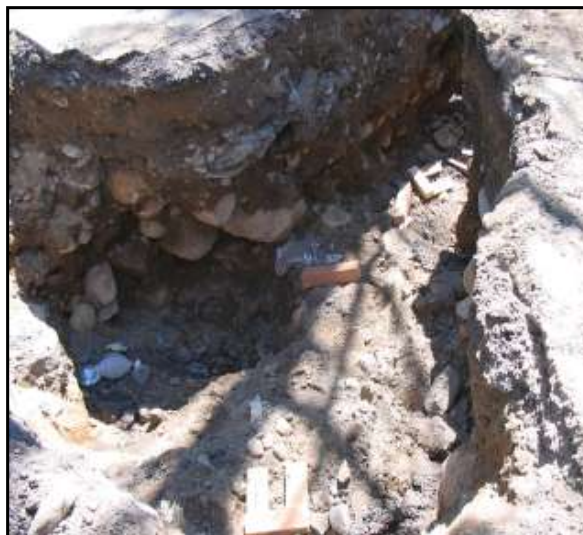
*Figure 4: Area of trench collapse  
Note the large boulders hanging from the excavation faces and undermined areas on the edge of the trench (courtesy of OSHA)*

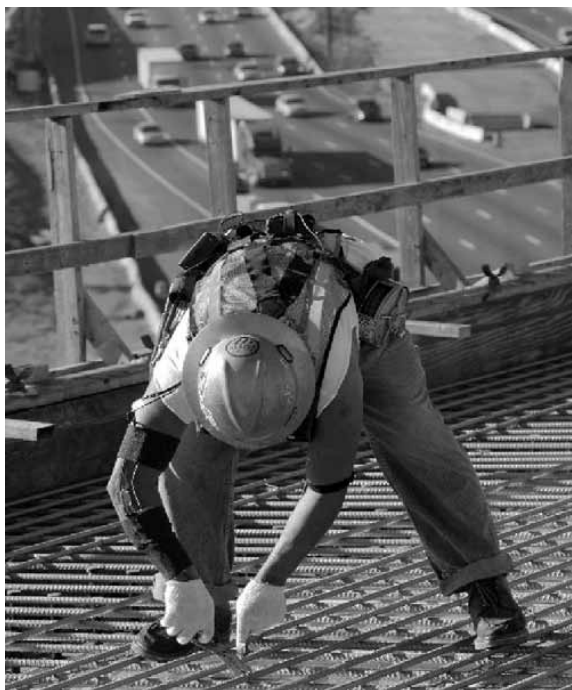
**Figure 1.** Rebar tying using pliers. Note the bent posture and awkward hand position.

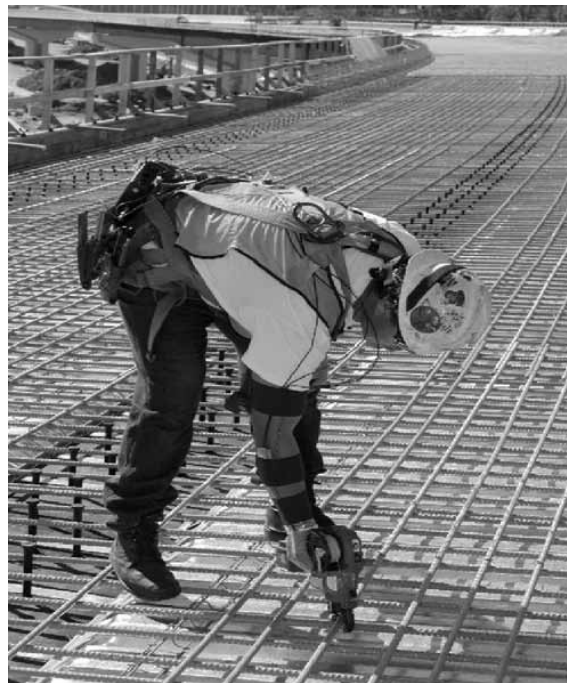
**Figure 2.** Rebar tying using a MAX-USA RB-392 power tool. Note the bent posture.

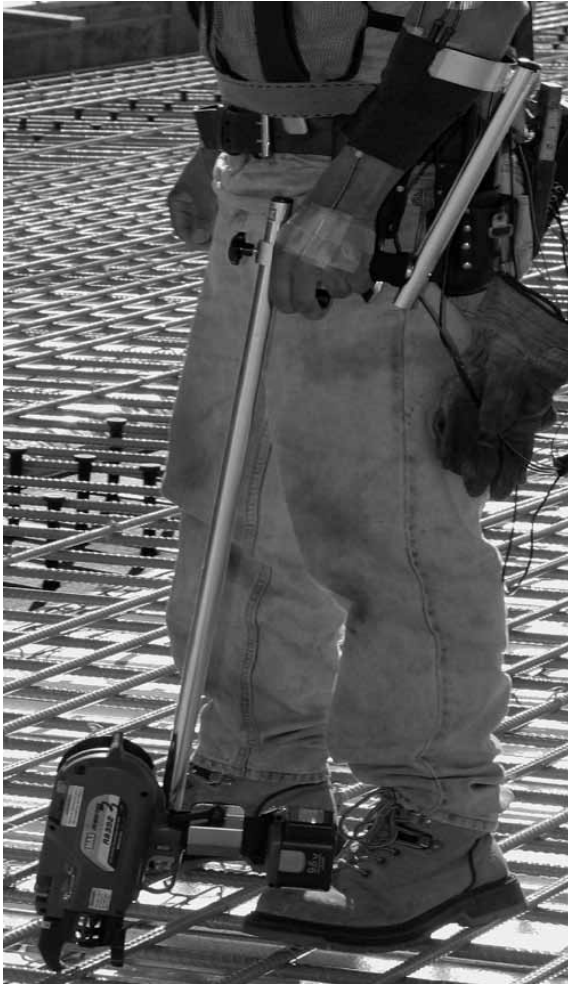
**Figure 3.** Rebar tying using a MAX-USA RB-392 power tool with adjustable extension.

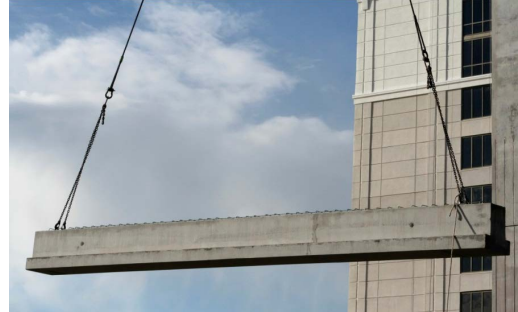
- For simple spans:
  - Tension in bottom of beam
  - Compression in top of beam
- Precast elements tied into buildings with hooks, lap splices, or couplers

Cast-in-place concrete beams and girders are formed and poured the same way as elevated slabs. Significant shoring is required, as well as reinforcement. Because the bottom of the beam experiences the most tension for simply supported members, this is where most of the rebar is located. It is not unusual for a concrete beam to have larger reinforcement at the bottom and smaller reinforcement at the top in order to save on steel costs. Rebar is held together by stirrups, which are wrapped around the rebar and hanger bars. Precast beams and girders are tied into the building by means of hooks, lap splices, or couplers.

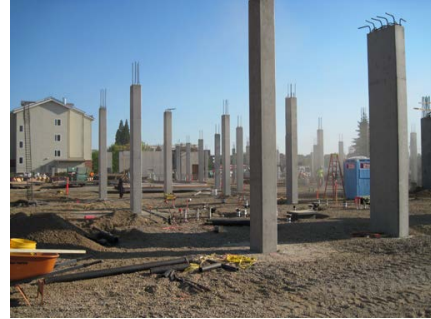
- Typically designed for compression, but must be able to resist bending
- Longitudinal rebar runs vertically and is held in place by ties
  - Longitudinal bars are typically about 4% of the gross column area; ties are usually #3 or #4 bars

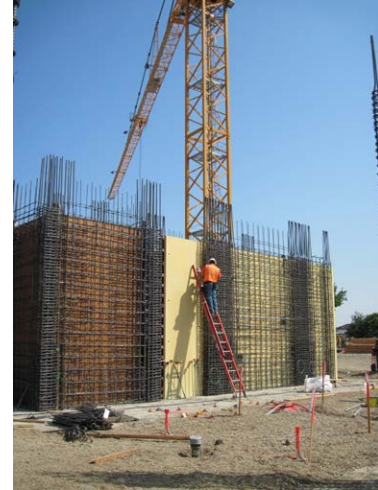
- Concrete walls resist compression forces.
- Walls are reinforced with a mesh of vertical and horizontal rebar in a layer on each wall face.
- Formwork and form ties are used to ensure proper wall thickness.

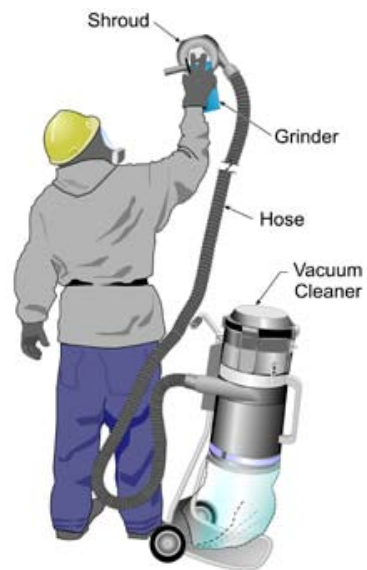
**Figure 1.** Grinder in use with the control in place.

acted as the fan and dust collector for the ventilation system (Figures 1 and 2). The concrete surfaces were flat and allowed the shroud to make a good seal with the concrete. Four commercially available shrouds were used in the NIOSH study. All grinder/shroud combinations reduced dust exposure by at least 90%.

The concrete finishers in the NIOSH studies were responsible for smoothing poured concrete walls and columns. The LEV system consisted of a grinder that was equipped with a ventilation shroud, a length of flexible corrugated hose, and a portable electric vacuum cleaner that

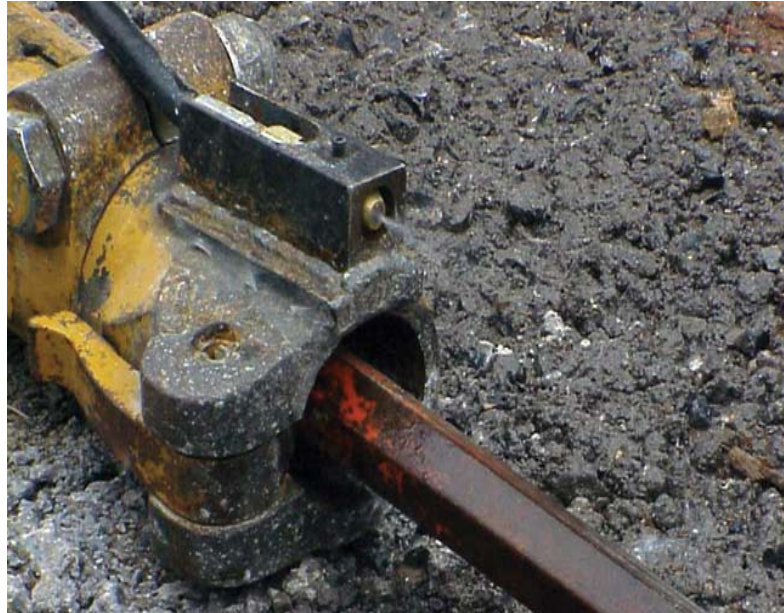
**Figure 1.** The water spray attachment, showing the method used to attach the nozzle to the tool.

NIOSH studied a water-spray attachment (Figure 1) to suppress dust created during concrete pavement breaking with jackhammers [Echt et al. 2003]. This low-flow, water-spray control reduced dust exposures by 70%–90%.

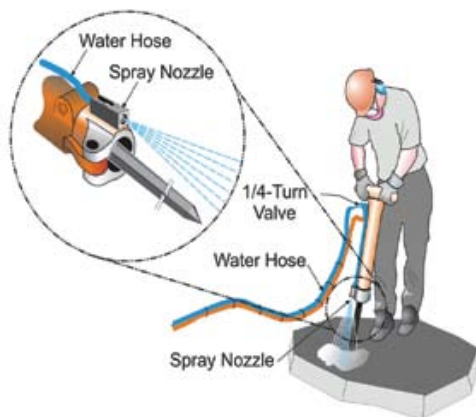
**Figure 2.** Diagram of water-spray control used in NIOSH study

NIOSH is not aware at this time of off-the-shelf, commercially available retrofit kits or jackhammers that come with built-in water spray units. However, it is relatively simple to build a water spray control for a jackhammer using the diagram in Figure 2 and the parts and instructions below:

- **Water-spray nozzle:** Use a solid-cone, furnace-spray water nozzle with an 80-degree spray angle (Type B, 11.00 GPH, 80°, Delavan Inc. Fuel Metering Products, Bamberg, SC [www.delavaninc.com](http://www.delavaninc.com)). Mount the nozzle in a bracket welded on the end of the jackhammer. The spray angle (the angle included between the sides of the cone formed by the water discharged by the nozzle) and the spray pattern are two critical design parameters required to match the performance of the tested device. Spray nozzles make several spray patterns such as hollow cone, full cone, and flat spray. This control used a solid cone nozzle.

- **Water flow rate:** The nozzle used in the NIOSH study delivered about 350 milliliters (11.8 ounces) of water per minute. This flow rate is the third critical design parameter for performance of this control. It is effective in reducing dust and it did not add a lot of water to the work surface or significantly wet workers' clothing or shoes. Higher flow rates may not greatly increase dust control, and lower flow rates may reduce performance.

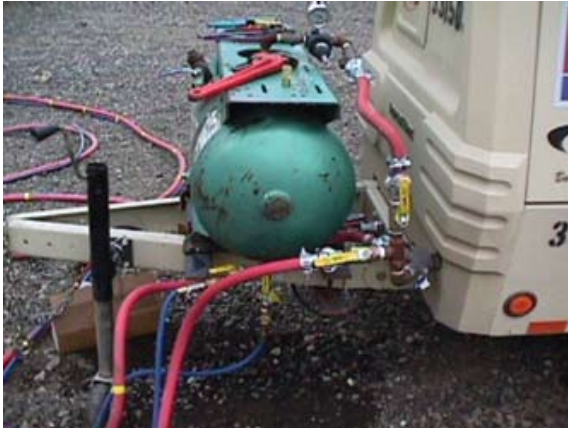
**Figure 3.** Water tank mounted on compressor trailer

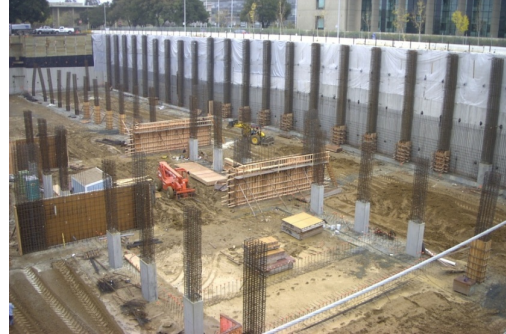
- Falls
- Obstructions
- Cave-in during foundation construction
- Lung or skin irritation from exposure to cement or admixtures [NIOSH 2008, 2009]
- Jack, cable, or fitting failure during tensioning

Falls and obstructions are common hazards on construction projects. Foundation construction creates holes for potential falls into trenches. Additionally, cave-in from foundation construction, although a well-known hazard, needs to be considered in design. Although there are specific guidelines related to trenching and shoring, they are not always followed.

Concrete post-tensioning operations can be hazardous to construction workers if a jack, cable, or fitting fails during tensioning. The large amount of tension put on each tendon could result in a whiplash effect if the cable snaps.

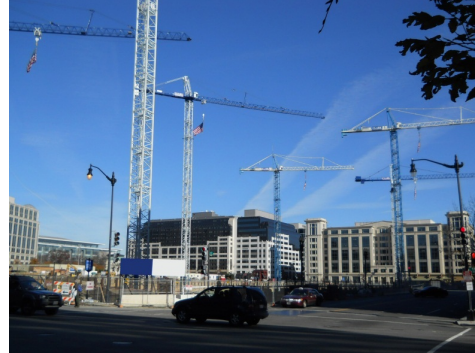
- Erection and disassembly must be carefully planned.
- Site layout affects crane maneuverability.
- Show site utilities on plans.
- Comply with OSHA standards.

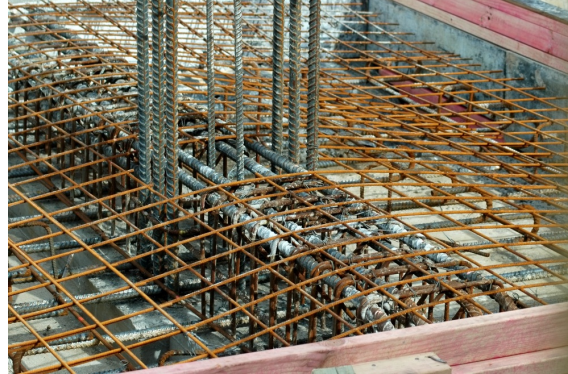
- Design-in adequate embedment in concrete foundations, piers, and walls
  - Allows easy attachment of platforms, stairs, light fixtures, etc.
- Provide railing or grating on top of sumps
  - Prevents falls into the sump pit

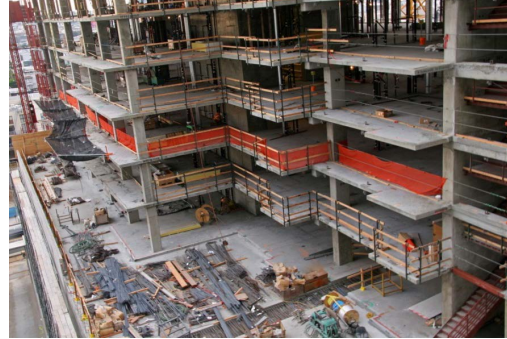
- Note on the contract drawings the existing and new floor design loads
  - Help the constructor in determining material stockpile locations and heavy equipment maneuverability
- For elevated floors, use permanent metal-formed decking with concrete fill to eliminate temporary formwork

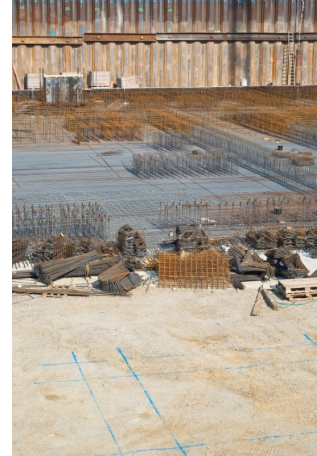
- Use one grade of rebar throughout the whole job
- Prefabricate column and wall cages when feasible
- Utilize welded wire fabric (WWF) (flat sheets) for area paving reinforcement
- Specify carbon microfibers where design allows

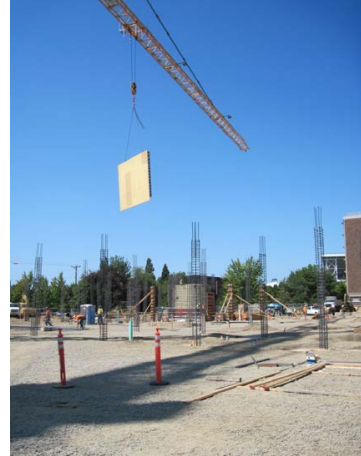
- It is customary to prohibit forming work by hand if wind speed exceeds 25 mph
- Limit the lift height of concrete pours to minimize the load on formwork and the risk of collapse of fresh concrete during pouring operations

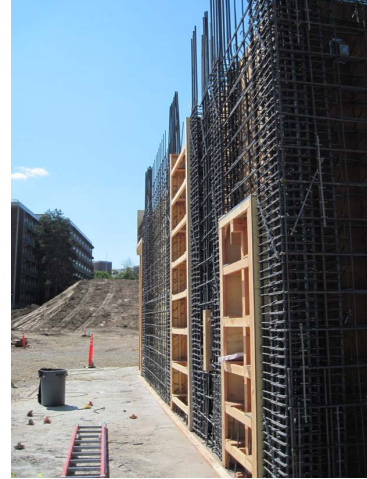
- Use one or more curtains of WWF for reinforced concrete walls and columns
  - Allows placement of large sections rather than many small pieces

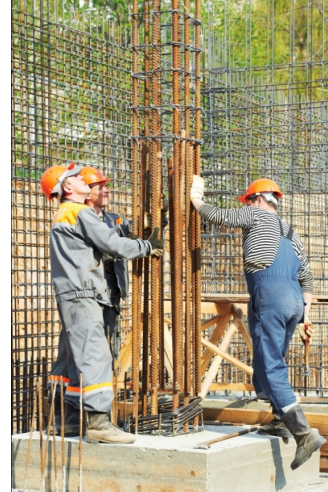
- Design columns with holes (sleeves) or embedded attachment points for guardrails and lifelines
- Specify long rebar lengths to minimize rebar splices
