**LINE OF DUTY
DEATH REPORT
REPORT SLIDES**

F2021-13 PA

Career Firefighter Dies and Three Others Injured in a Struck-By Incident while On-Scene at a Roadway Crash

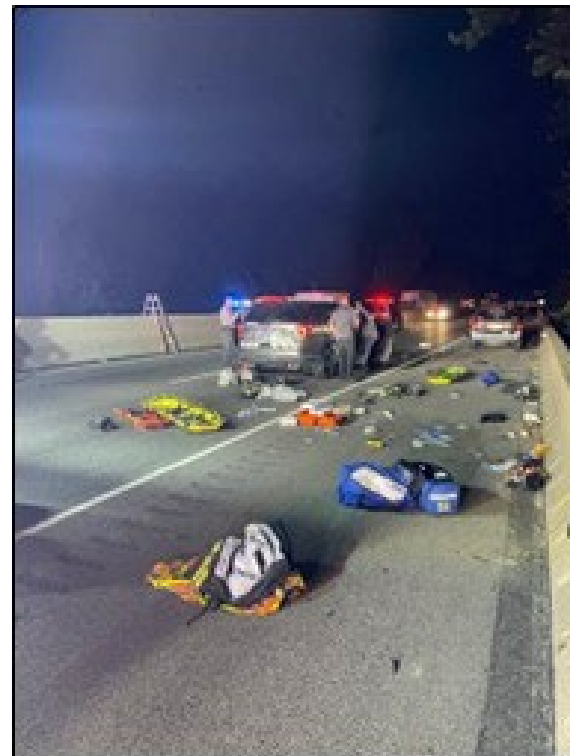
Westbound view of roadway shown from alongside rescue displaying medical equipment and supplies on the roadway and shoulder with a police vehicle and involved civilian vehicles in the distance. Photo by Fire Marshal Office

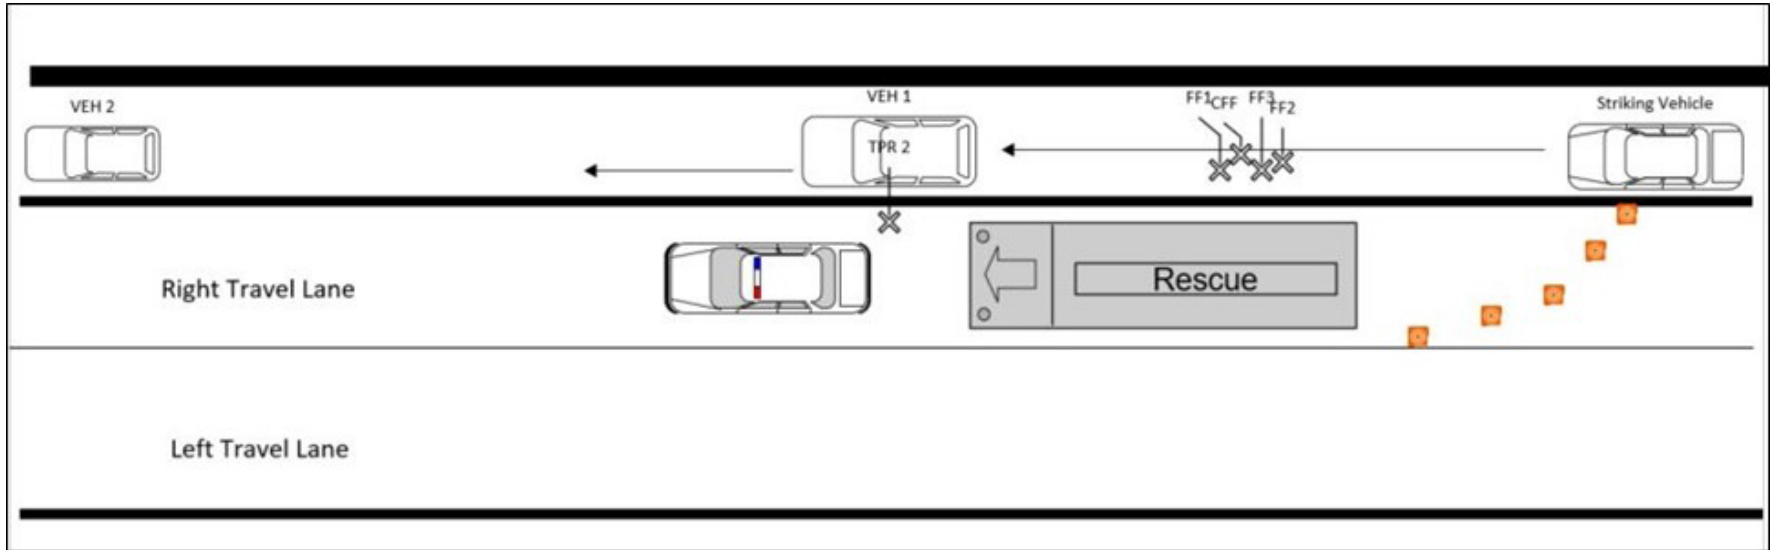
- R-CPT notified the engine that they were released.
- The engine merged into traffic in the left travel lane, proceeded forward, came to a stop near VEH 2 to briefly talk with TPR 1, and then pulled away while notifying county dispatch of being back in service.
- During this same time, a vehicle traveling westbound was observed by R-CPT approaching the crash scene in the right travel lane and then swerving onto the right shoulder.
- R-CPT yelled “RUN.”
- The vehicle was further observed passing by the rear of the rescue striking R-CFF, R-FF1, and R-FF2 standing within the right shoulder area and striking the rear of the first civilian vehicle and pushing it forward approximately 15-feet.

Diagram of vehicle and personnel location at the time of impact. Arrows show direction of vehicle movement during and after impact. Diagram by NIOSH.

- R-FF3 had jumped on to the shoulder barrier wall, holding on to avoid falling to the ravine below.
- TPR 2 sustained a secondary strike during this event.
- R-CPT immediately requested multiple EMS units to respond, while available crew began triage and initiated treatment based on severity of those struck.
- After hearing the R-CPT's message to county dispatch, the engine immediately stopped and proceeded to back-up, approximately one-tenth mile to the scene, and the crew assisted with medical care.
- R-CFF was located in front of the police vehicle, approximately twenty feet away from the impact area, in cardiac arrest.

- R-FF1 was located between the rescue and police vehicle with altered levels of consciousness and extremity trauma.
- The trunk and rear window of the police vehicle sustained damage that indicates R-FF1 initially impacted the police vehicle before landing on the roadway.
- R-FF2 was found unresponsive with head trauma against the barrier wall shoulder wall.
- TPR 2 was found along the passenger side of the police vehicle with extremity trauma from a secondary strike.
- Five EMS units and multiple fire companies responded to the scene.

- Ineffective temporary traffic control in the following Temporary Traffic Control (TTC) zones:
 - Advance Warning Area
 - Transition Area
 - Activity Area
 - Termination Area
- Inadequate termination of a Traffic Incident Management Area (TIMA)
- Lack of continuous risk assessment
- Ineffective situational awareness
- Failure to require and provide traffic incident management training and ensure competencies
- Inadequate and ineffective department and company traffic incident management policy and company traffic incident management standard operating procedures for response to roadway incidents

- All emergency responders involved with incident command operations should ensure an appropriate TIMA is identified and effective TTC zones are implemented for traffic incidents.
- All emergency responders involved with incident command operations should ensure a proper and effective termination of a TIMA to maintain the safety of all responders through their departure from the scene.
- All emergency responders involved with incident command and fire officers should ensure ongoing risk assessments through the duration of the incident until all responders have departed the scene.

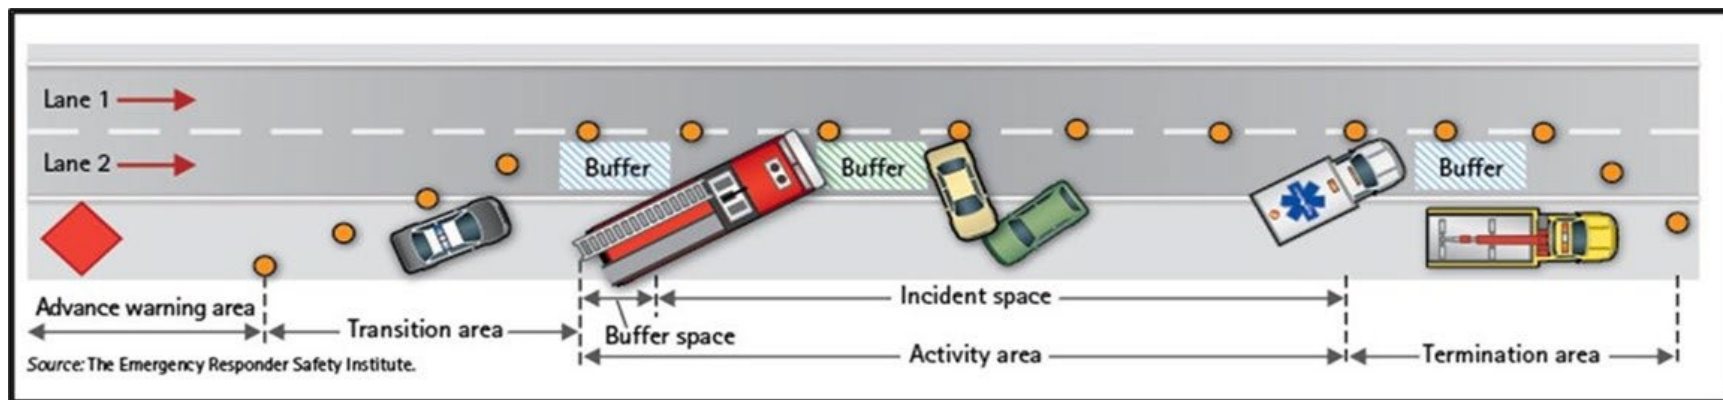
Diagram of a traffic incident management area with identified temporary traffic control zones.
Diagram by Emergency Responder Safety Institute
