INVESTIGATION OF PILLAR-ROOF CONTACT FAILURE IN NORTHERN APPALACHIAN STONE MINE WORKINGS

Gabriel S. Esterhuizen, *Mining Engineer*
Anthony T. Iannacchione, *Senior Scientist*
National Institute for Occupational Safety and Health
Pittsburgh Research Laboratory
Pittsburgh, Pennsylvania USA

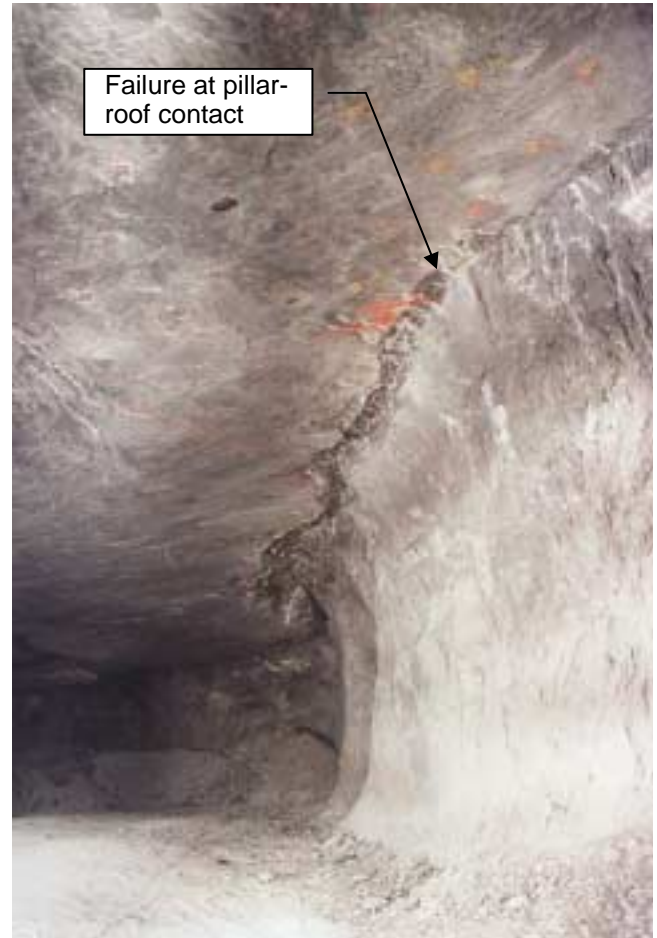
Figure 1. Photograph showing failure at pillar-roof contact after loose rock has been removed and roof has been re-supported.

Pillar-roof contact failure differs from the typical failure mode described above because it is asymmetrical, usually occurring only along one edge of each pillar in an array of pillars. The failure is initially restricted to a small area around the pillar edge, but may propagate to the full collapse of an entire room. Figure 1 illustrates a typical example of pillar-roof contact failure. The failures all appeared to be caused by stress related damage of the intact rock. The mode of failure, whether tensile or compressive, was not always readily observable. In several cases the failed rock had been removed and the roof had been scaled back to a solid face, which precluded direct observation of the failure mechanism. Both cases of pillar-roof contact failure were associated with a dip of greater than 5°.

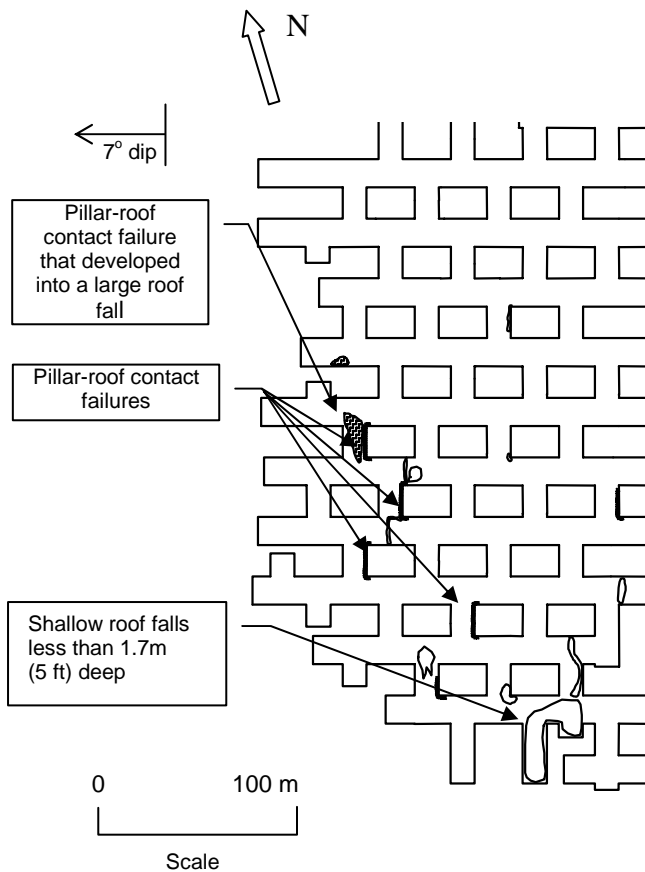
Figure 2. Plan showing layout of pillars and location of pillar-roof contact failures at case study site.

Asymmetrical failures at the pillar-roof contact were observed only in the southwestern part of the mine where the dip is gradually increasing. Figure 2 shows a plan view of a portion of the workings and the locations of pillar-roof contact failures as well as other roof failures. At one of the locations, the pillar-roof contact failure progressed into a massive directional failure. In this area the major horizontal stress appears to be oriented at approximately N80°W, parallel to the dip of the limestone. The change in orientation is apparent from major roof falls which are oriented along the strike of the workings in this area. Further indirect evidence of the major horizontal stress parallel to the dip is the dip-symmetry of the pillar-roof contact failures.

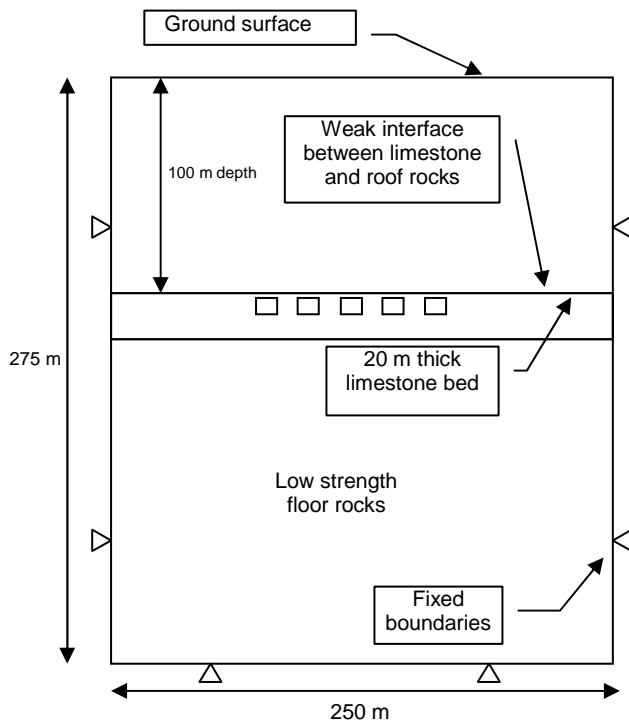
showing the room, pillars and location of the weak interface is presented in figure 3. The material properties were selected to represent typical Loyalhanna limestone and the surrounding weaker rocks. Table 3 lists the material properties used in the basic model setup. The model was loaded in the vertical direction by gravity. The horizontal stresses were initialized to simulate the effects of constant tectonic strain, varying between 0.1 and 0.4 millistrain. The horizontal stress in the stiff limestone was always higher than in the softer surrounding rocks owing to the constant tectonic strain field. In these models the rock was assumed to be linearly elastic, so that shedding of stresses due to rock failure would not occur.

Figure 3. Numerical model layout showing location of rooms and pillars in the limestone formation.

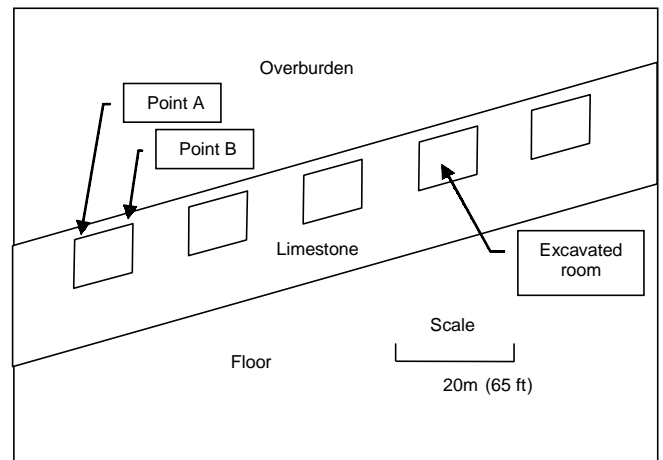
The effect of an increase in the dip of the workings on stresses in the roof was assessed by changing the dip of the limestone in the model to 5, 10 and 15°, see figure 4.

Figure 4. Detail of numerical model showing dipping limestone formation and location of Points A and B for assessment of stresses in the roof beam.

The results of an analysis in which the horizontal stress in the limestone was 25 MPa (3,620 psi) (corresponding to a tectonic strain of 0.36 millistrain) are presented in table 4. These results show that the stress at the down-dip corner of the roof tends to decrease with increasing dip, while the stress at the upper corner increases. The changes in stress are relatively small. This implies that failure will only be caused by an increase in dip if the roof is already highly stressed and is near the point of failure. Under such a scenario, an increase in dip may initiate asymmetrical failure at the pillar roof contact on the up-dip side of a room.

¹Refer to figure 4 for location of points A and B.

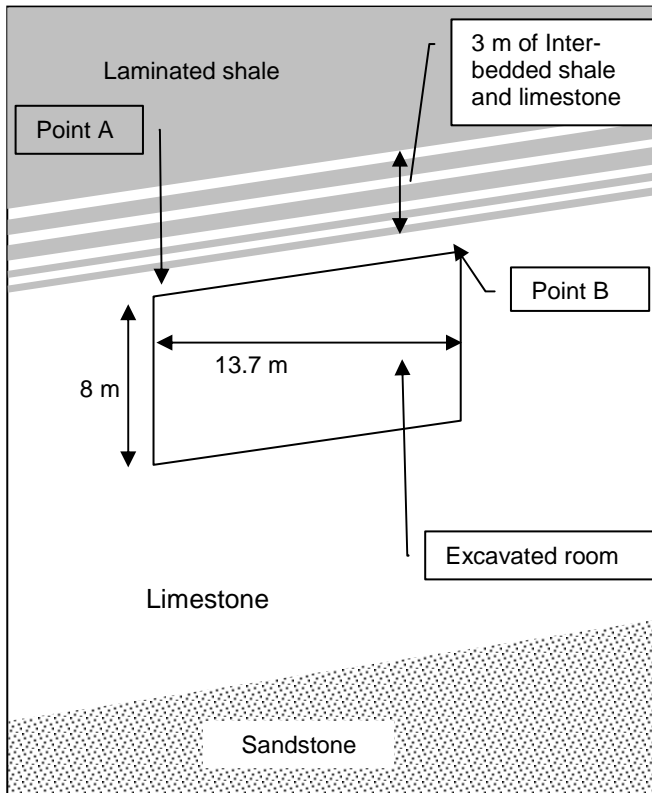
A detailed FLAC model of three rooms and the four adjacent pillars was used to back analyze the observed pillar-roof contact failures. The strain-softening ubiquitous joint constitutive model in FLAC was used to simulate the effect of layering of the rocks. This allows initial rock yield to occur and stresses to be shed as the failure progresses. A portion of the FLAC model is presented in figure 5, which shows the detail of the layering of the limestone and weaker overburden materials. The strength properties of the limestone rocks and the weak and strong roof beds are listed in table 5. The large scale rock strengths of the limestone and surrounding rocks were reduced by 0.58 from the laboratory determined strength values to account for the difference in strength of laboratory size specimens relative to the field scale, after Hoek and Brown (1980). The main body of the limestone was modeled as a massive unit, without any bedding weaknesses. The effect of weak bedding layers within the limestone pillars was evaluated separately.

Figure 5. Detail of the numerical model used to assess the effect of dip on roof stability for the case study site. The locations of point A and B for assessment of roof stability are shown.

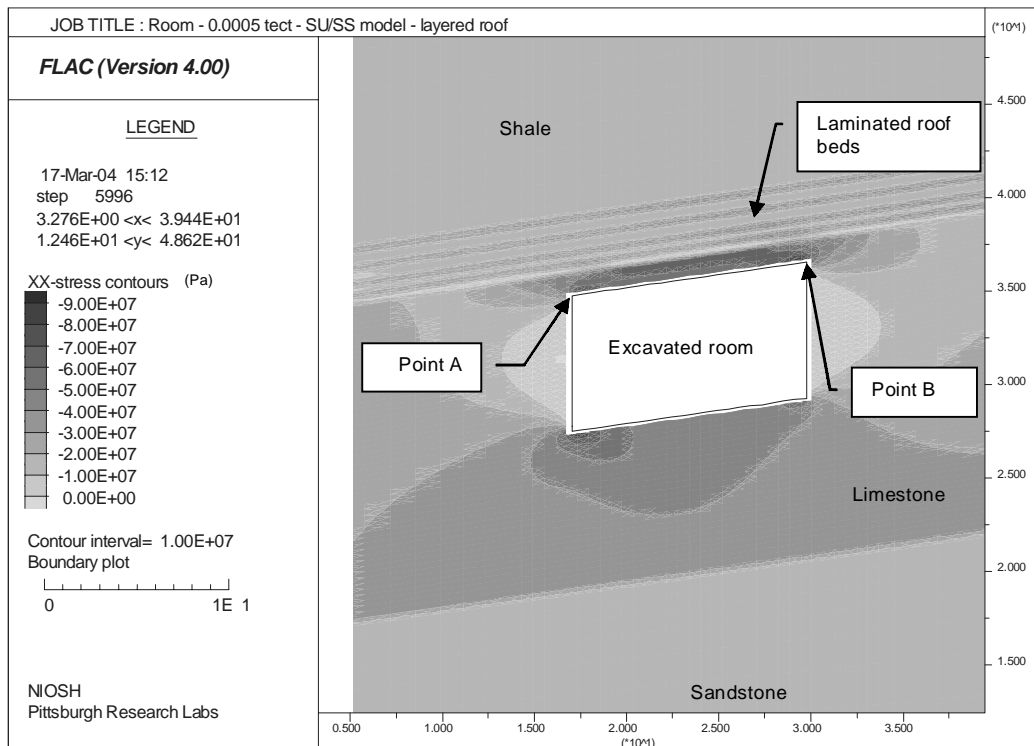
The horizontal stresses in the rock surrounding the room are presented in figure 6 which clearly shows the asymmetrical nature of the stress distribution. The average horizontal stress in the roof beam increased considerably above the tectonic stress in the limestone, being in the range of 50-60 MPa (7,250-8,700 psi) at center span while the tectonic stress was 35 MPa (5,070 psi). The maximum horizontal stress values in the roof beam are found near the corners of the room. The horizontal stresses adjacent to the down-dip corner (Point A) and up-dip corner of the roof (Point B) were 73.5 MPa (10,660 psi) and 88.5 MPa (12,830 psi), respectively.

Figure 6. FLAC plot showing horizontal stress distribution around a room with interbedded roof rocks in massive limestone. Contour intervals are 10 MPa (1,450 psi). The tectonic stress was 0.5 millistrain.

The stress near the updip corner of the room is therefore approximately 20% higher than at the downdip corner. This is consistent with the observations that showed that failure initiated at the up-dip corner of the rooms and confirms that failures at the pillar-roof contact are likely to be the result of asymmetrical stresses owing to the dip of the workings.

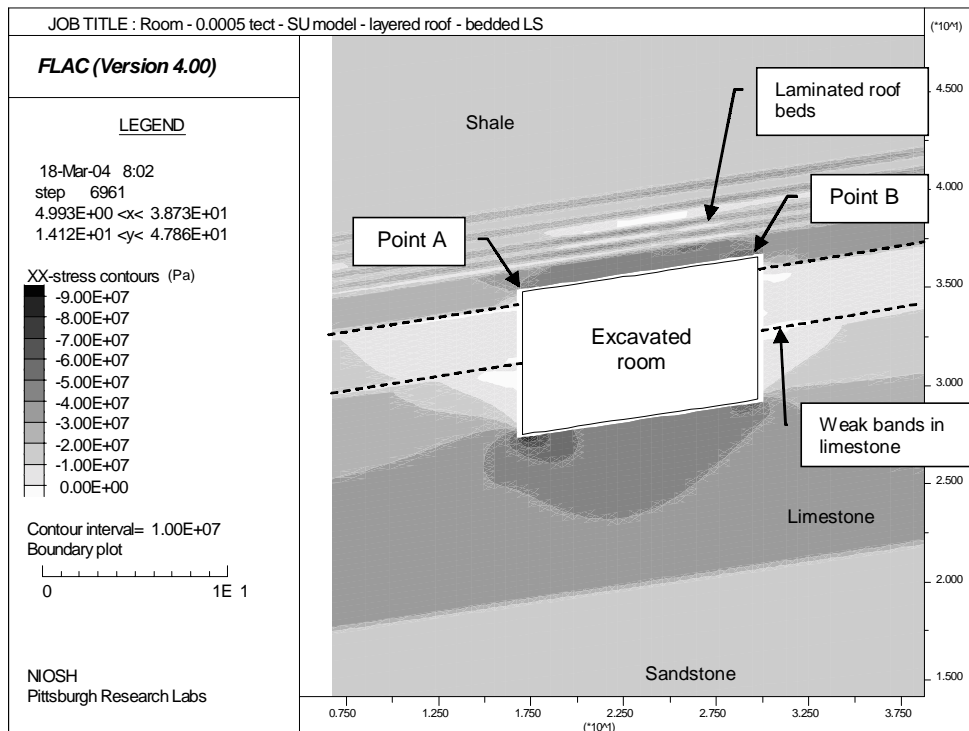
Figure 7. FLAC plot showing horizontal stress distribution around a room with interbedded roof rocks in limestone containing weak bands. Contour intervals are 10 MPa (1,450 psi).

The above analyses demonstrated the importance of layering in the roof and stress relief by sliding along weak beds. The fact that failure at the pillar-roof contact did not occur at all the pillars was thought to be related to a stress relief mechanism, which may be associated with weak bands in the limestone. Consequently, a model was set up to simulate limestone pillars that contain two weak bands near mid-height. Figure 7 shows the horizontal stress distribution in such a pillar, and can be directly compared to figure 6. It can be seen that stress relief along the weak bands in the pillar result in a significant reduction in the stress in the roof. The horizontal stress at Point A reduces from 73.5 MPa (10,660 psi) to 54.3 MPa (7,870 psi), which is a 26% reduction. The horizontal stress at Point B reduces from 95.6 MPa (13,860 psi) to 65.1 MPa (9,440 psi), which is a 32% reduction.

The results demonstrate that the presence of weak bands in the limestone may act as a stress relief mechanism. Limestone containing strong and discontinuous bedding would therefore be more prone to stress related roof failures than a limestone with weak bedding planes.
