# Improving stopping construction to minimise leakage

Roy H. Grau III, Andrew L. Mazzella and Anu L. Martikainen  
Office of Mine Safety and Health Research (OMSHR)  
National Institute for Occupational Safety and Health (NIOSH)  
Pittsburgh

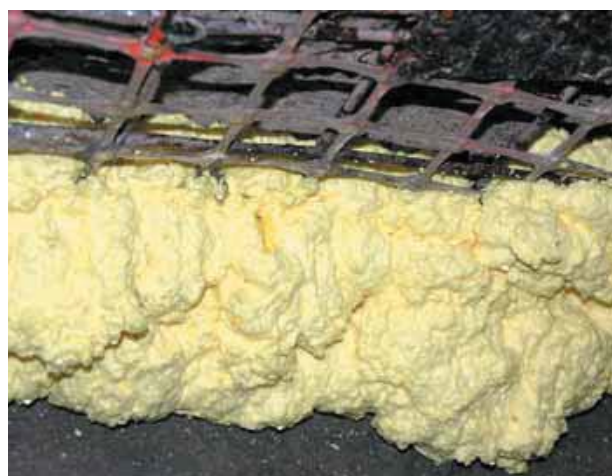
Figure 4. Polyurethane foam sealing stopping at roof on pressurised stopping side for Test 3

Preparation for the third pressure-leakage test (Test 3) included adding polyurethane foam sealant to the perimeter of the high-pressure side of the stopping as shown in

Figure 4 and around the man-door. These improvements resulted in a leakage reduction of 62% to 0.177 m<sup>3</sup>/sec (375 cfm) at 1245 Pa (5 in WG). The pressure increase followed the relationship shown in Figure 2.

Although airflow leakage was significantly reduced during Test 3, leakage was still evident even though the stopping was sealed with polyurethane foam. Ventilation tube smoke released on the high-pressure side readily passed between the roof and foam, showing that the interface between the stopping and the roof provided minimal resistance to airflow leakage. Although the foam appeared to thoroughly seal the stopping perimeter, the foam was covering the stopping and roof control screen only superficially, which did not create an adequate seal. This test showed that there were two hindrances to effectual sealing of the stopping: the presence of roof control screen and the presence of wooden wedges that are typically used to keep the stopping in place. Both the roof control screen

and the wooden wedges blocked the penetration of the polyurethane foam and prevented the foam from filling voids between the blocks and the roof or ribs. The wooden wedges were positioned in the normal manner with the wedges extended out past the plane of the stopping wall. Nevertheless, the placement of the wedges in this manner prevented the foam from being sandwiched between the stopping block and the roof and allowed only a superficial foam coating.

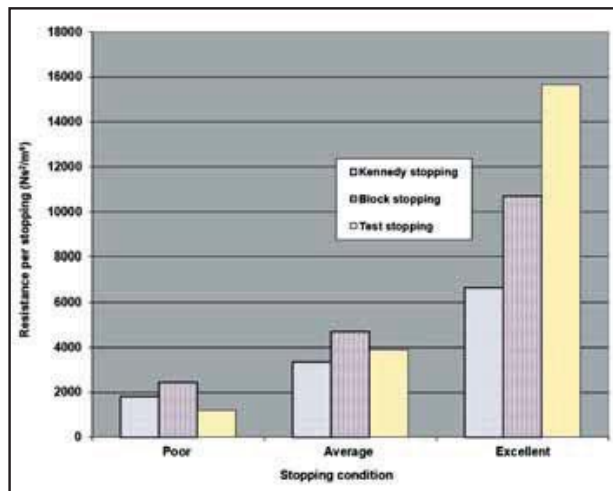
Figure 5. Resistance factors for various stopping types

In order to determine the benefit of sealing the stoppings and to relate the test results with those for other types of stoppings, resistance factors for the stoppings performed in Tests 2 to 4 are compared to those found by Oswald (2008) and are detailed in Figure 5. The chart shows varying resistance factors compared to stopping quality and provides ratings for Kennedy (steel) stoppings and concrete block stoppings on a scale of poor, average, and excellent based on observation criteria reported by Oswald.

Stoppings rated in poor condition have several cracks that allow significant leakage and are in need of repair. Average stoppings are the most common stopping condition found in underground coal mines and would be stoppings that although not near perfect in both condition and construction, are adequate in their application in the mine. Stoppings in excellent condition have high air resistance and have minimal leakage; generally, these stoppings are those that have been coated with a sealant. The stopping assessed in Test 1 was not considered in this evaluation due to its high leakage quantity. The stopping in Test 2 fell into the poor category and had slightly lower resistance than both the block stopping and Kennedy stopping. The stopping in Test 3 fell into the average stopping category, as it had a resistance lower than the block stopping but higher than the Kennedy stopping. The stopping in Test 4 fell into the excellent category; and had a resistance nearly 50% greater than the block stopping with excellent condition, and 140% greater than the Kennedy stopping.

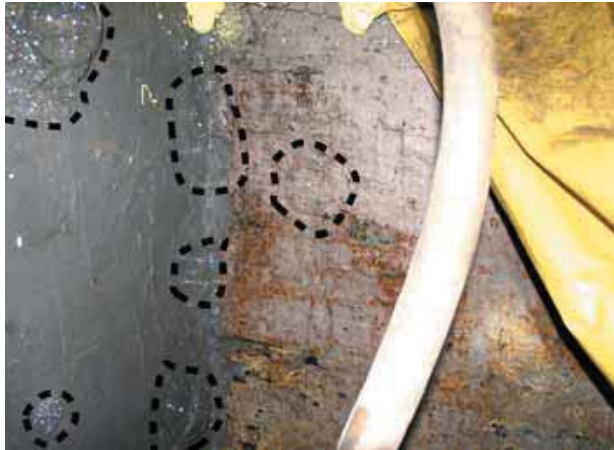
Figure 6. Soap bubbles on stopping and at the right rib at 1245 Pa (4.5 in) WG

Visual observation of leakage through stoppings gives a better understanding of leakage paths, particularly those through the strata surrounding the stopping. Also, smoke can be difficult to discern at low leakage quantities, as evidenced in Test 4. To further understand leakage pathways, after Test 4 was completed, the stopping was left intact and a watery soap mixture was sprayed onto the

surrounding strata and on the low-pressure side of the stopping. As in the previous tests, compressed air was injected into the room. A photographic record was developed of bubbles being formed on the stopping's surface and surrounding strata. This was performed at pressures of 375 Pa, 750 Pa, and 1120 Pa (1.5 in, 3.0 in, and 4.5 in WG).

Bubbles started forming at the lowest pressure, 375 Pa (1.5 in WG), and as would be expected, bubble size, growth rate, and quantity increased with pressure. The bulk of the bubbles formed at the stopping perimeter, primarily at the roof, but also along both ribs. No leakage was observed at the floor. The access door, which was sealed with a rubber gasket and foam, leaked at all pressures. The air leakage through the coal rib appeared to be minimal, and bubbles were only present at 1120 Pa (4.5 in WG) and located about 0.3 m (1 ft) outby the stopping. At one point, a very small bubble appeared approximately 0.91 m (3 ft) outby the stopping on the right rib.
