PRELIMINARY SURVEY REPORT:  
EVALUATION OF BRAKE DRUM SERVICE CONTROLS  
AT  
Pennsylvania Bureau of Vehicle Management  
Vehicle Maintenance Division  
Harrisburg, Pennsylvania

REPORT NO.:  
152-19a

PLANT SURVEYED: Pennsylvania Vehicle Maintenance  
Division Garage  
2221 Forster Street  
Harrisburg, Pennsylvania 17103

SURVEY DATE: March 13, 1986

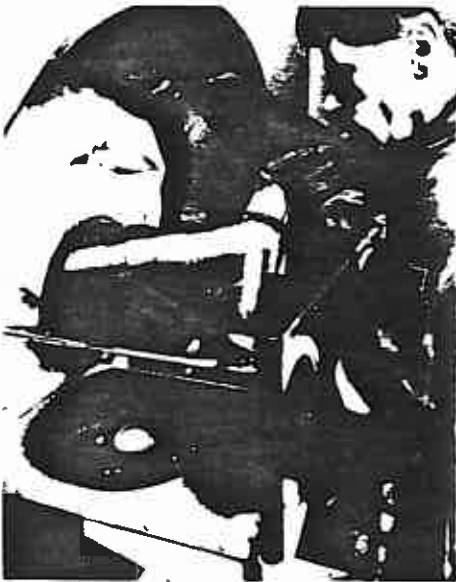
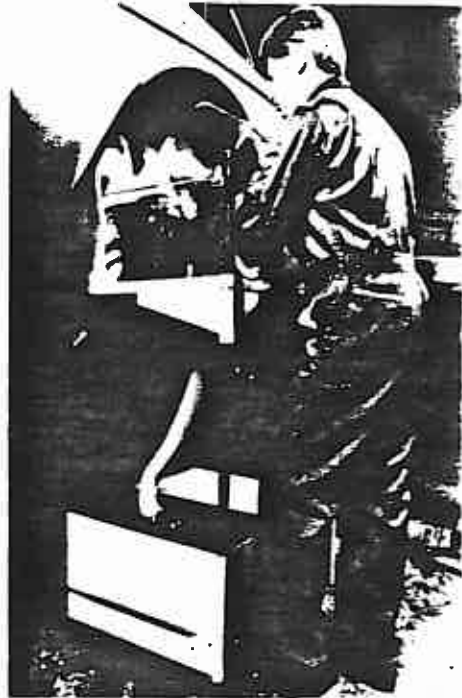
The readily portable Clayton unit consists of an adjustable height glove box for enclosing the brake assembly (after wheel removal) connected by hose to a three-stage vacuum dust filter assembly. Figure 1 shows a mechanic both positioning and working within the glove box, while Figure 2 is a detailed sketch of the dust filter assembly. Discussion of the Clayton unit and the procedures followed in its operation will be presented in detail under III - Controls.

This Pennsylvania state garage uses the BCE-1000 Clayton unit, comprising a transparent enclosure hood and an HEPA vacuum filter dust collector, for servicing of all vehicular brakes during their cleaning, maintenance, repair, and particularly replacement. The Clayton unit, especially designed to contain and collect all brake lining dust (including its hazardous asbestos fiber content) exemplifies the engineering control principles of source enclosure, local ventilation, and dust entrapment and removal through effective filtration. The toxicological effects of worker inhalation of asbestos fibers is well documented and instances of auto repair workers developing mesothelioma identified. Referring to Figure 2, the first stage filter bag is similar to a conventional home vacuum cleaner bag, while the second stage 12" by 12" square prefilter is similar to home hot air furnace filters. The third stage, the high efficiency particulate filter (HEPA), is a unique and expensive filter which has been tested as removing 99.999% of all particulate matter larger than 0.12 microns in size. All three types of filters are standard items purchased from outside suppliers. Filter life is dependent on usage and resultant total collection. With both vacuum pumps operating the vacuum gauge mounted on the vacuum pump case normally shows about 4-5" water vacuum. When the vacuum reading drops to 1"-2" after continued use, the bag and prefilter are subject to removal and replacement with new ones. Under normal operation (5-10 brake jobs per week) of the Clayton unit, the first stage bag filter will likely need replacement in 1-2 months, the second stage prefilter in 3-12 months, and the third stage HEPA filter in 3-5 years. The recommended procedure for removal and replacement of the first and second stage filters involves common sense work practices (see work practices). Removal of the HEPA filter and especially its careful replacement to prevent any bypass leakage poses a problem. With this in mind, Clayton is introducing a special exchange service involving fast shipment of the complete base assembly to the Clayton plant and its immediate replacement by another reconditioned assembly containing a new HEPA filter. Clayton proposes maximum 72-hour turnaround time with an approximate \$75 charge added above the \$400 cost of the replacement HEPA filter. The glove box enclosure is constructed of clear Lexan plastic with the opaque backside comprising four overlapping neoprene fabric flexible strips. These allow easy passage of the

brake drum assembly into the enclosure and also provides the essential tight fit around the axle. Fastened to the front face of the enclosure and extending inwardly are two long gloves into which the mechanic shoves his hands and arms up to and sometimes past the elbows. These loosely fitting gloves permit the mechanic to readily operate the following items which either penetrate the enclosure or are kept within it to assist dismantling of the brake drum and subsequent cleaning of the brake linings, pads, and other elements of the brake system. These items comprise (1) a conventional compressed air gun, (2) a vacuum line with brush attachment, (3) a hammer and/or mallet, and (4) a separate brush. Referring to Figure 1, the entire hood enclosure can be quickly moved up or down the four corner frame posts to permit servicing of vehicular brakes at nearly floor level as well as at higher levels. A lift rack will position the vehicle to suit the stature and optimum working levels for the various individual mechanics. Consequently, the hood enclosure is positioned at this optimum working level. The Clayton unit has plenty of extension cord to reach the working bays and rolls readily to its destination. The mechanics expressed satisfaction with both the quality and operation of their Clayton BCE-1000 unit and operated it with confidence. There had been a few complaints which merited equipment changes and their rectification was the purpose of Mr. Brian Shaw's (Customer Service Manager for CAI) visit. He had just completed the following equipment modifications prior to our visit:
