REPORT#: 2014-02

REPORT DATE: January 30, 2018
Revised Date: June 19, 2020

Laborer, Pipefitter, and Utility Foreman Crushed by Falling Block Wall—Tennessee

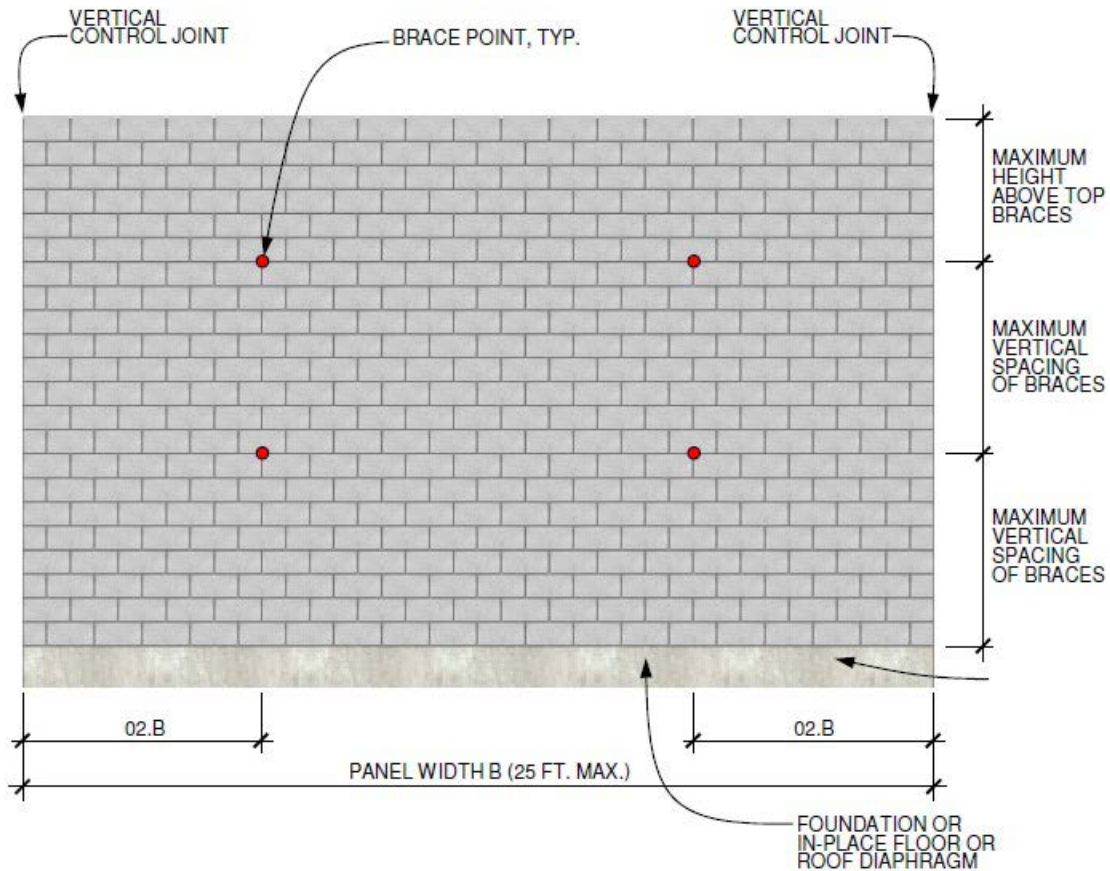
The wall bracing system used in this incident was a modified triangle system and composed of two scaffold boards. The vertical board was positioned on the wall but not attached to the wall. The vertical board had a 2- by 4-foot cleat across it horizontally (Photo 1 and Photo 3). The inclined brace boards were wedged at an angle that varied between 34 and 41 degrees. A 4-foot length of rebar was driven into the ground; one masonry block was placed over the rebar with the other placed on top of the inclined board (Photo 2 and Photo 3). There was no permanent tie from the ground to the wall brace. The wall extended between 13½ and 15 feet above the brace.

The MCCA Standard Practice for Bracing Masonry Walls Under Construction recommends that for a 23-foot, 4-inch wall with 8-inch block, reinforced with No. 5 rebar 4 feet on center, the wall should extend no more than 8 feet, 8 inches above the brace and the angle of the inclined brace should be between 35 and 45 degrees. A typical triangle wood bracing system should include a horizontal brace, a vertical brace, a diagonal brace positioned with a cleat on both ends of the brace, and a diagonal stiffener anchored to the wall or footer and nailed to the diagonal brace [[MCCA 2012](#)] (Figures 2 and 3). Michigan OSHA requires the masonry contractor to maintain a copy of the *Masonry Wall Bracing Design Handbook* or other permitted method of bracing on the jobsite [[MIOSHA 2015a](#)].

In this incident, the wall extended more than 8 feet 8 inches above the braces in some instances, and several of the recommended brace system components were missing. If a masonry wall bracing plan had been in place and one of the employers had a trained competent person at the time of the incident, the competent person could have recognized the hazard posed by the unbraced wall and made the appropriate changes to provide a safe bracing system. Since this incident, the masonry subcontractor has trained their employees on proper concrete and masonry wall bracing.

Figure 1. Wall bracing placement diagram.
(Figure courtesy of MCCA [MCCA 2012].)

Recommendation #2: Employers should develop and follow a masonry wall bracing plan, train employees on proper masonry wall bracing, and ensure masonry walls are properly braced throughout the project.

Discussion: Employers should develop a masonry wall bracing plan before construction begins. A masonry wall bracing plan includes notification criteria and detailed bracing locations, based on masonry wall structure and construction periods. The notification criteria details who is responsible for the erection and dismantling of the bracing, monitoring wind speeds, and establishing restricted/limited access zones. The plan also delineates who has the authority to supervise subcontractors and employees who work in the restricted/limited access zone and how to communicate the plan.

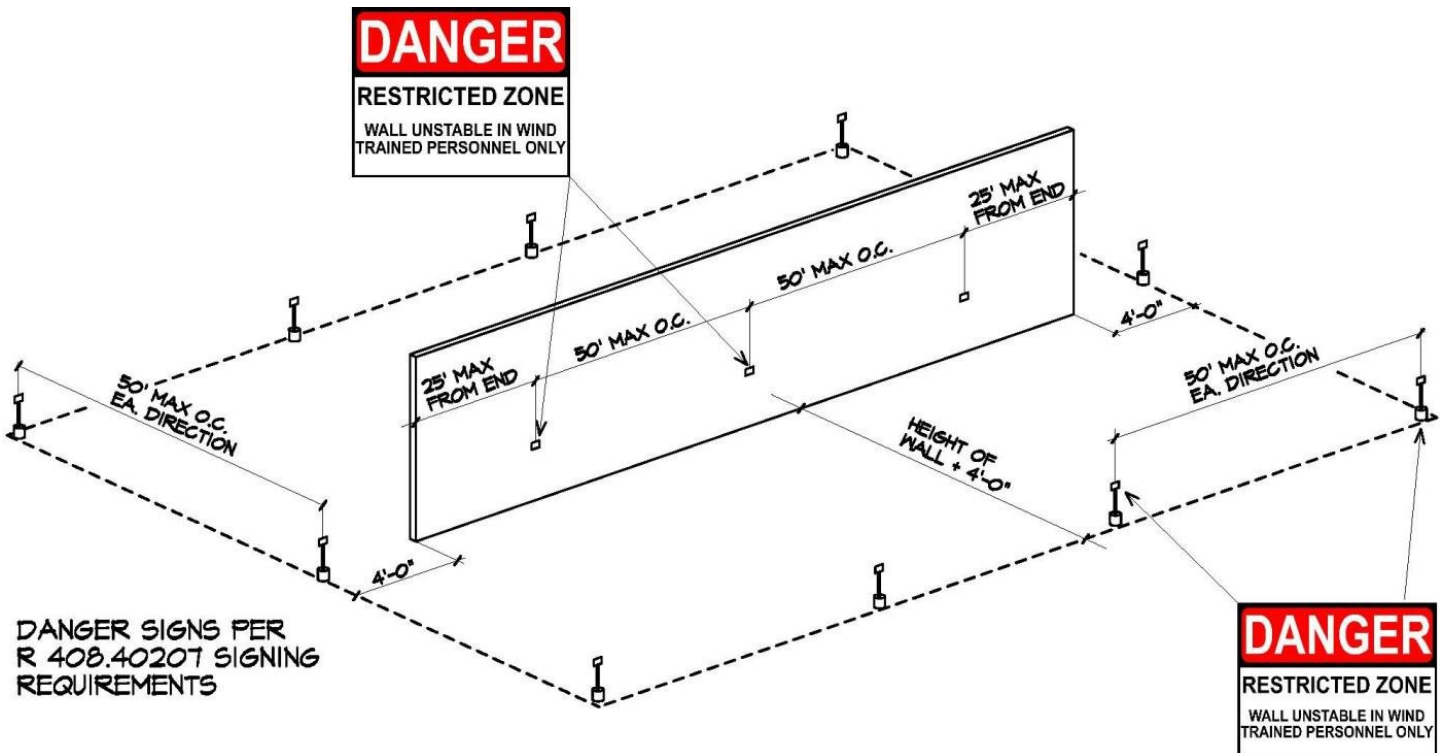
Discussion: OSHA regulation 29 CFR 1926.706(a) states that a restricted/limited access zone shall be established whenever a masonry wall is being constructed. The restricted/limited access zone shall conform to the following:

- Be established prior to the start of construction of the wall.
- Be equal to the height of the wall to be constructed plus 4 feet and shall run the entire length of the wall.
- Be established on the side of the wall that will be unscaffolded.
- Be restricted to entry by employees actively engaged in constructing the wall. No other employees shall be permitted to enter the zone.
- Remain in place until the wall is adequately supported to prevent overturning and to prevent collapse unless the height of the wall is over 8 feet, in which case, the restricted/limited access zone shall remain in place until permanent supporting elements of the structure are in place [OSHA 1988].

Figure 4. Restricted/limited access zone diagram.
(Figure courtesy of MIOSHA [MIOSHA 2015b].)

Recommendation #3: Employers should develop and implement a restricted/limited access zone.
