LINE OF DUTY DEATH REPORT

REPORT F2023-09 • September 2024

Career Acting Fire Officer Dies from Floor Collapse during Interior Fire Attack – Maryland

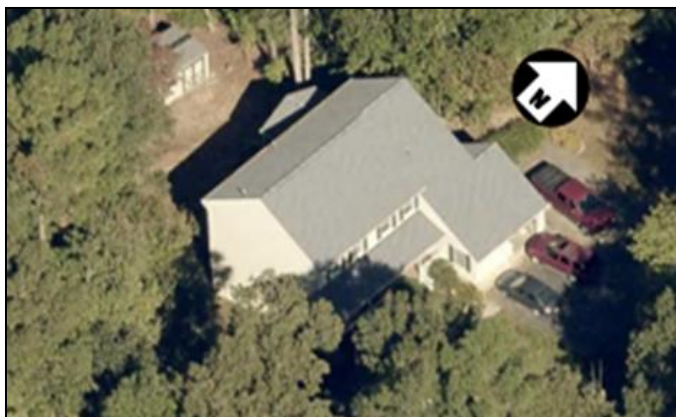
Photo 1. Aerial view of structure
(Courtesy of Google Earth)

This single-family non-sprinkled residential structure was situated on a four-acre lot with no fire hydrant availability within the community. The local government zoning office listed the structure as a 1,285 square foot main floor, the second floor as 1,115 square feet, with a 400 square foot attached garage. The basement covered the entire structure except for the attached garage. (see Photo 1)

This wood-framed single-family residential structure was built in 1997, with a vinyl siding exterior with masonry basement walls, wood 1st and 2nd floor joist, 2x4 stud walls, and common drywall interior covering. The sloping roof structure was constructed of wood rafters with wood roof decking covered in asphalt shingles. For the purposes of this report, side Delta is orientated to the north followed by side Alpha to the east, side Bravo to the south, and side Charlie to the west. The fire structure had been demolished and excavated prior to the arrival of NIOSH Investigators. All diagrams and descriptions provided in this report are not to scale and based on scene photographs.

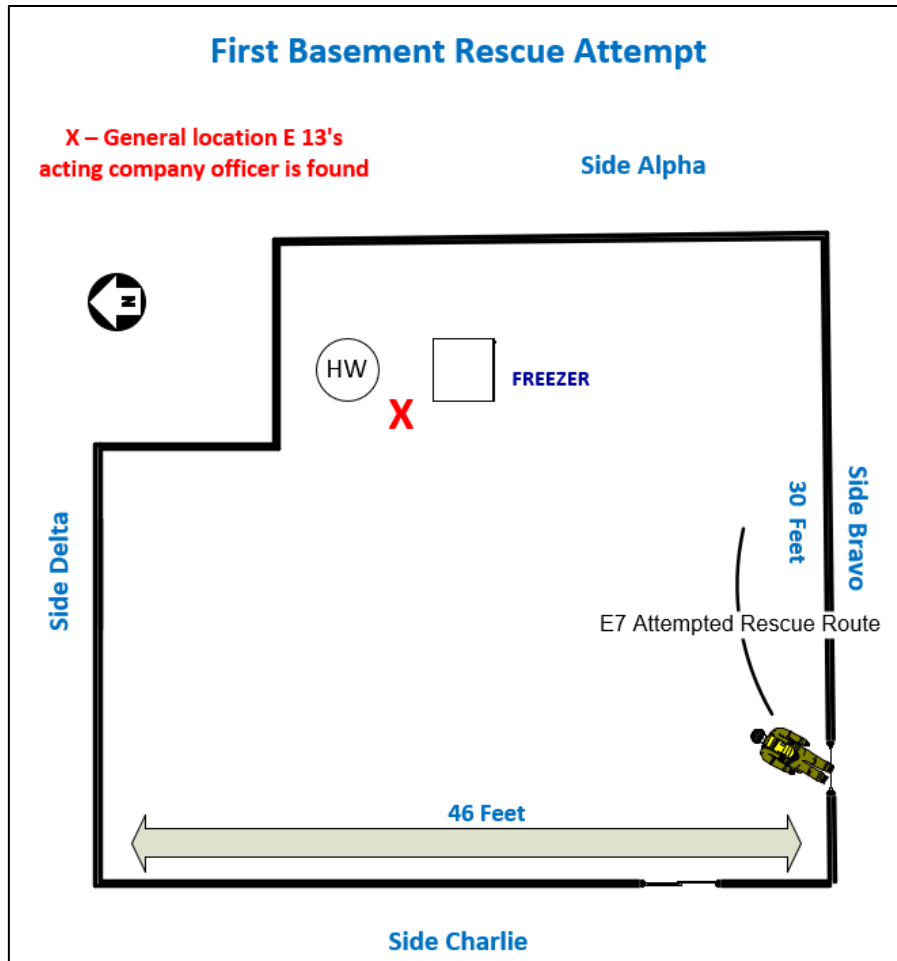
Diagram 3. First Basement Rescue Attempt

At 0431 hours, the IC attempted to contact E132's company officer again via the radio with no response. C7A advised IC that a crew from E7 (self-initiated company not originally assigned on the Box) would be attempting to enter the basement from a window on side Bravo. C7A requested that the two 1¾-inch attack lines that were flowing on side Alpha continue to flow in the direction of the Alpha and Bravo quadrants. Two firefighters from E7 entered the basement from a window on side Bravo with a charged 250-foot 2-inch pre-connected attack line. This first attempt to locate the company officer from E132 was met with heavy fire conditions, zero visibility, and collapsed debris. Due to these factors, the two firefighters from E7 withdrew back to the side Bravo window and exited the basement. At 0433 hours C7A requested concrete cutting saws and breaching equipment to side Bravo with anticipation of breaching the exterior basement wall for better access into the basement. Due to the limited resources and time to breach the masonry wall, C7A redirected E7 and all rescue efforts back to side Alpha.

(Due to collapse and excavation this drawing is not to scale nor are any interior walls marked)

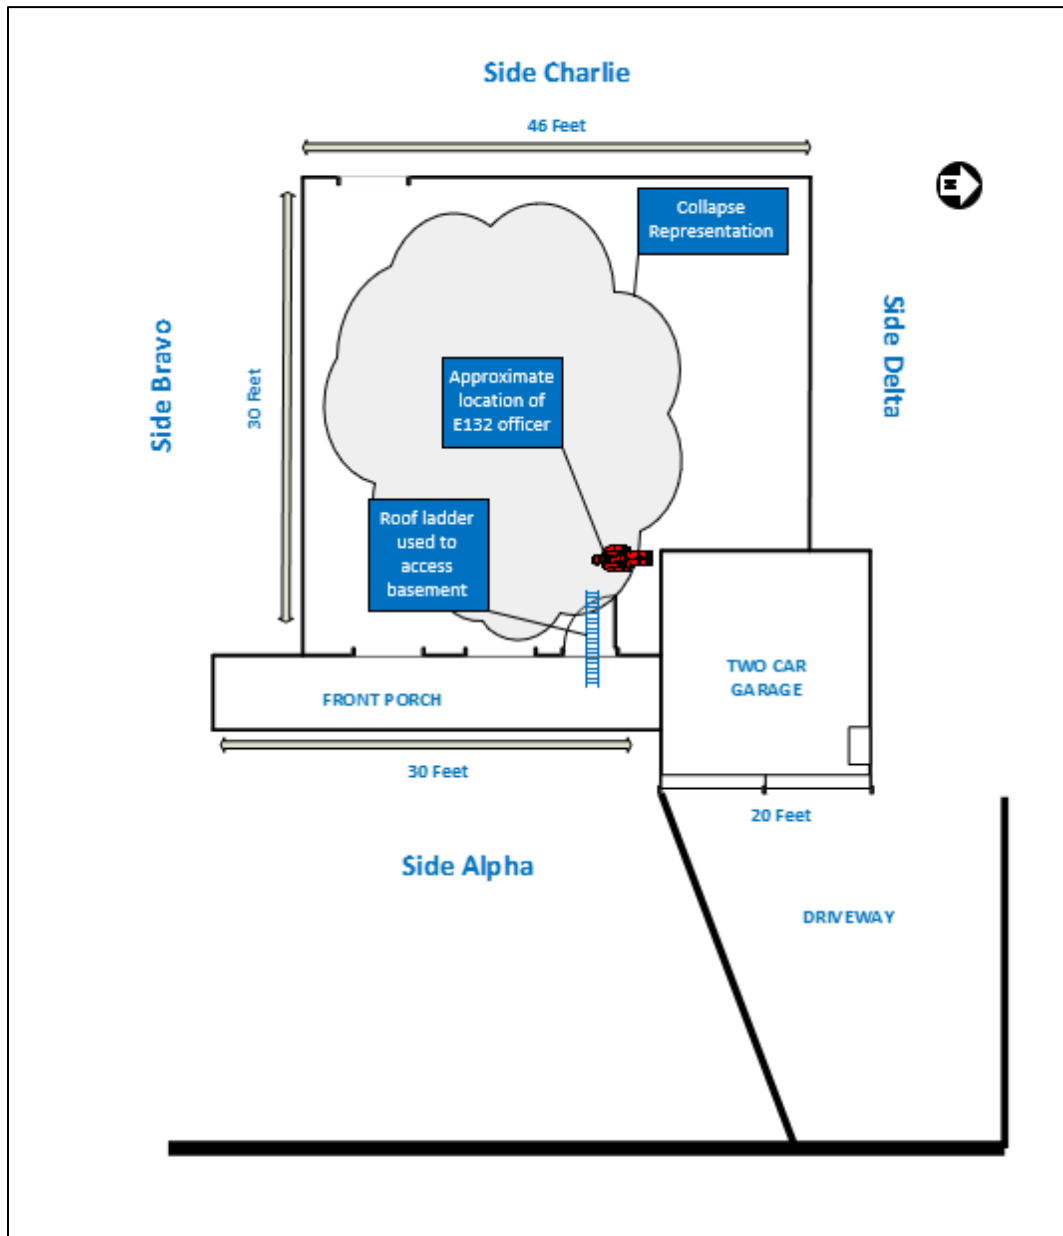
Diagram 4. Side Alpha First Floor Access
(Diagram is not to scale and is approximate based upon interviews)

At 0437 hours C7A updated IC that there was no access to E132's company officer from sides Delta, Bravo, or Charlie and that alternative locations for breaching the masonry wall needed to be identified. C7A assembled a rescue group comprised of specific personnel from varying departments that had arrived on-scene. First alarm companies were staged in the yard on side Alpha and were also working various tasks on-scene such as fire attack, staging tools, and equipment. C7A requested a ladder be brought to the front door of side Alpha so that personnel from the rescue group could try and get into the basement from the front door. The collapse had created a void space that the rescue group accessed via ladder and descended into the basement. C7A suggested that IC request heavy equipment, such as an excavator, to assist in the removal of debris and rescue operations. IC made the request for heavy equipment to the local PSAP.

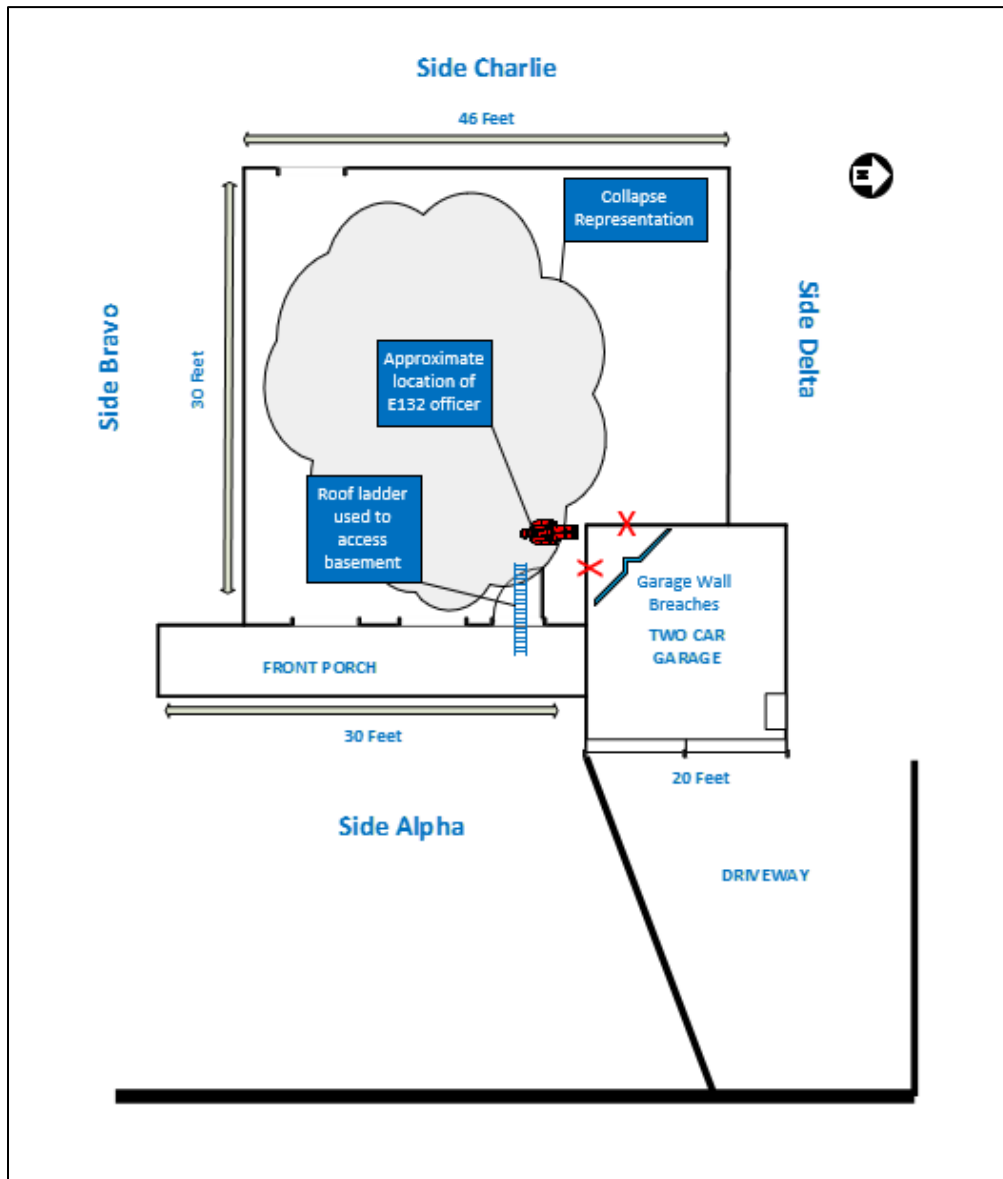
Diagram 5. First Floor Garage Wall Breaches

The rescue group first used a folding ladder to descend into the basement. However, the ladder was narrow and unstable. It rested on top of debris in the basement and not the basement floor. After two firefighters from the rescue group descended the ladder into the basement, it was replaced with a roof ladder. Basement conditions were described as having moderate heat and zero visibility requiring working by feel. At 0439 hours C7A requested that additional rapid intervention kits, stokes basket, and rope bags be brought to the porch area of side Alpha for staging. The company officer from E7 (assigned to the rescue group) worked with other personnel to breach the attached common garage wall to gain access and a visual of the rescuers in the basement.
