**Decontamination of Building Materials Contaminated with
Methamphetamine**

John W. Martyny, Ph.D., CIH
Associate Professor
National Jewish Medical and Research Center
Division of Environmental and Occupational Health Sciences

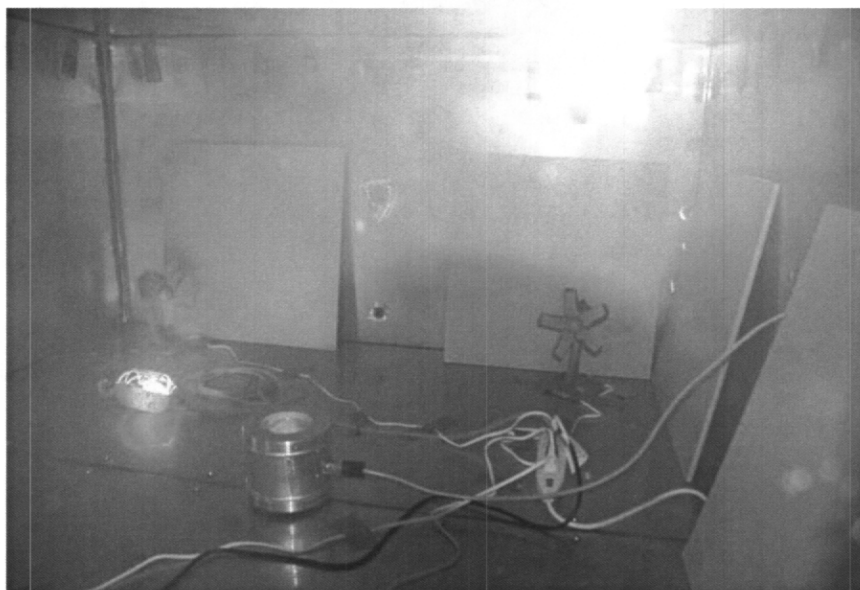
After painting, the plywood panels, the drywall panels, the metal and the glass panels were put into the chamber for contamination. Each of the materials were put into the chamber at different times and using different amounts of methamphetamine (although all were approximately 200 mg). The contamination information is as follows:

The methamphetamine utilized for contamination was a street-manufactured methamphetamine provided by the North Metro Task Force in Colorado. The drug was approximately 77% methamphetamine and also contained small amounts of amphetamine, ephedrine, and pseudophedrine. No MDMA or phenylpropanolamine were found to be present. The methamphetamine was put into a beaker and the chamber was sealed and the methamphetamine aerosolized in the chamber. The methamphetamine was completely aerosolized within a short time (listed above) and the beaker heater was turned off. The fans within the chamber were kept running for another period of time to assure even distribution of the methamphetamine. The chamber was then allowed to sit overnight and the material was removed the next day.

Figure 2. Painted drywall material being contaminated within the chamber.

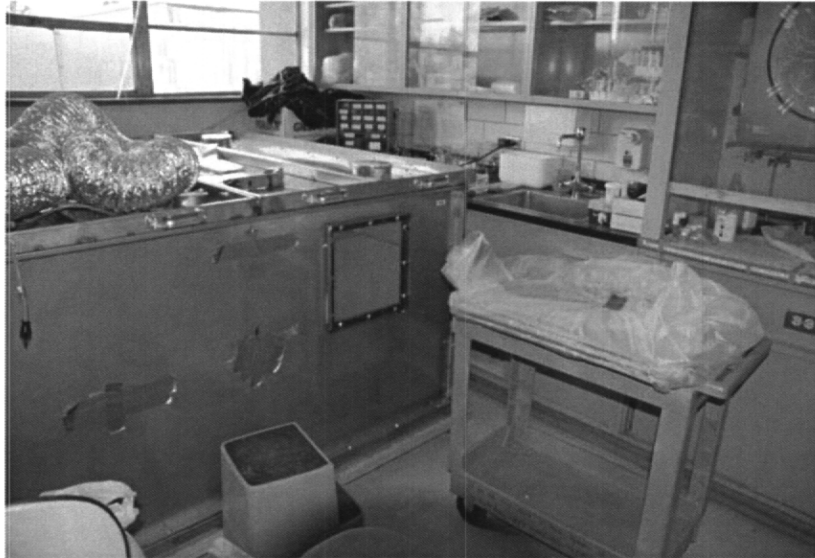
After the material was removed from the chamber, it was placed in a plastic bag and transported to an area to be pre-sampled, washed, and post sampled.

Figure 3. Drywall being removed for transportation to an area to be sampled and treated.
