# OCCURRENCE AND REMEDIATION OF COAL MINE BUMPS: A HISTORICAL REVIEW

By Anthony T. Iannacchione<sup>1</sup> and Joseph C. Zelanko<sup>2</sup>

## ABSTRACT

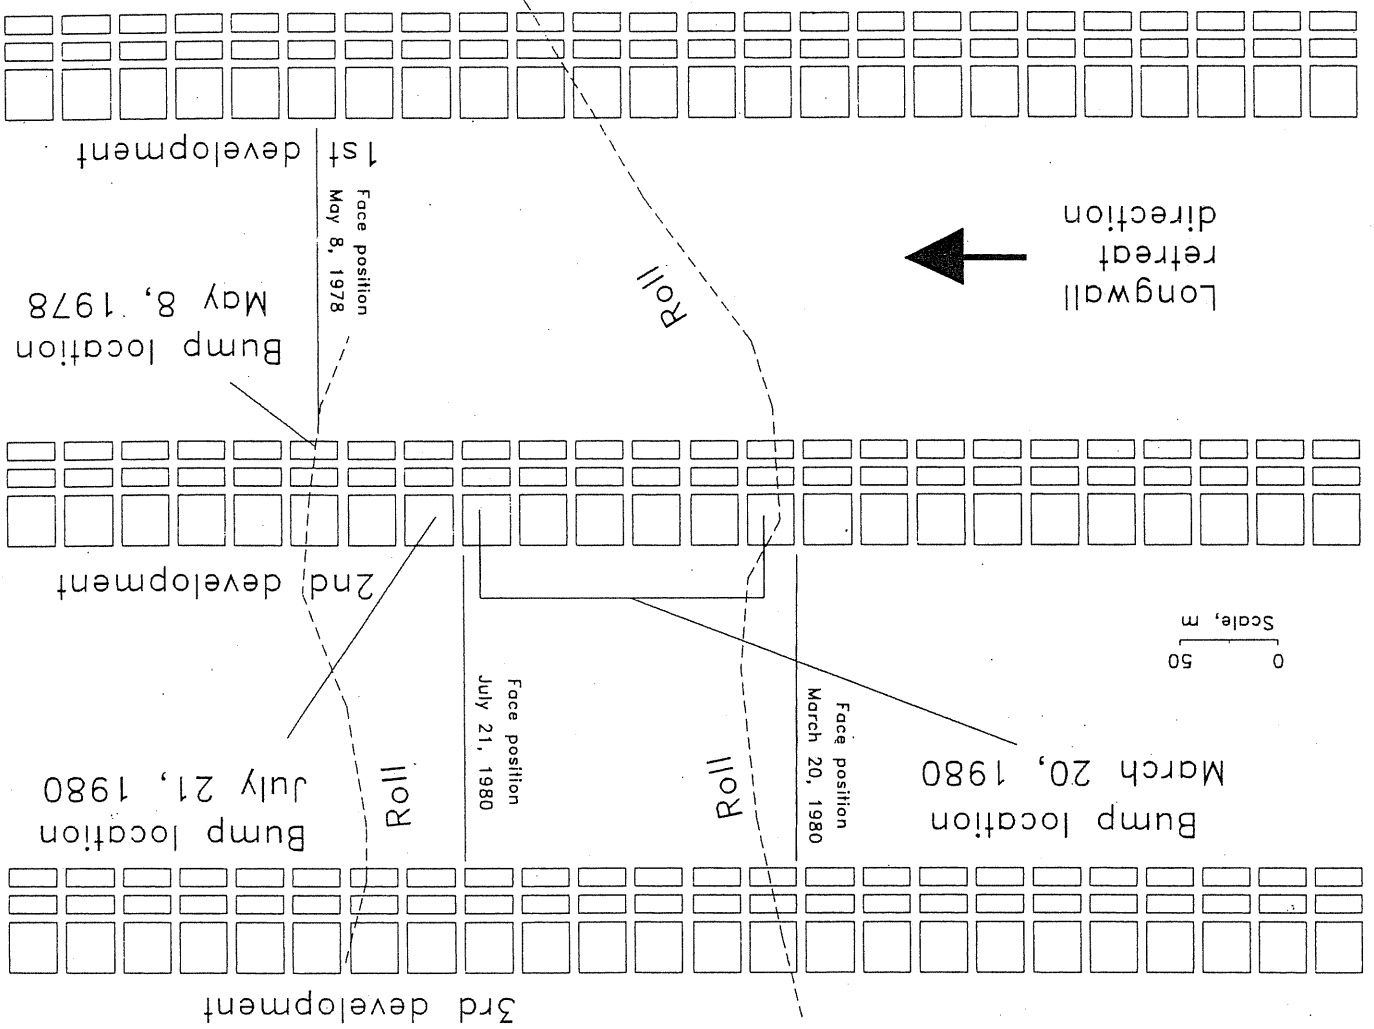
**Figure 24** Effects of Large-Scale Structural Roll on Three Headgate and Tailgate Entry Bumps at Beatrice Mine.

This section of longwall panel was referred to as the "stall area." ⊗ indicates miners.

longwall panel approached this same roll (figure 24). Then, on March 20, 1980, six narrow pillars bumped, two of them violently (11). No miners were injured in this tail-gate bump. Because the floor in the roll area resisted heaving for a distance of 200 m, the operator decided to volley fire or shot fire ribs of three abutment pillars outby
