A summary of a NIOSH fire fighter fatality investigation

Forest Fire Service Fire Fighter Monitoring Prescribed Burn from Roadway is Struck and Killed When Smoke Obscures Visibility Following a Wind Shift —New Jersey

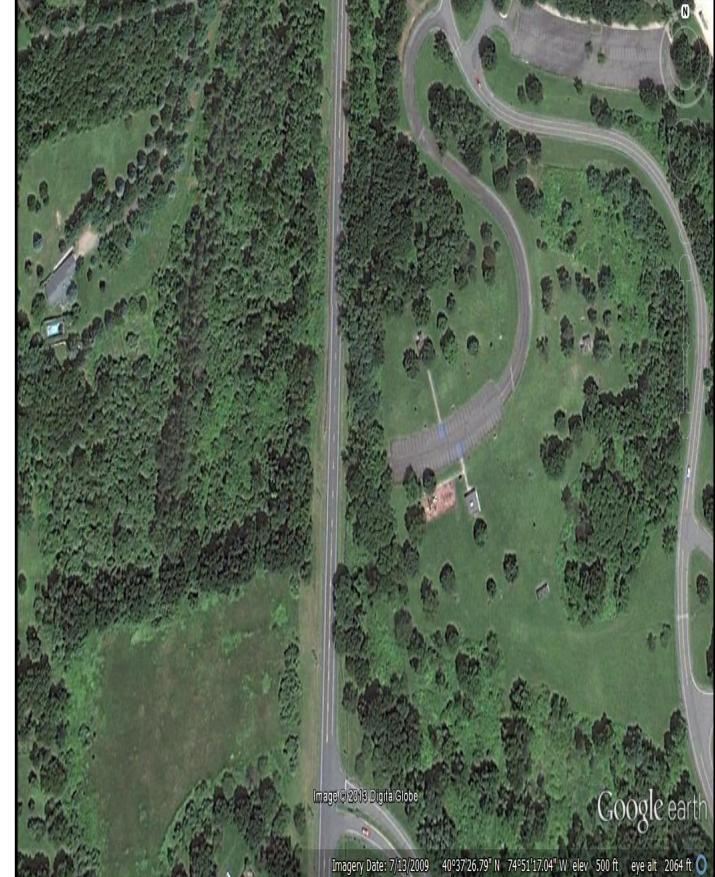
Aerial view of section of roadway where incident occurred. (Adapted from Google Earth® satellite image.)

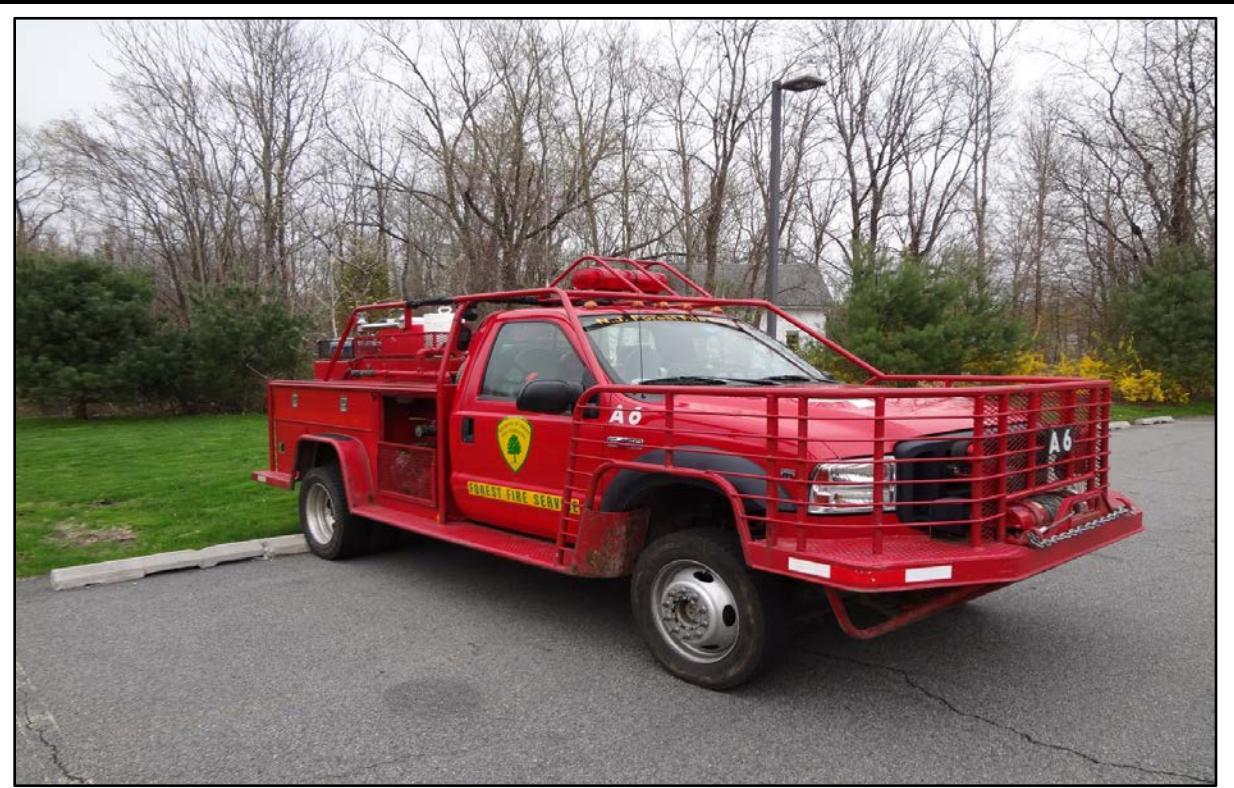
Photo 1. Engine operated by the victim prior to being struck. (NIOSH photo.)

The state forest fire service vehicle operated by the victim was a 2006 diesel-powered heavy-duty pick-up truck chassis with an automatic transmission and dual rear wheels. It was classified as a Type 6 engine carrying 300 gallons of water and a 250-gallon-per-minute pump. When purchasing new apparatus, the state forest fire service research and development shop would take possession of the chassis and then fabricate and install the rear body, including pump, cabinets, plumbing, ROPS, emergency lighting and markings, and brush guards. According to the state forest fire service circulars provided to NIOSH, the vehicle was appropriately identified with emergency lighting (above minimum requirements), decals and logos, reflective striping, and lettering (see Photo 1 and Photo 2). According to circulars provided to NIOSH during the investigation, amber warning lights or bar lights were not required for this type of state forest service vehicle. At the time of this incident, the vehicle the victim was using was scheduled for replacement with a new one, but it was still under construction and unavailable as the replacement at the time of the incident. The NIOSH investigator photographed the new vehicle, which was being made ready for service during the NIOSH investigation, and determined additional high-visibility retro-reflective striping and chevrons had been added to make the vehicle more conspicuous (see Photo 3 and Photo 4). The new vehicle went into service after the NIOSH investigation.

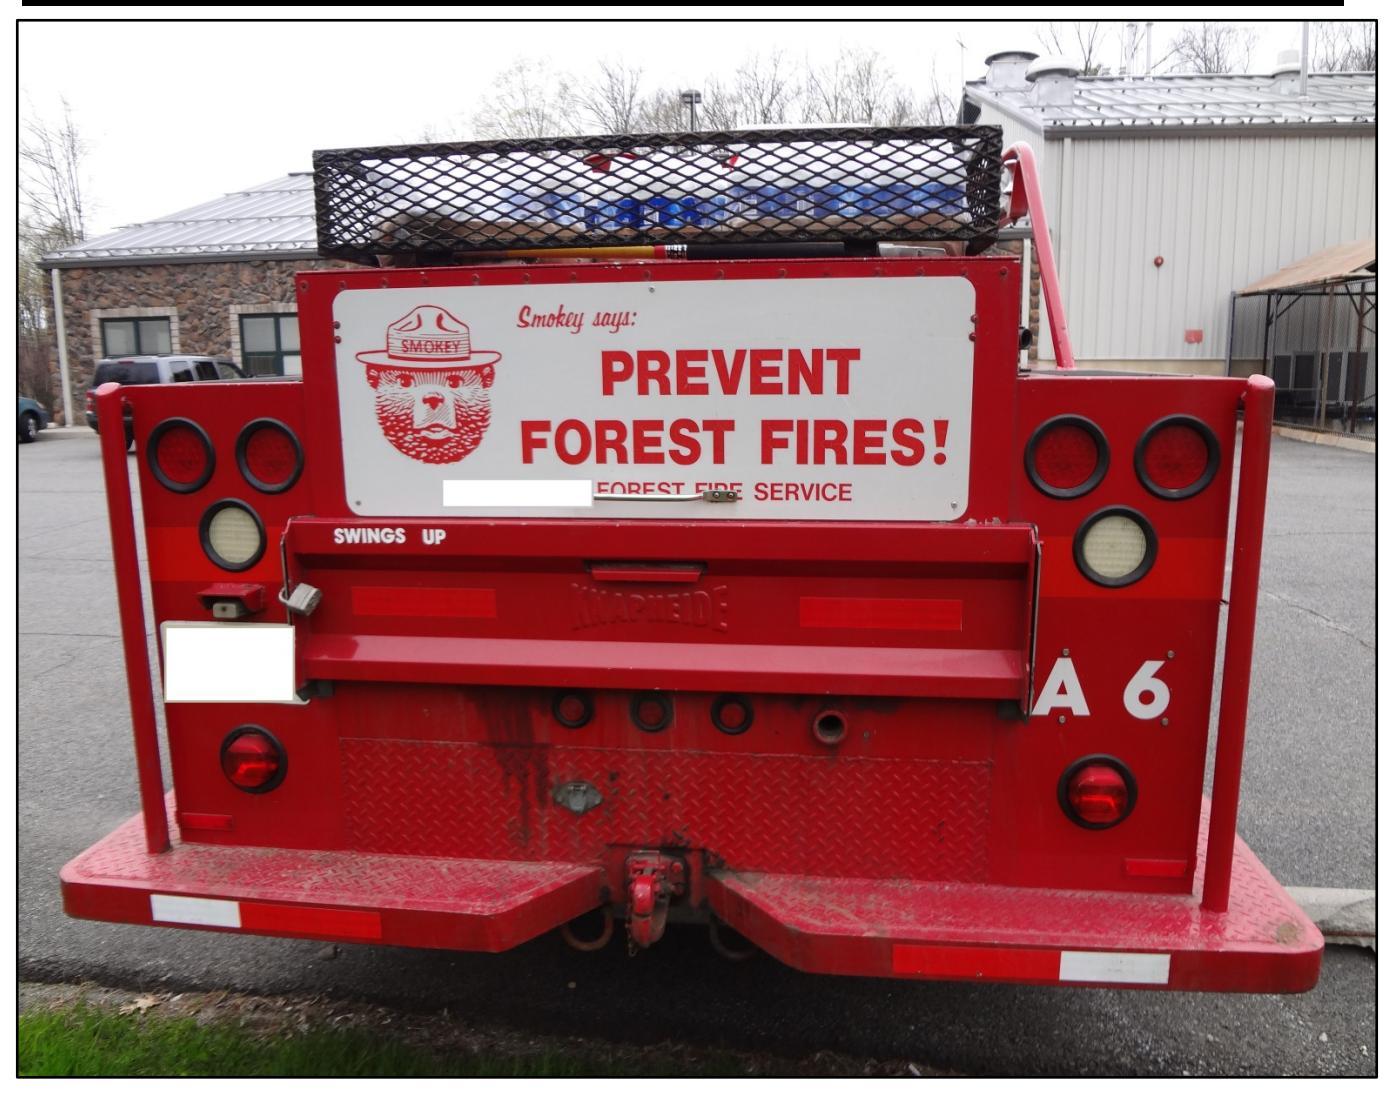
Photo 2. Rear of engine operated by the victim prior to being struck. (NIOSH photo.)

At the time of the incident, the engine driven by the victim did not have chevrons on the back and the use of chevrons had never been required. The *State Forest Service Incident Traffic Safety* circular provided information that wasn't utilized for this incident, and the NIOSH investigator could not determine whether the scope of the circular included prescribed burns. All state forest services should review their circulars, procedures, and/or guidelines to ensure that all potential instances where an individual is working in a roadway or alongside a roadway are properly protected. A model SOP for establishing advance warning and transition areas at roadway-related incidents can be found on the Emergency Responder Safety Institute Website

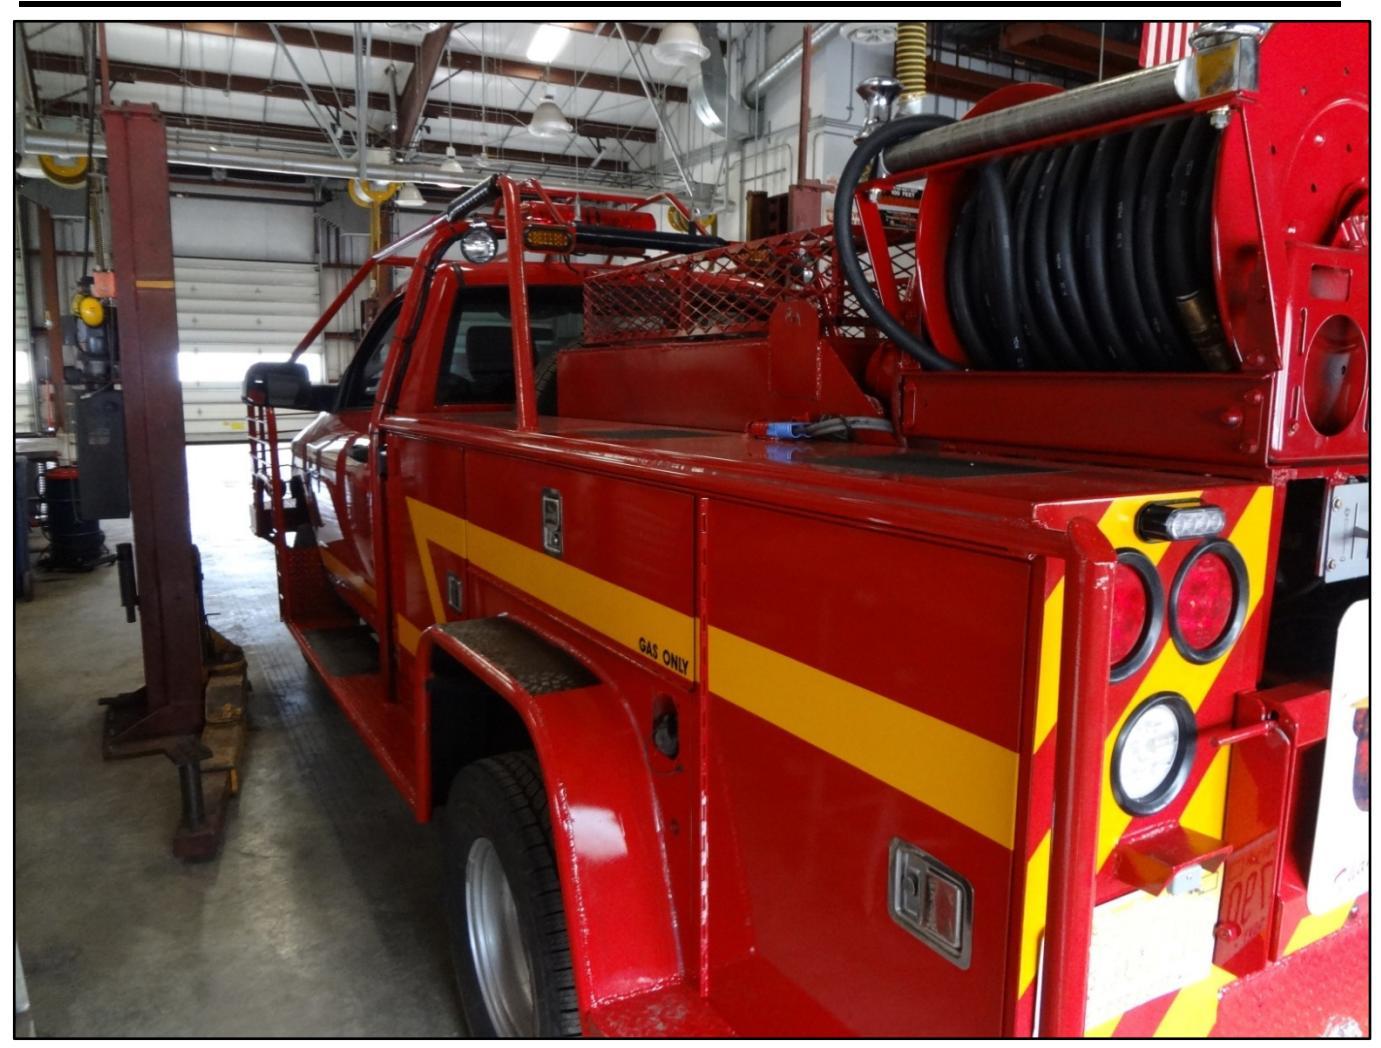
Photo 3. Vehicle purchased to replace engine used during the incident. The replacement unit was being made ready for service during the NIOSH investigation. (NIOSH photo.)

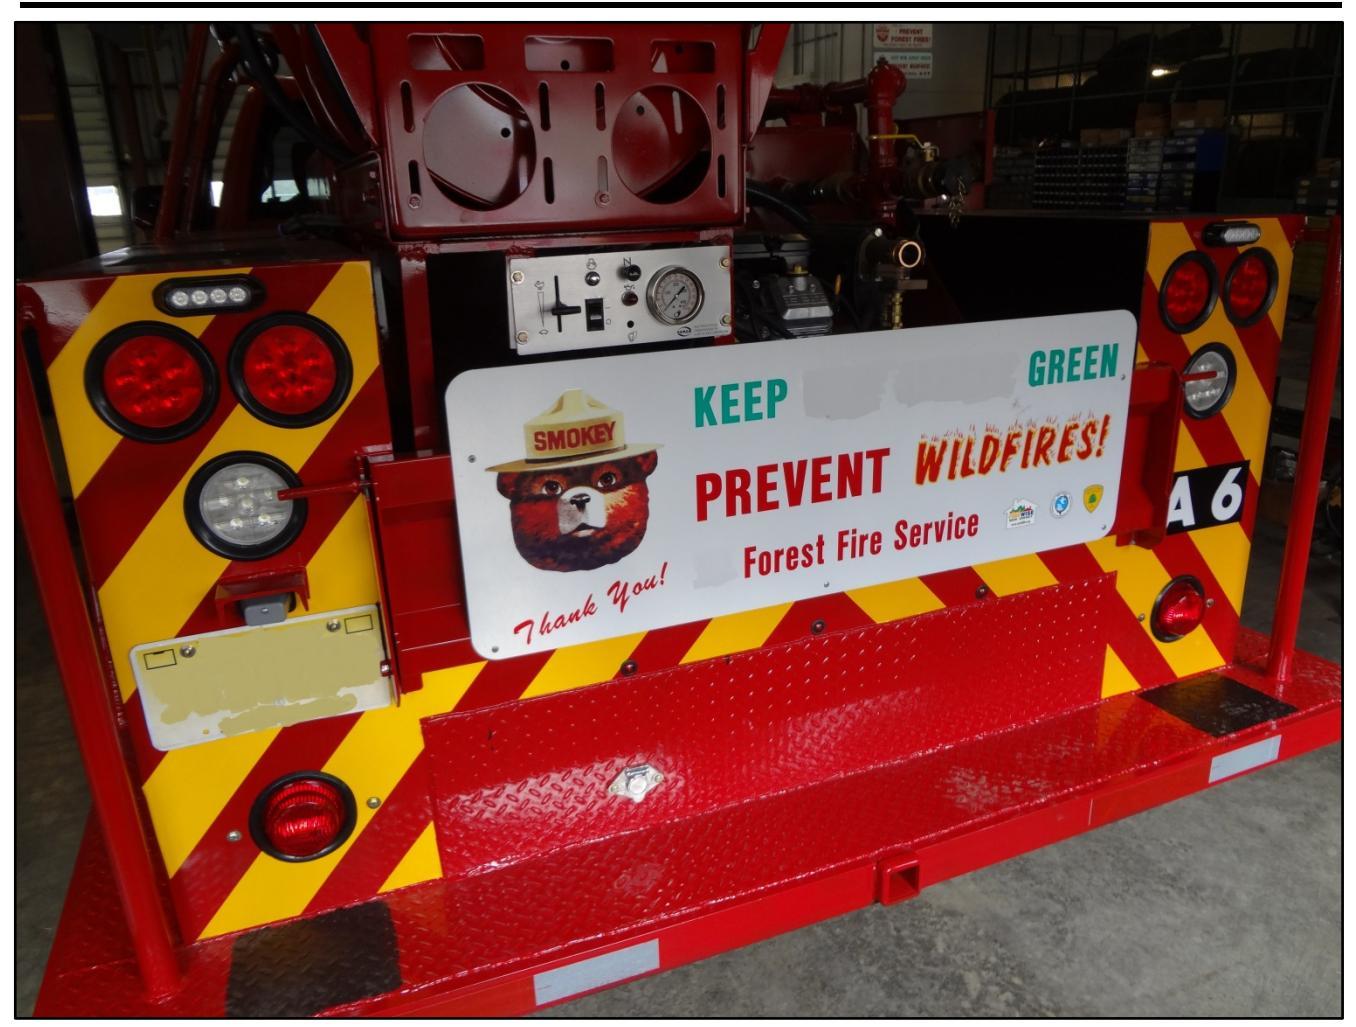
Photo 4. Another view of the new engine. Note the high-visibility chevrons added on the rear of the engine for increased conspicuity. (NIOSH photo.)

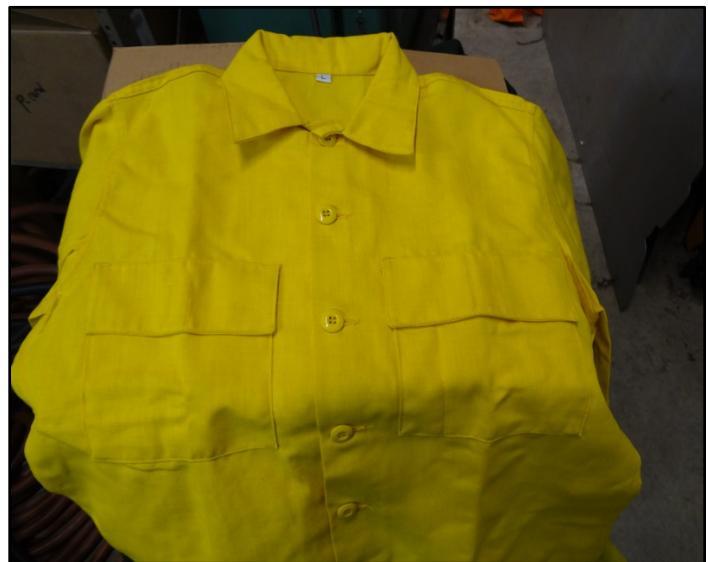
Photo 5. Example of wildland long-sleeve shirt worn by the victim. (NIOSH photo.)

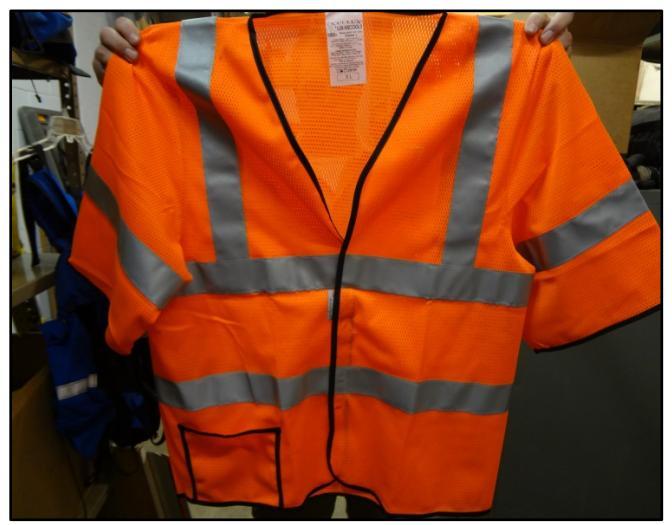
Photo 6. Example of high-visibility retro-reflective vest available to the victim. (NIOSH photo.)

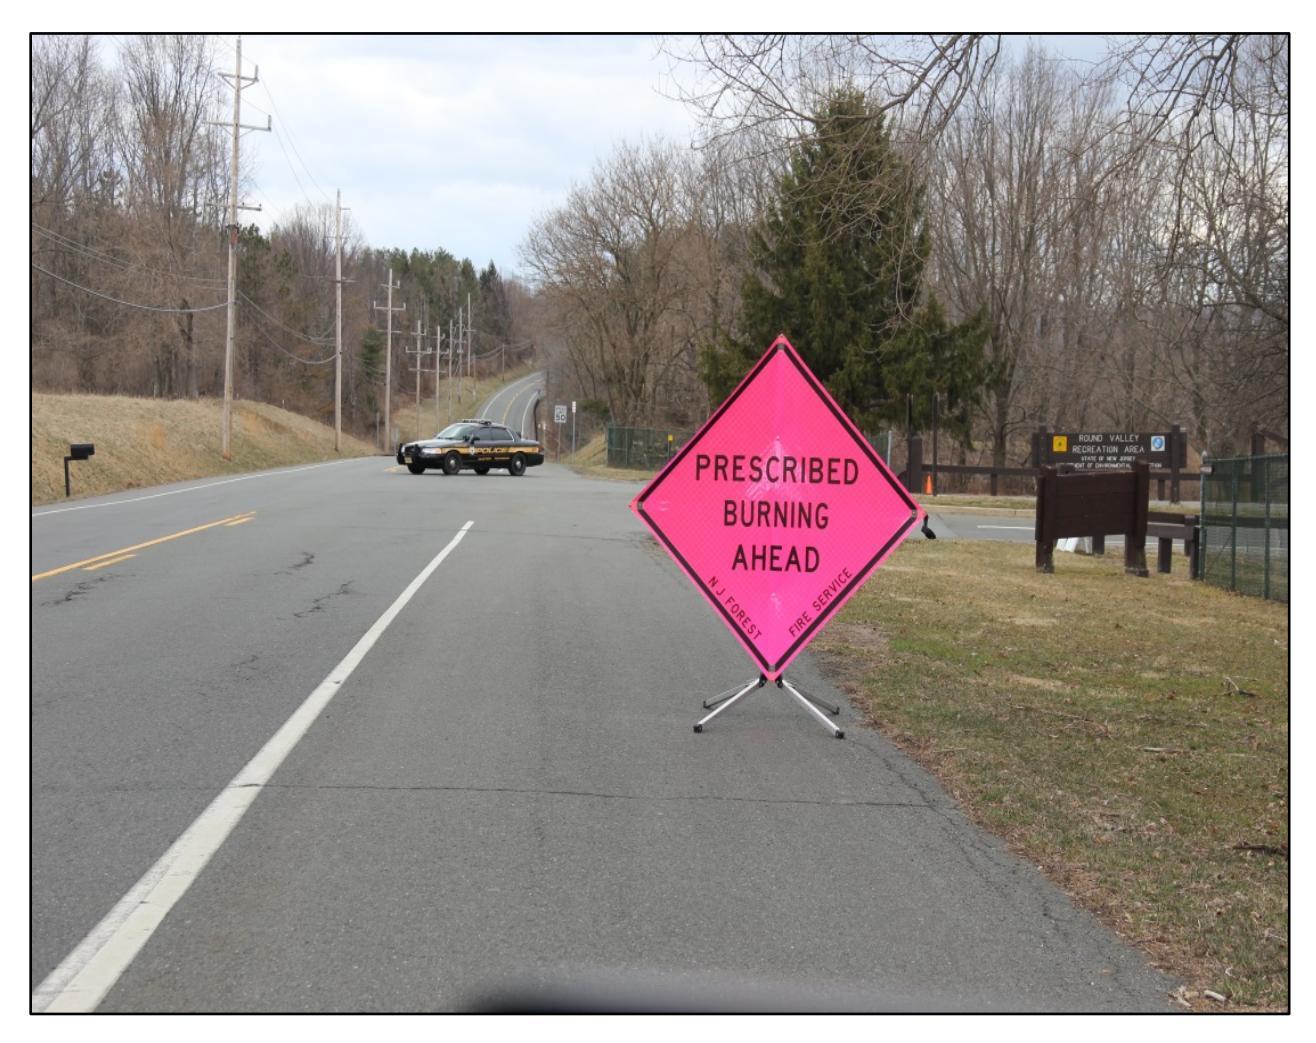
On the day of the incident, the temperature was approximately 50°F and overcast with no rain. The fatal incident occurred on a two-lane, paved, rural roadway that ran adjacent to the state park where the prescribed burn was taking place. The lanes ran north and south and were separated by painted, broken and solid, yellow lines with periodic recessed roadway reflectors just off the centerline. A solid, white fog line on the outer edges of the paved roadway separated the roadway from the shoulder. The state forest fire service had deployed a portable, fluorescent pink sign reading "Prescribed Burning Ahead" approximately 2/10 of a mile south of the incident site on the northbound shoulder (see Photo

Photo 7. Scene photo from the incident, as seen approaching from the south. (Photo courtesy of law enforcement.)

The roadway on which the incident occurred had a 50-mph posted speed limit. The state forest fire service had placed two portable signs: one for motorists approaching from the north and one for motorists approaching from the south. No additional TTC devices were available to establish a TIMA

and warn approaching motorists of potential vehicles or individuals working in or alongside the roadway. Only one of these signs warned motorists of potential visibility problems from smoke. These signs did not indicate, or warn motorists, that there may be emergency personnel and/or vehicles on the roadway. Additionally, side streets feeding between the posted signs had no warnings. Finally, the MUTCD TTC guidelines include the need for a warning to traffic for a temporary incident, but not as in the case of a mobile traffic control zone. Since a prescribed burn situation near a roadway produces unique safety hazards for passing motorists, including the potential for changing smoke and visibility conditions as well as the presence of emergency personnel or moving emergency vehicles, a combination of MUTCD TTC zone signage and state forest fire service signage might be considered to provide additional warning to motorists of potential hazards ahead.

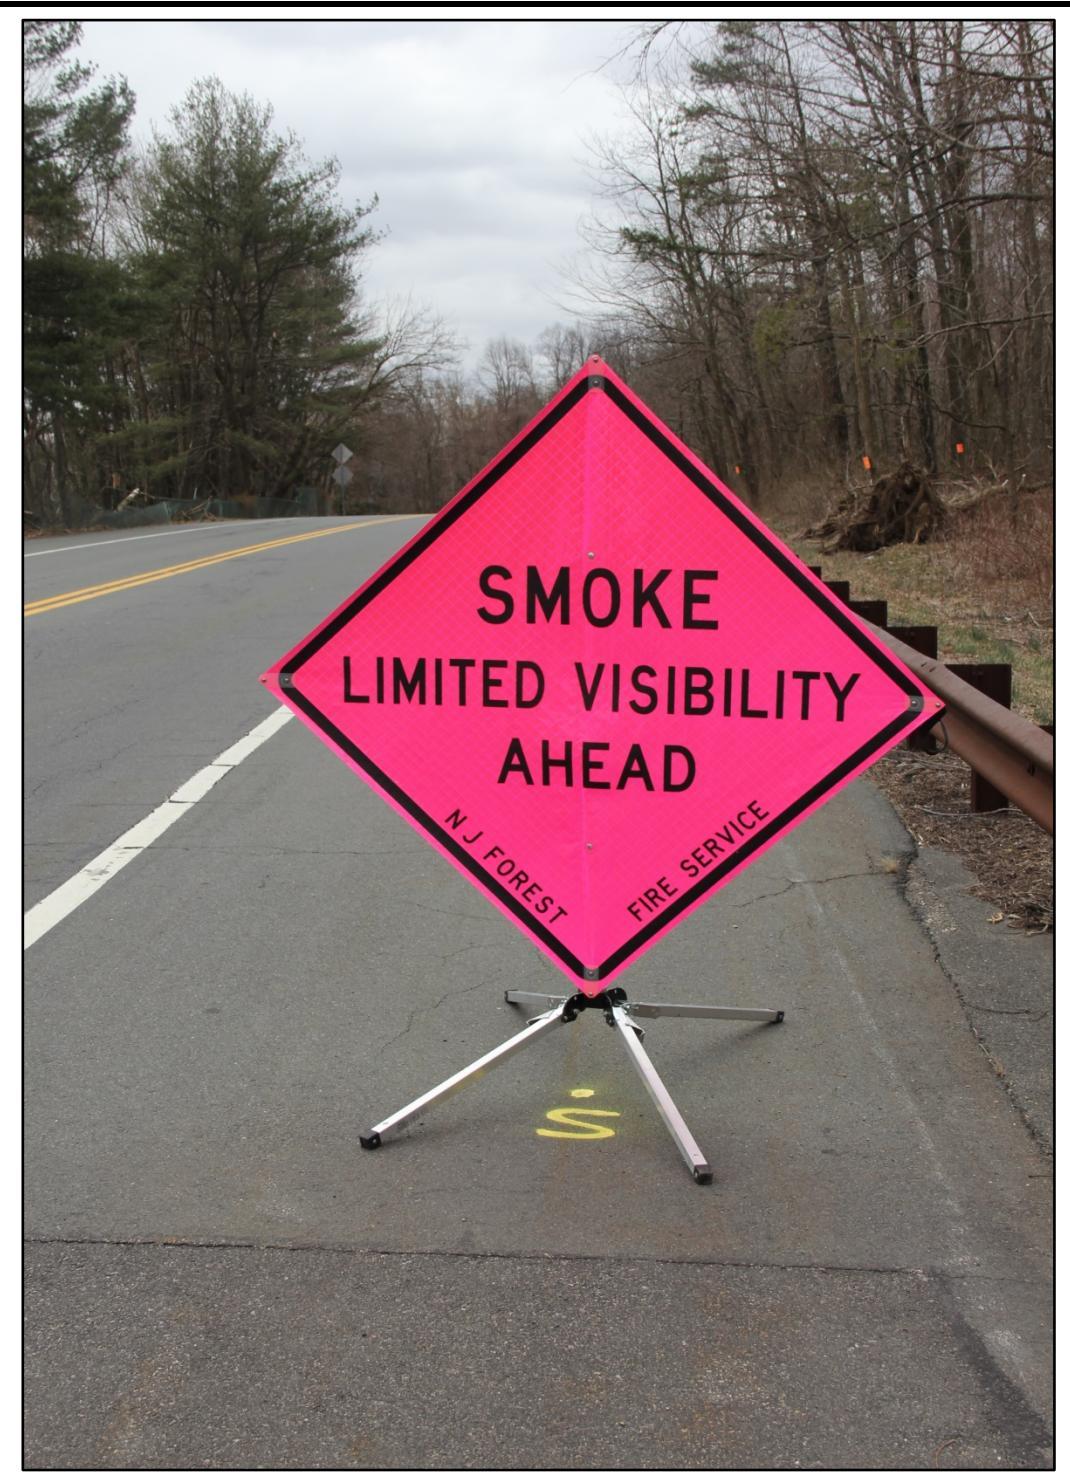
7). An additional sign reading "Smoke Limited Visibility Ahead" was posted approximately 7/10 of a mile north of the incident site on the southbound shoulder (see Photo 8). The posted speed limit was 50 miles per hour. The motorist was traveling slower than the posted speed limit because of the smoke-limited visibility conditions.

Photo 8. Scene photo from the incident, as seen approaching from the north. (Photo courtesy of law enforcement.)

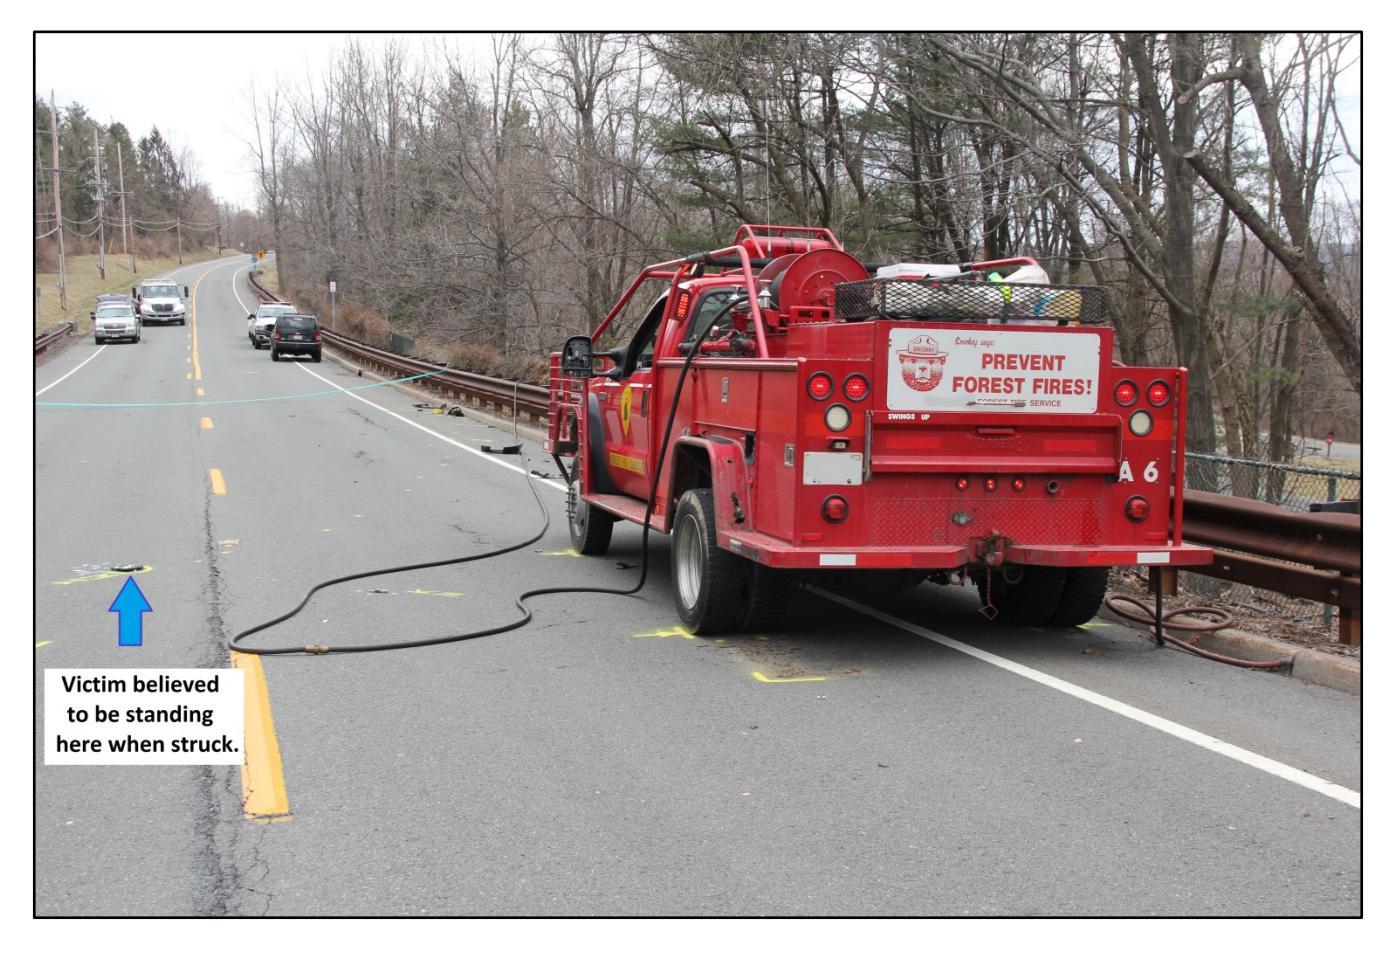
The victim was struck while in the southbound lane just off the passing yellow centerline of the roadway; approximately 6 feet from the engine (see Photo 9 and Diagram). Three vehicles were traveling north in the direction of the parked engine (within close proximity of each other). The first vehicle swerved urgently into the southbound lane to miss striking the victim's vehicle. The second vehicle, which had slowed, also swerved into the southbound travel lane, inadvertently striking the victim who was standing in the roadway. The third vehicle side-swiped the engine before coming to a rest. The motorists stated that smoke was visually obstructing the roadway when the victim was struck.

Photo 9. Position of engine when the victim was struck (see also Diagram). Note: The hoselines were deployed after the incident to control the prescribed burn. (Photo courtesy of law enforcement.)

During this incident, the victim was struck while standing in the southbound travel lane. At the time he was struck, roadway conditions were obscured by smoke from the adjacent prescribed burn he was monitoring. Establishment of a more complete TIMA in this incident might have included temporarily suspending personnel operations on the roadway due to smoke conditions. Also, extreme caution should be taken if a vehicle must be parked within a travel lane where occupants exiting the vehicle could be exposed to oncoming traffic. Departmental safety circulars or standard operating procedures that detail safety measures along roadways should be routinely evaluated, implemented, and enforced.

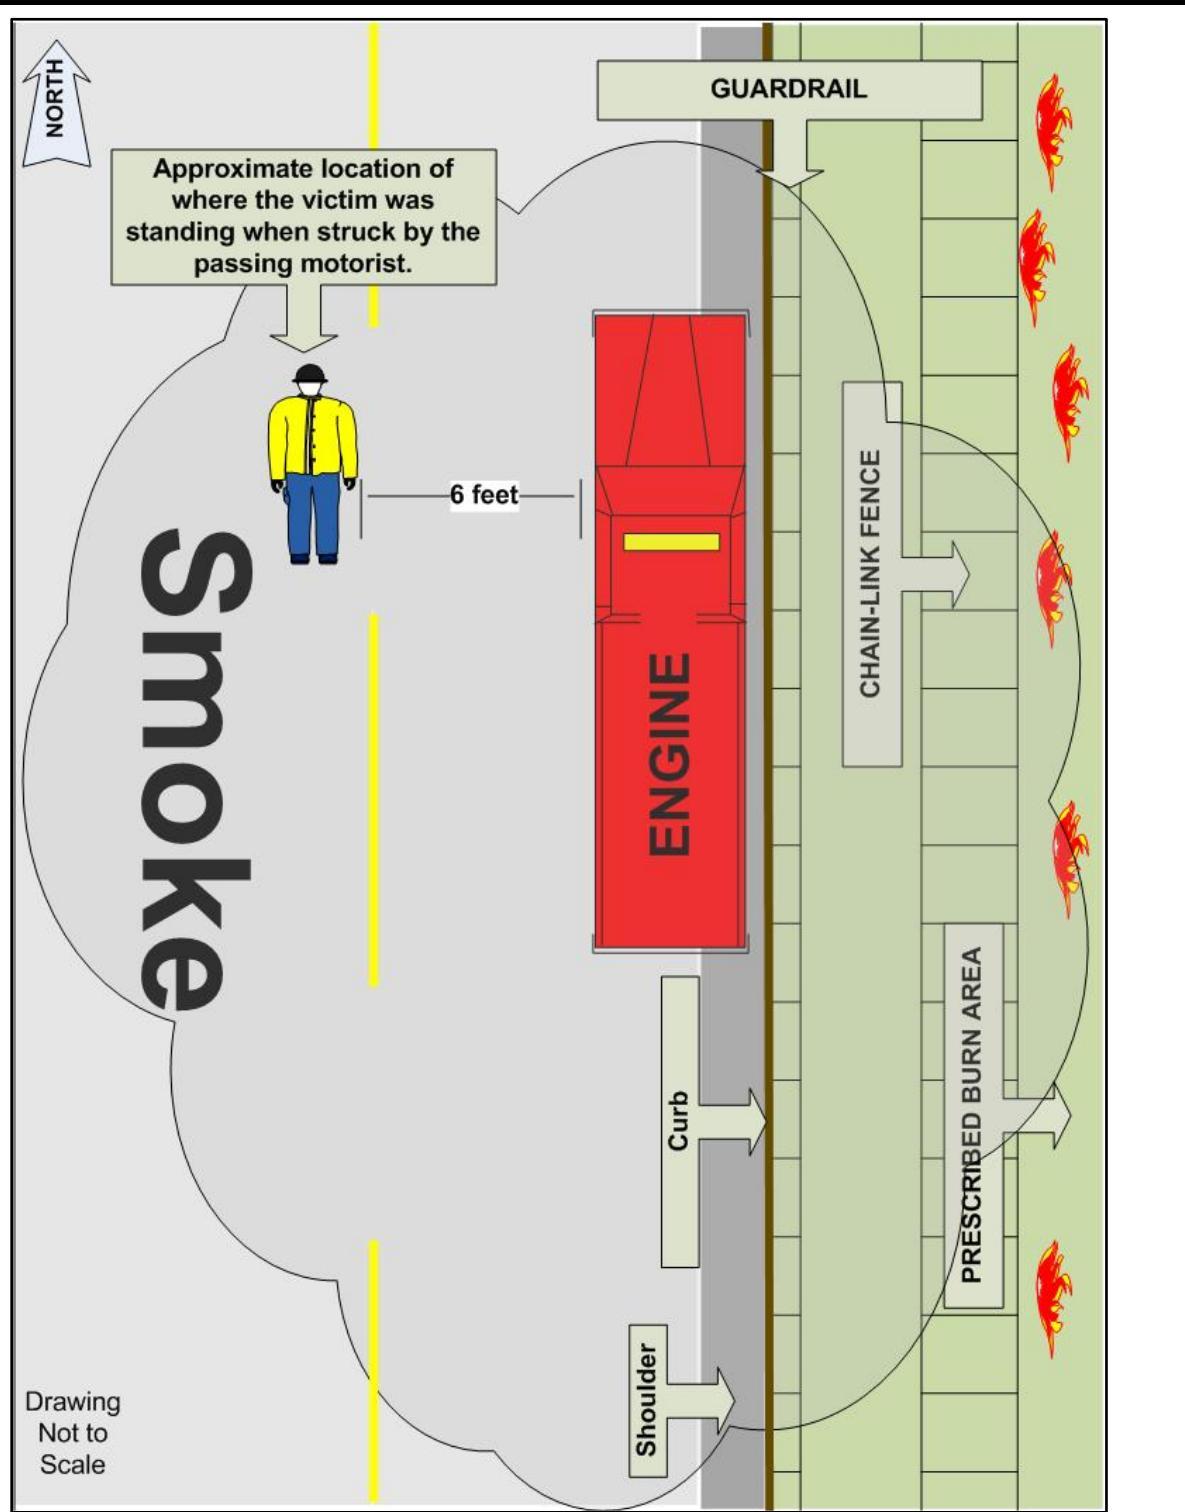
Diagram. Incident scene at the time the victim was struck.
