# **AN EVALUATION OF LEAKY FEEDER COMMUNICATION IN UNDERGROUND MINES**

## **FINAL REPORT**

**Contract No.: JO 199048**

**June 1980**

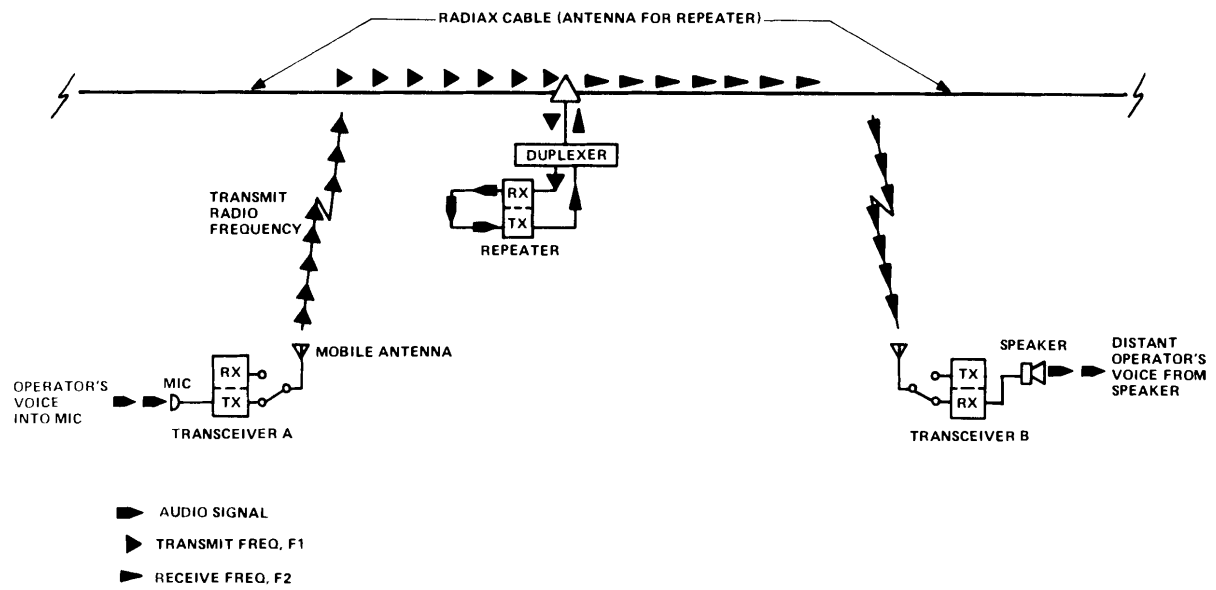
Figure 2.2. Single Repeater System.

The operation of a leaky feeder single repeater system is illustrated in Figure 2.2. The repeater base station transceiver in the center is connected to a length of cable through a power splitter. Typically, the cable will consist of about 5,000 feet of 1/2 inch Radiax. It is assumed in the figure that the operator of the mobile Transceiver A is speaking to the operator of the mobile Transceiver B. Transceiver A transmits on frequency F1. This is picked up by the cable and transmitted to the repeater receiver. The received audio keys and modulates the repeater transmitter, which transmits on F2. The retransmitted signal propagates along the cable (in both directions from the repeater) and can be received by any receiver tuned to F2 and in the proximity of the cables. In the illustration, it is heard by the operator of mobile Transceiver B. If the operator of Transceiver B wishes to reply to Transceiver A, the process is reversed. Transceiver A transmits on F1 which is received and repeated on F2 by the repeater, which is received by Transceiver A. Not shown is a dispatcher's control console which can be at the repeater site or at some distance away from the site with wire line interconnection. The dispatcher, by direct control of the repeater transmitter and receiver, can monitor or communicate with all mobile transceivers using the system. The system also allows all mobile and portable units capable of receiving F2 and within the area of coverage to monitor both sides of all conversations conducted on the system.

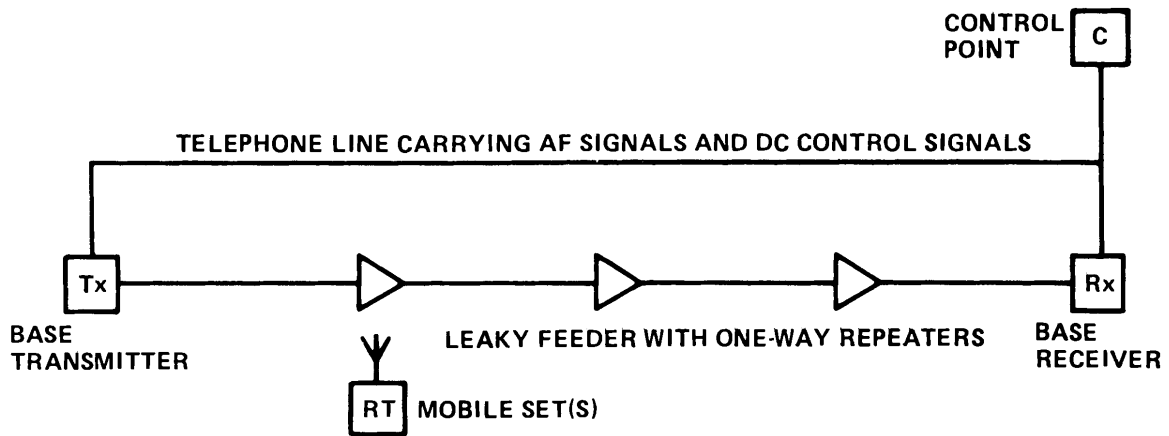
Figure 2.4. Daisy Chain Systems.

The simplest system using in-line repeaters is the “daisy chain,” illustrated in Figure 2.4A. The transmitter and receiver are located at the opposite ends of the cable. A particular requirement of this system is an audio line (or other means) for returning the received signal to the control point. Nonetheless, over 70 coal mines in the UK are reportedly equipped with this type of system.

A. SIMPLE DAISY-CHAIN SYSTEM

B. DOUBLE DAISY-CHAIN

C. BI DIRECTIONAL AMPLIFIER

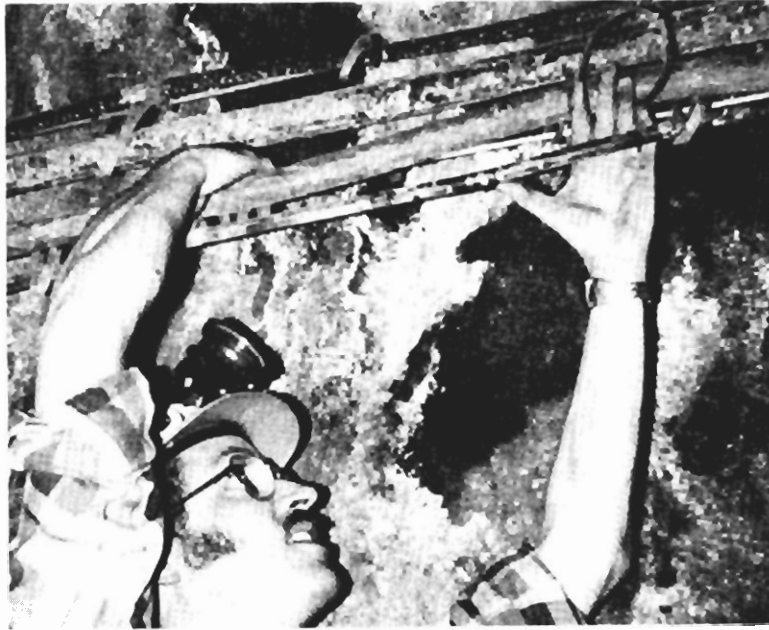
**Figure 3.8. Blasting Damage Done to Unprotected Radiax in Loading Drifts.**

Radiax damage frequently occurs in the loading area by the blasting of excess ore from the top of overloaded rail cars (Figure 3.8). The blasting is necessary to ensure the minimum required clearance of 4 inches between the top of the loaded ore car and the trolley power system. The blasting causes the Radiax to be peppered with small high speed projectiles which either completely destroy a section of cable or penetrate enough to cause the outer conductor to collapse against the inner conductor causing either a short circuit or dramatic change in impedance characteristics. As cable is replaced within the loading area, it is being placed inside fabric reinforced air hose and then reinstalled (Figure 3.9). This operation is performed by inserting the Radiax in sections of used hose and reinstalling in the drifts. It is assumed that the lengths of both fabric reinforced hose and the Radiax must be kept to a manageable length. This has proven effective in reducing damage caused by blasting.

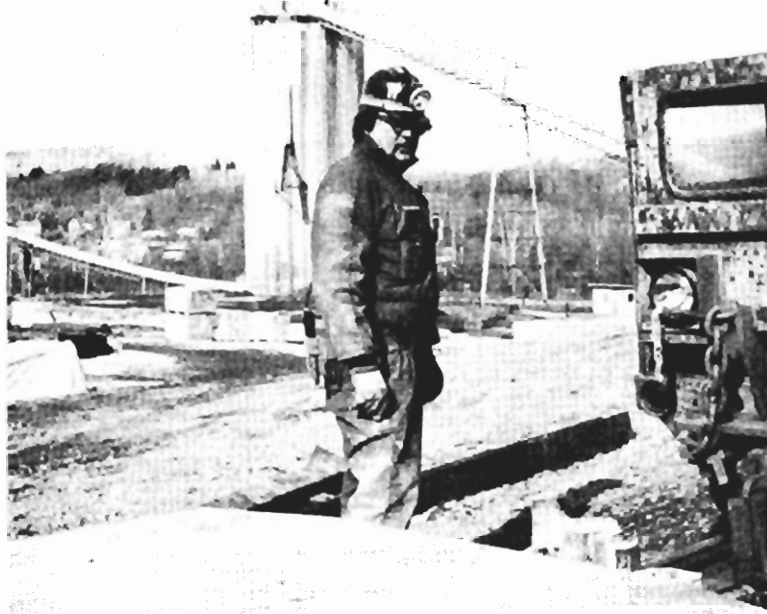
**Figure 3.23.** Snapper, Hooking and Unhooking Cars, with UHF Portable Radio in Upper Right Pocket.

Like Mine A, the leaky feeder system was installed new during the early development of the mine. No comparison can be made by management as to effects on production and no direct tie to safety can be made as there have been no major incidences in which the communications system was needed. The single most obvious benefit is that of convenience and smooth operation of the electric rail system (Figure 3.23).
